## Profile/Photo Observation Report

Street:	<b>Bracken</b>	Flow Control:	<b>Not Controlled</b>
City:	<b>Hobart, IN</b>	Year Renewed:	
Location:	<b>Sidewalk</b>	Tape/Media #:	
Purpose:	<b>Maintenance Related</b>	Dia/Height:	<b>12"</b>
Use:	<b>Sanitary</b>	Material:	<b>PVC</b>
Drain Area:	<b>NA</b>	Lining:	<b>Cured in Place</b>
Category:	<b>NA</b>		
Comment:	<b>Reverse setup.</b>

Location Details:		Direction of Survey:	<b>Upstream</b>
US MH:	<b>M-708-105</b>	DS MH:	<b>M-708-104</b>
		Total Length Surveyed (ft):	<b>103.9</b>

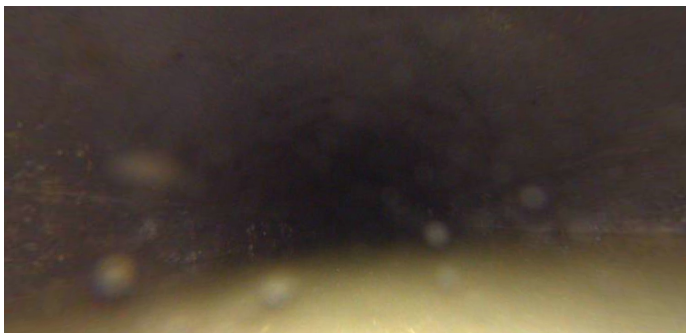
Code: **AMH**  
Description: **Manhole**

Distance (ft): **.0**  
Structural Grade: **0**  
O&M Grade: **0**  
Clock Start/From:  
Clock To:  
1st Value:  
2nd Value:  
Value Percent:  
Continuous Index:  
Within 8" of Joint: **NO**  
Remarks: **M-708-104**

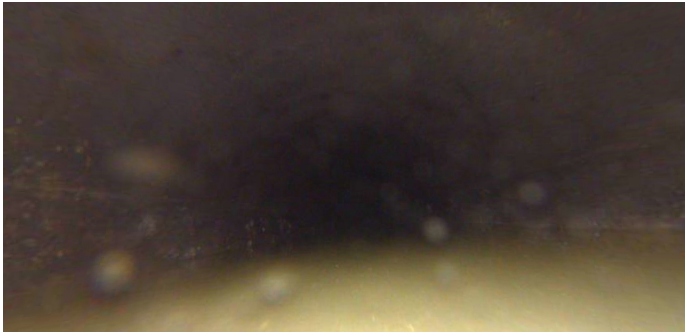
Code:	<b>MWL</b>
Description:	<b>Water Level</b>

Distance (ft):	<b>.0</b>
Structural Grade:	<b>0</b>
O&M Grade:	<b>0</b>
Clock Start/From:	
Clock To:	
1st Value:	
2nd Value:	
Value Percent:	<b>40.000</b>
Continuous Index:	
Within 8" of Joint:	<b>NO</b>
Remarks:

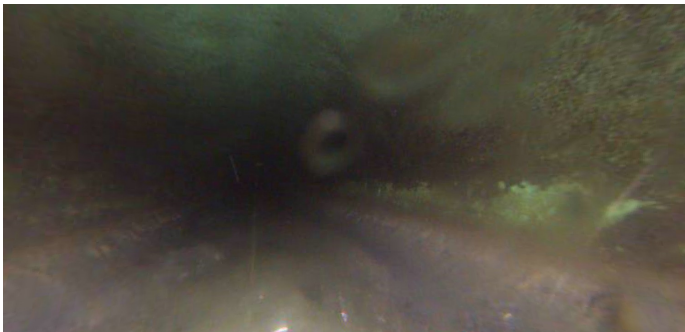
Code:	<b>MGO</b>
Description:	<b>General Observation</b>

Distance (ft):	<b>11.7</b>
Structural Grade:	<b>0</b>
O&M Grade:	<b>0</b>
Clock Start/From:	
Clock To:	
1st Value:	
2nd Value:	
Value Percent:	
Continuous Index:	
Within 8" of Joint:	<b>NO</b>
Remarks:	<b>rear camera</b>

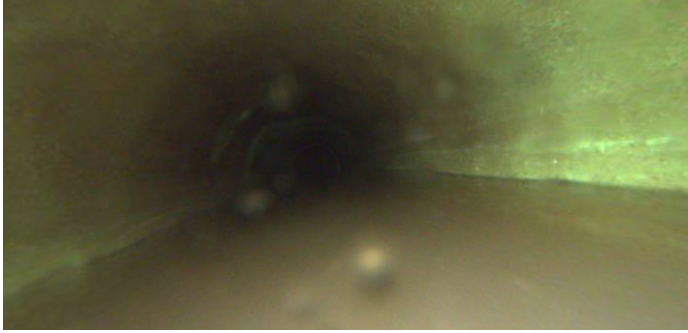
Code:	<b>MSA</b>
Description:	<b>Abandoned Survey</b>
Distance (ft):	<b>103.9</b>
Structural Grade:	<b>0</b>
O&M Grade:	<b>0</b>
Clock Start/From:	
Clock To:	
1st Value:	
2nd Value:	
Value Percent:	
Continuous Index:	
Within 8" of Joint:	<b>NO</b>
Remarks:	<b>debris under water</b>
