Profile/Photo Observation Report

Street:	BRACKEN PKWY & LAKE ST	Flow Control:	Not Controlled
City:	Hobart, IN	Year Renewed:	
Location:	Sidewalk	Tape/Media #:	
Purpose:	Maintenance Related	Dia/Height:	12"
Use:	Sanitary	Material:	PVC
Drain Area:	NA	Lining:	Cured in Place
Category:	NA		
Comment:	Debris at 53'.

Location Details:		Direction of Survey:	Downstream
US MH:	M-708-105	DS MH:	M-708-104
		Total Length Surveyed (ft):	54.8

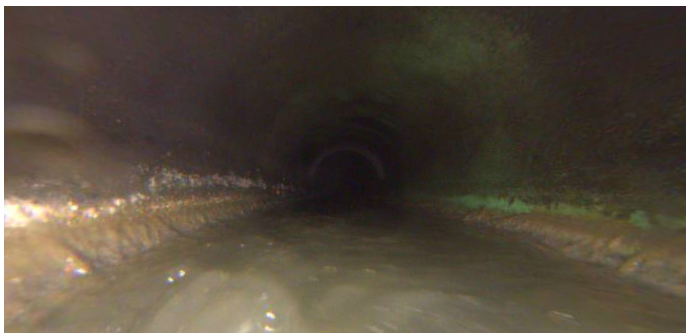
Code: **AMH**
Description: **Manhole**

Distance (ft): **.0**
Structural Grade: **0**
O&M Grade: **0**
Clock Start/From:
Clock To:
1st Value:
2nd Value:
Value Percent:
Continuous Index:
Within 8" of Joint: **NO**
Remarks: **M-708-105**

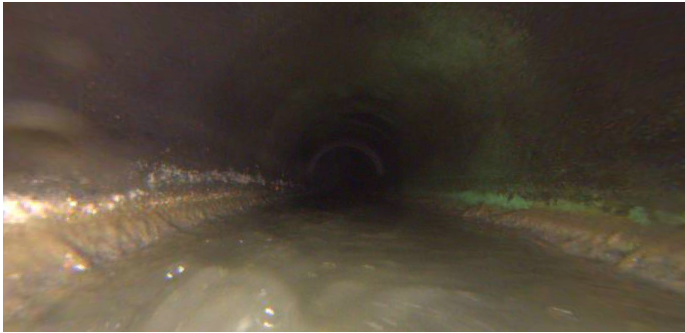
Code:	MWL
Description:	Water Level

Distance (ft):	.0
Structural Grade:	0
O&M Grade:	0
Clock Start/From:	
Clock To:	
1st Value:	
2nd Value:	
Value Percent:	30.000
Continuous Index:	
Within 8" of Joint:	NO
Remarks:

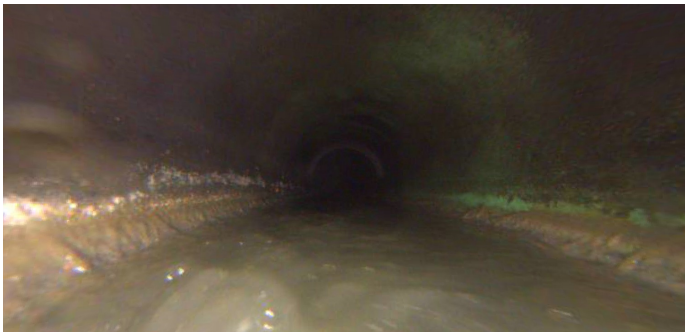
Code:	DAGS
Description:	Deposits Attached Grease

Distance (ft):	.0
Structural Grade:	0
O&M Grade:	2
Clock Start/From:	8
Clock To:	4
1st Value:	
2nd Value:	
Value Percent:	5.000
Continuous Index:	S01
Within 8" of Joint:	NO
Remarks:

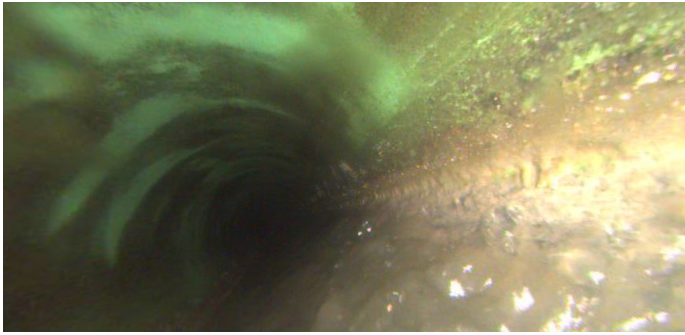
Code: **DAGS**
Description: **Deposits Attached Grease**

Distance (ft): **54.8**
Structural Grade: **0**
O&M Grade: **2**
Clock Start/From: **8**
Clock To: **4**
1st Value:
2nd Value:
Value Percent: **5.000**
Continuous Index: **F01**
Within 8" of Joint: **NO**
Remarks:

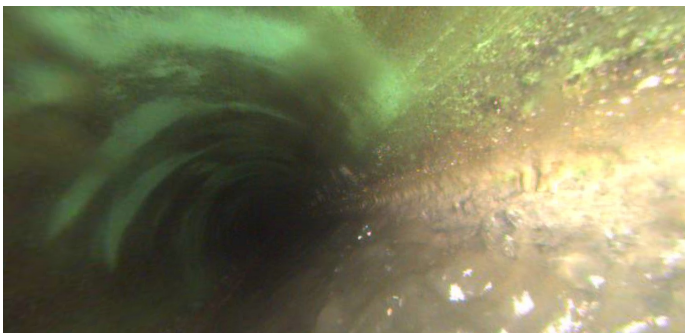
Code: **MSA**
Description: **Abandoned Survey**

Distance (ft): **54.8**
Structural Grade: **0**
O&M Grade: **0**
Clock Start/From:
Clock To:
1st Value:
2nd Value:
Value Percent:
Continuous Index:
Within 8" of Joint: **NO**
Remarks: **overturned**
