Profile/Photo Observation Report

Street:	Bracken	Flow Control:	Not Controlled
City:	Hobart, IN	Year Renewed:	
Location:	Sidewalk	Tape/Media #:	
Purpose:	Maintenance Related	Dia/Height:	12"
Use:	Sanitary	Material:	PVC
Drain Area:	NA	Lining:	Cured in Place
Category:	NA		
Comment:	Debris at 53'.

Location Details:		Direction of Survey:	Downstream
US MH:	M-708-105	DS MH:	M-708-104
		Total Length Surveyed (ft):	54.8

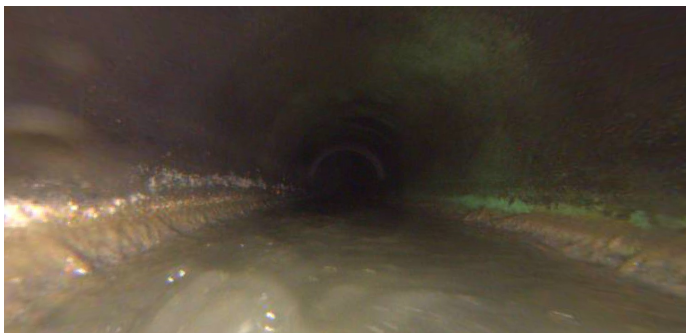
Code: **AMH**
Description: **Manhole**

Distance (ft): **.0**
Structural Grade: **0**
O&M Grade: **0**
Clock Start/From:
Clock To:
1st Value:
2nd Value:
Value Percent:
Continuous Index:
Within 8" of Joint: **NO**
Remarks: **M-708-105**

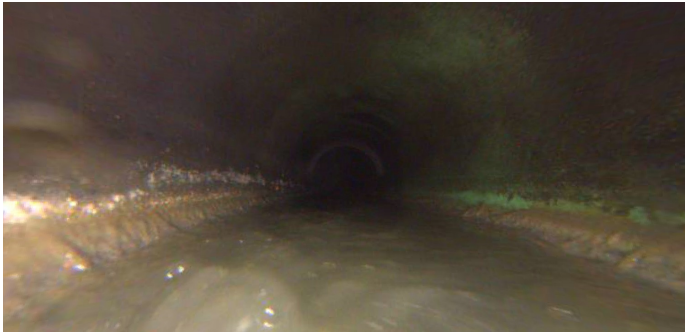
Code:	MWL
Description:	Water Level

Distance (ft):	.0
Structural Grade:	0
O&M Grade:	0
Clock Start/From:	
Clock To:	
1st Value:	
2nd Value:	
Value Percent:	30.000
Continuous Index:	
Within 8" of Joint:	NO
Remarks:

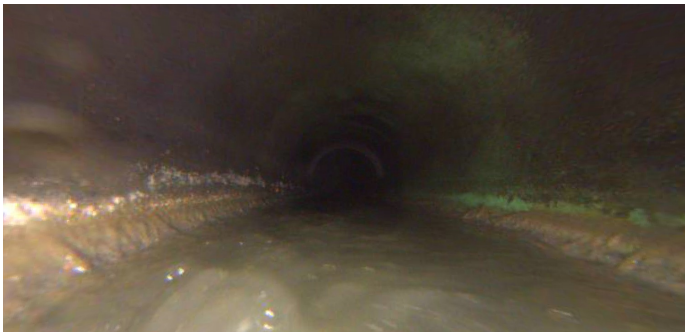
Code:	DAGS
Description:	Deposits Attached Grease

Distance (ft):	.0
Structural Grade:	0
O&M Grade:	2
Clock Start/From:	8
Clock To:	4
1st Value:	
2nd Value:	
Value Percent:	5.000
Continuous Index:	S01
Within 8" of Joint:	NO
Remarks:

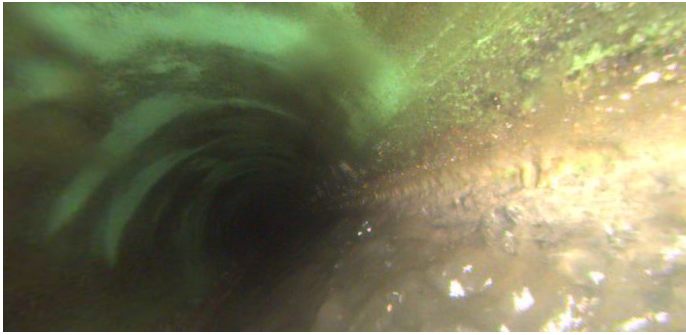
Code: **DAGS**
Description: **Deposits Attached Grease**

Distance (ft): **54.8**
Structural Grade: **0**
O&M Grade: **2**
Clock Start/From: **8**
Clock To: **4**
1st Value:
2nd Value:
Value Percent: **5.000**
Continuous Index: **F01**
Within 8" of Joint: **NO**
Remarks:

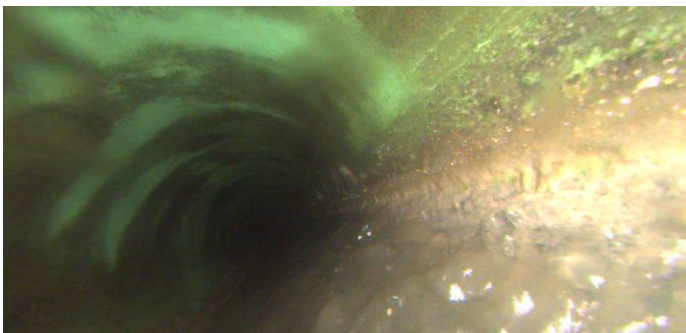
Code: **MSA**
Description: **Abandoned Survey**

Distance (ft): **54.8**
Structural Grade: **0**
O&M Grade: **0**
Clock Start/From:
Clock To:
1st Value:
2nd Value:
Value Percent:
Continuous Index:
Within 8" of Joint: **NO**
Remarks: **overturned**
