Profile/Photo Observation Report

Street:	BRACKEN PKWY & LAKE ST	Flow Control:	Not Controlled
City:	Hobart, IN	Year Renewed:	
Location:	Sidewalk	Tape/Media #:	
Purpose:	Maintenance Related	Dia/Height:	12"
Use:	Sanitary	Material:	PVC
Drain Area:	NA	Lining:	Cured in Place
Category:	NA		
Comment:	Flow direction wrong.

Location Details:		Direction of Survey:	Downstream
US MH:	M-708-105	DS MH:	M-708-140
		Total Length Surveyed (ft):	174.5

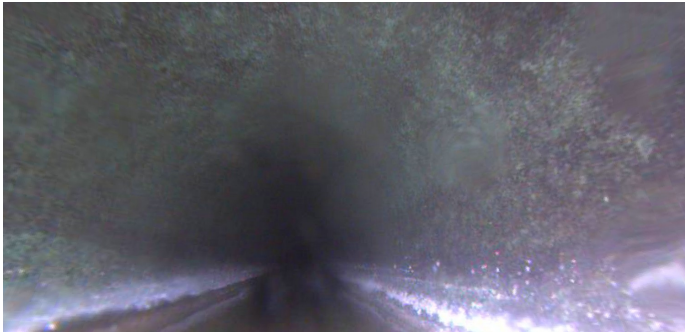
Code:	MWL
Description:	Water Level

Distance (ft):	.0
Structural Grade:	0
O&M Grade:	0
Clock Start/From:	
Clock To:	
1st Value:	
2nd Value:	
Value Percent:	10.000
Continuous Index:	
Within 8" of Joint:	NO
Remarks:

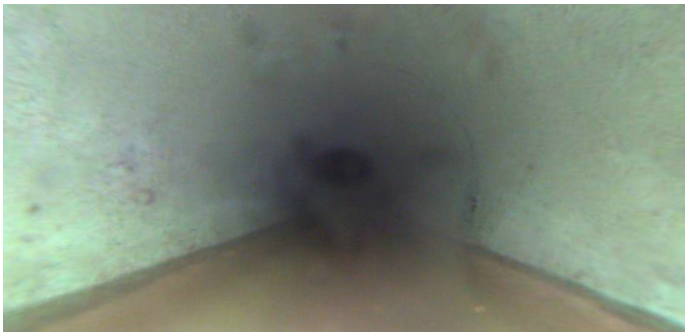
Code:	MWL
Description:	Water Level

Distance (ft):	38.8
Structural Grade:	0
O&M Grade:	0
Clock Start/From:	
Clock To:	
1st Value:	
2nd Value:	
Value Percent:	20.000
Continuous Index:	
Within 8" of Joint:	NO
Remarks:

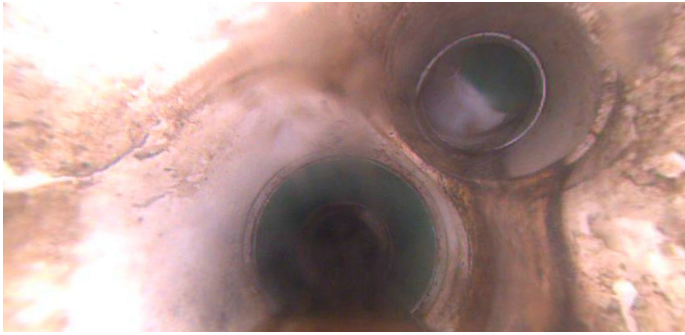
Code: **TF**
Description: **Tap Factory**

Distance (ft): **134.2**
Structural Grade: **0**
O&M Grade: **0**
Clock Start/From: **2**
Clock To:
1st Value: **4.000**
2nd Value:
Value Percent:
Continuous Index:
Within 8" of Joint:
Remarks:

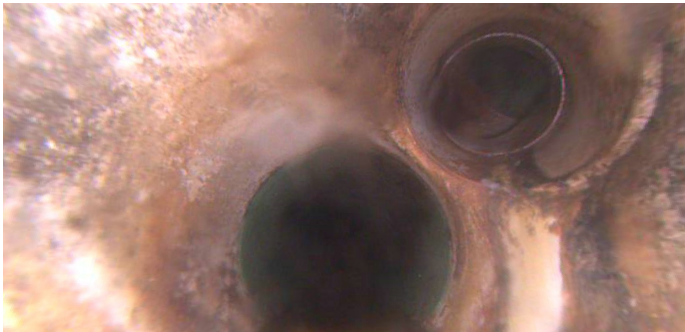
Code: **TF**
Description: **Tap Factory**

Distance (ft): **136.8**
Structural Grade: **0**
O&M Grade: **0**
Clock Start/From: **2**
Clock To:
1st Value: **4.000**
2nd Value:
Value Percent:
Continuous Index:
Within 8" of Joint:
Remarks:

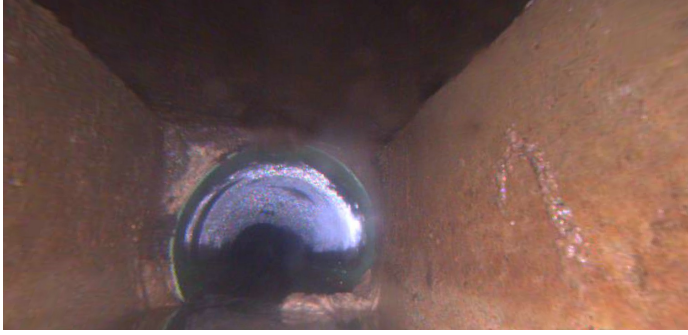
Code:	AMH
Description:	Manhole
Distance (ft):	174.5
Structural Grade:	0
O&M Grade:	0
Clock Start/From:	
Clock To:	
1st Value:	
2nd Value:	
Value Percent:	
Continuous Index:	
Within 8" of Joint:	NO
Remarks:	M-708-140
