## Profile/Photo Observation Report

Street:	<b>Bracken</b>	Flow Control:	<b>Not Controlled</b>
City:	<b>Hobart, IN</b>	Year Renewed:	
Location:	<b>Sidewalk</b>	Tape/Media #:	
Purpose:	<b>Maintenance Related</b>	Dia/Height:	<b>12"</b>
Use:	<b>Sanitary</b>	Material:	<b>PVC</b>
Drain Area:	<b>NA</b>	Lining:	<b>Cured in Place</b>
Category:	<b>NA</b>		
Comment:	<b>Flow direction wrong.</b>

Location Details:		Direction of Survey:	<b>Downstream</b>
US MH:	<b>M-708-105</b>	DS MH:	<b>M-708-140</b>
		Total Length Surveyed (ft):	<b>174.5</b>

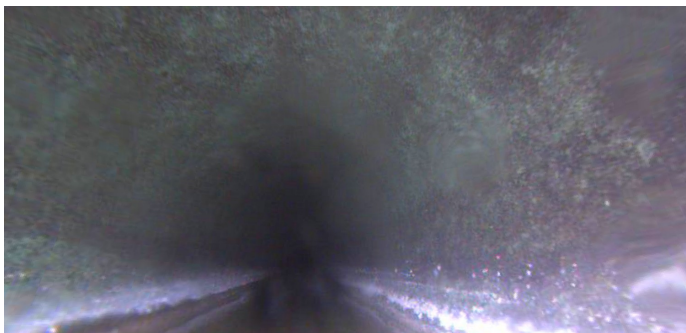
Code: **AMH**  
Description: **Manhole**

Distance (ft): **.0**  
Structural Grade: **0**  
O&M Grade: **0**  
Clock Start/From:  
Clock To:  
1st Value:  
2nd Value:  
Value Percent:  
Continuous Index:  
Within 8" of Joint: **NO**  
Remarks: **M-708-105**

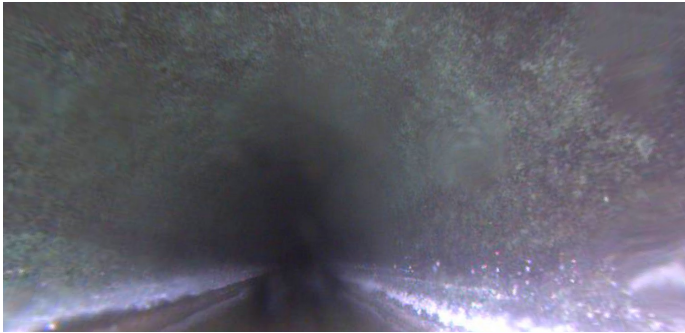
Code:	<b>MWL</b>
Description:	<b>Water Level</b>

Distance (ft):	<b>.0</b>
Structural Grade:	<b>0</b>
O&M Grade:	<b>0</b>
Clock Start/From:	
Clock To:	
1st Value:	
2nd Value:	
Value Percent:	<b>10.000</b>
Continuous Index:	
Within 8" of Joint:	<b>NO</b>
Remarks:

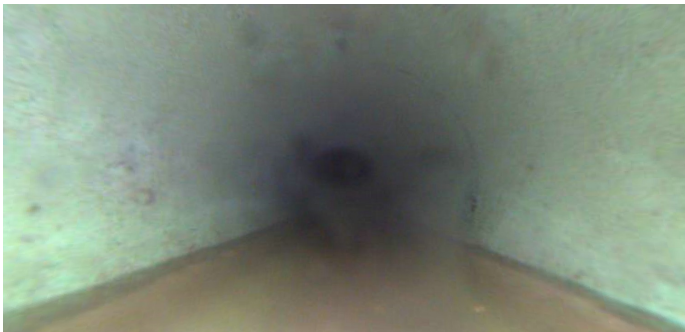
Code:	<b>MWL</b>
Description:	<b>Water Level</b>

Distance (ft):	<b>38.8</b>
Structural Grade:	<b>0</b>
O&M Grade:	<b>0</b>
Clock Start/From:	
Clock To:	
1st Value:	
2nd Value:	
Value Percent:	<b>20.000</b>
Continuous Index:	
Within 8" of Joint:	<b>NO</b>
Remarks:

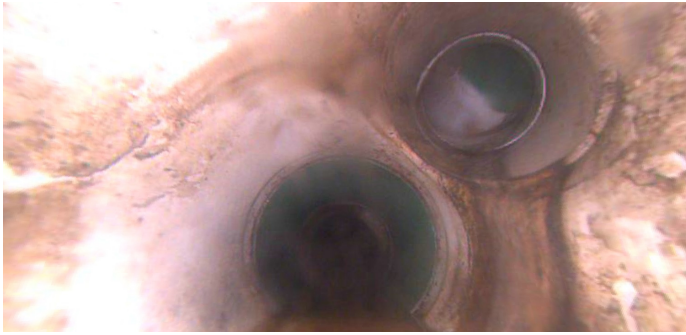
Code: **TF**  
Description: **Tap Factory**

Distance (ft): **134.2**  
Structural Grade: **0**  
O&M Grade: **0**  
Clock Start/From: **2**  
Clock To:  
1st Value: **4.000**  
2nd Value:  
Value Percent:  
Continuous Index:  
Within 8" of Joint:  
Remarks:

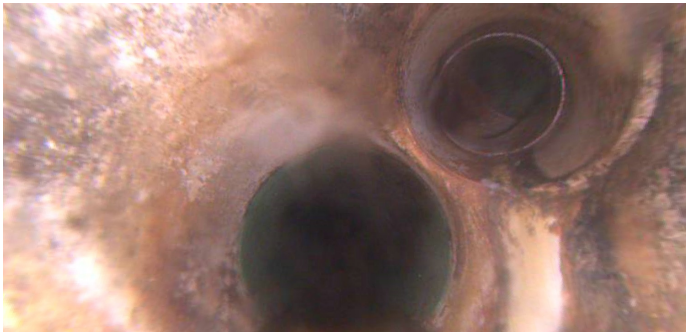
Code: **TF**  
Description: **Tap Factory**

Distance (ft): **136.8**  
Structural Grade: **0**  
O&M Grade: **0**  
Clock Start/From: **2**  
Clock To:  
1st Value: **4.000**  
2nd Value:  
Value Percent:  
Continuous Index:  
Within 8" of Joint:  
Remarks:

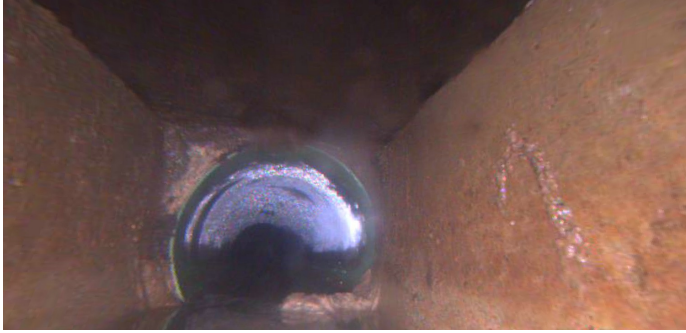
Code:	<b>AMH</b>
Description:	<b>Manhole</b>
Distance (ft):	<b>174.5</b>
Structural Grade:	<b>0</b>
O&M Grade:	<b>0</b>
Clock Start/From:	
Clock To:	
1st Value:	
2nd Value:	
Value Percent:	
Continuous Index:	
Within 8" of Joint:	<b>NO</b>
Remarks:	<b>M-708-140</b>
