Profile/Photo Observation Report

Street:	BRACKEN PKWY & LAKE ST	Flow Control:	Not Controlled
City:	Hobart, IN	Year Renewed:	
Location:	Sidewalk	Tape/Media #:	
Purpose:	Maintenance Related	Dia/Height:	8"
Use:	Sanitary	Material:	PVC
Drain Area:	NA	Lining:	Cured in Place
Category:	NA		
Comment:	Debris at 77'.

Location Details:		Direction of Survey:	Downstream
US MH:	M-708-106	DS MH:	M-708-105
		Total Length Surveyed (ft):	78.6

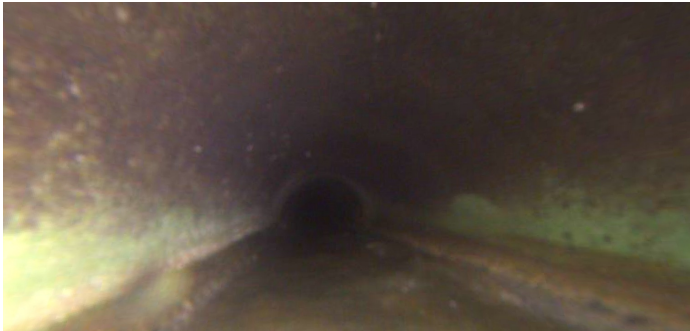
Code: AMH

Description: Manhole

Distance (ft): .0

Remarks: M-708-106

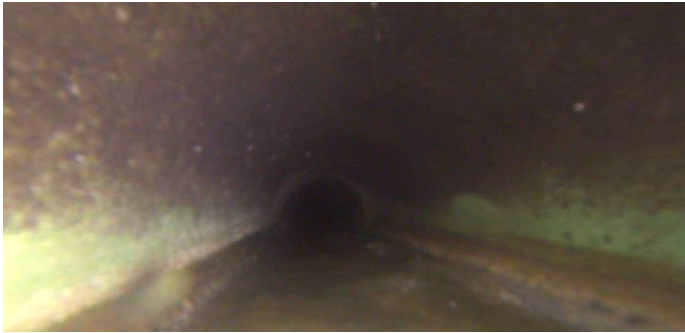
Code:	MWL
Description:	Water Level

Distance (ft):	.0
Structural Grade:	0
O&M Grade:	0
Clock Start/From:	
Clock To:	
1st Value:	
2nd Value:	
Value Percent:	20.000
Continuous Index:	
Within 8" of Joint:	NO
Remarks:

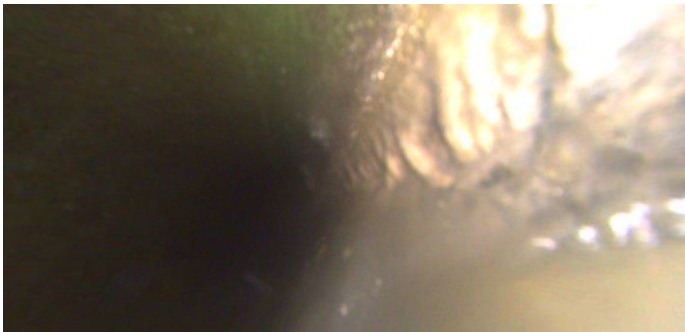
Code:	MSA
Description:	Abandoned Survey

Distance (ft):	78.6
Structural Grade:	0
O&M Grade:	0
Clock Start/From:	
Clock To:	
1st Value:	
2nd Value:	
Value Percent:	
Continuous Index:	
Within 8" of Joint:	NO
Remarks:	debris
