## Profile/Photo Observation Report

Street:	<b>Bracken</b>	Flow Control:	<b>Not Controlled</b>
City:	<b>Hobart, IN</b>	Year Renewed:	
Location:	<b>Sidewalk</b>	Tape/Media #:	
Purpose:	<b>Maintenance Related</b>	Dia/Height:	<b>8"</b>
Use:	<b>Sanitary</b>	Material:	<b>PVC</b>
Drain Area:	<b>NA</b>	Lining:	<b>Cured in Place</b>
Category:	<b>NA</b>		
Comment:	<b>Debris at 77'.</b>

Location Details:		Direction of Survey:	<b>Downstream</b>
US MH:	<b>M-708-106</b>	DS MH:	<b>M-708-105</b>
		Total Length Surveyed (ft):	<b>78.6</b>

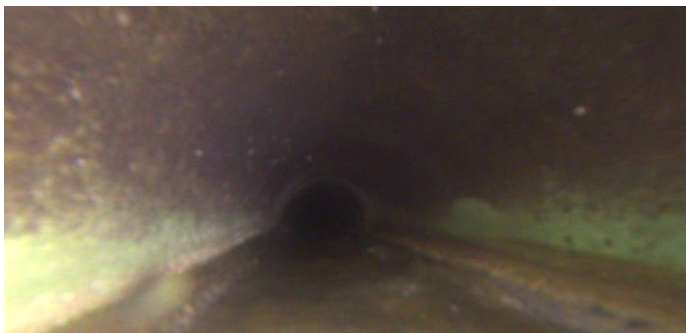
Code: **AMH**  
Description: **Manhole**

Distance (ft): **.0**  
Structural Grade: **0**  
O&M Grade: **0**  
Clock Start/From:  
Clock To:  
1st Value:  
2nd Value:  
Value Percent:  
Continuous Index:  
Within 8" of Joint: **NO**  
Remarks: **M-708-106**

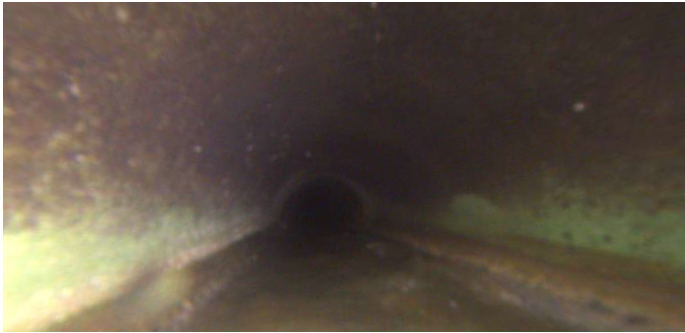
Code:	<b>MWL</b>
Description:	<b>Water Level</b>

Distance (ft):	<b>.0</b>
Structural Grade:	<b>0</b>
O&M Grade:	<b>0</b>
Clock Start/From:	
Clock To:	
1st Value:	
2nd Value:	
Value Percent:	<b>20.000</b>
Continuous Index:	
Within 8" of Joint:	<b>NO</b>
Remarks:

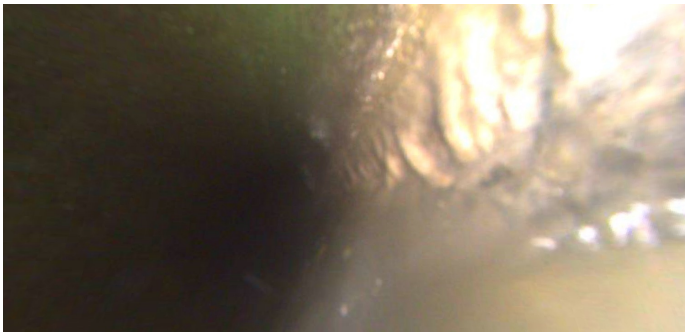
Code:	<b>MSA</b>
Description:	<b>Abandoned Survey</b>

Distance (ft):	<b>78.6</b>
Structural Grade:	<b>0</b>
O&M Grade:	<b>0</b>
Clock Start/From:	
Clock To:	
1st Value:	
2nd Value:	
Value Percent:	
Continuous Index:	
Within 8" of Joint:	<b>NO</b>
Remarks:	<b>debris</b>
