## Profile/Photo Observation Report

Street:	<b>TAMARACK DR</b>	Flow Control:	<b>Not Controlled</b>
City:	<b>Hobart, IN</b>	Year Renewed:	
Location:	<b>Sidewalk</b>	Tape/Media #:	
Purpose:	<b>Maintenance Related</b>	Dia/Height:	<b>8"</b>
Use:	<b>Sanitary</b>	Material:	<b>PVC</b>
Drain Area:	<b>NA</b>	Lining:	<b>Cured in Place</b>
Category:	<b>NA</b>		
Comment:	<b>Flow direction wrong.</b>

Location Details:		Direction of Survey:	<b>Upstream</b>
US MH:	<b>M-708-106</b>	DS MH:	<b>M-708-120</b>
		Total Length Surveyed (ft):	<b>149.9</b>

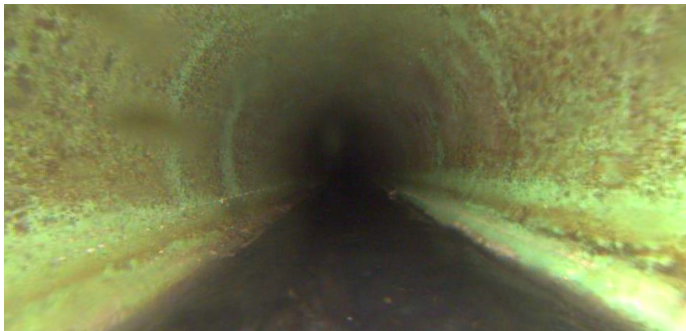
Code: **AMH**  
Description: **Manhole**

Distance (ft): **.0**  
Structural Grade: **0**  
O&M Grade: **0**  
Clock Start/From:  
Clock To:  
1st Value:  
2nd Value:  
Value Percent:  
Continuous Index:  
Within 8" of Joint: **NO**  
Remarks: **M-708-120**

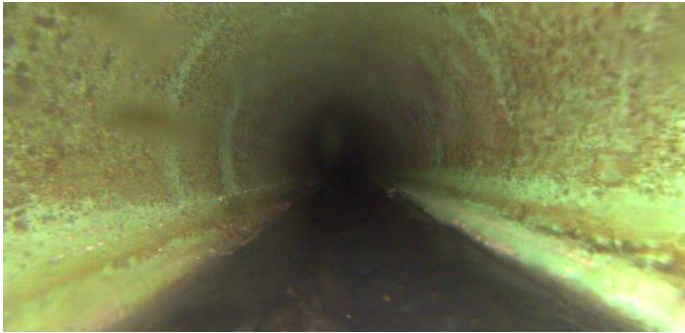
Code:	<b>MWL</b>
Description:	<b>Water Level</b>

Distance (ft):	<b>.0</b>
Structural Grade:	<b>0</b>
O&M Grade:	<b>0</b>
Clock Start/From:	
Clock To:	
1st Value:	
2nd Value:	
Value Percent:	<b>10.000</b>
Continuous Index:	
Within 8" of Joint:	<b>NO</b>
Remarks:

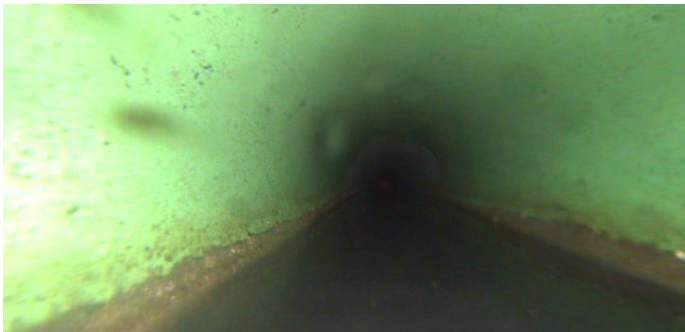
Code:	<b>MWL</b>
Description:	<b>Water Level</b>

Distance (ft):	<b>89.9</b>
Structural Grade:	<b>0</b>
O&M Grade:	<b>0</b>
Clock Start/From:	
Clock To:	
1st Value:	
2nd Value:	
Value Percent:	<b>40.000</b>
Continuous Index:	
Within 8" of Joint:	<b>NO</b>
Remarks:

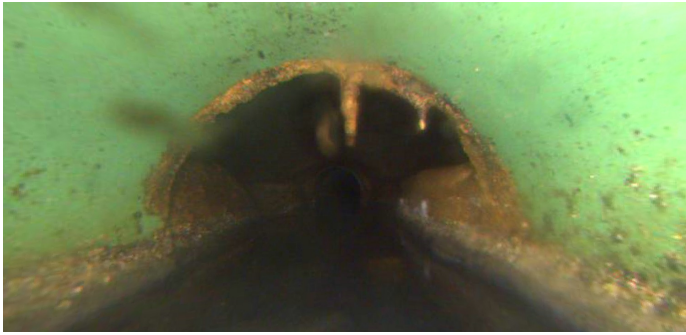
Code: **DAE**  
Description: **Deposits Attached Encrustation**

Distance (ft): **147.2**  
Structural Grade: **0**  
O&M Grade: **2**  
Clock Start/From: **8**  
Clock To: **4**  
1st Value:  
2nd Value:  
Value Percent: **5.000**  
Continuous Index:  
Within 8" of Joint: **YES**  
Remarks: **AT MH**

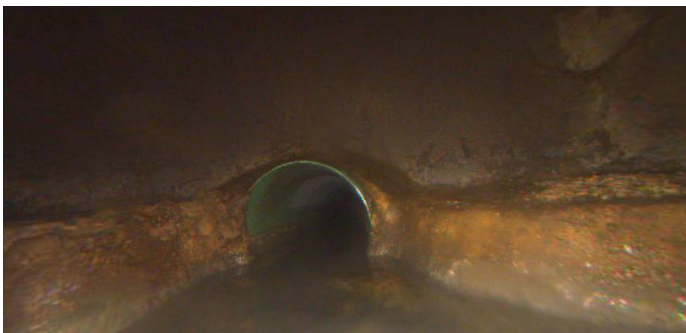
Code: **AMH**  
Description: **Manhole**

Distance (ft): **149.9**  
Structural Grade: **0**  
O&M Grade: **0**  
Clock Start/From:  
Clock To:  
1st Value:  
2nd Value:  
Value Percent:  
Continuous Index:  
Within 8" of Joint: **NO**  
Remarks: **M-708-106**
