## Profile/Photo Observation Report

Street:	<b>Magnolia</b>	Flow Control:	<b>Not Controlled</b>
City:	<b>Hobart, IN</b>	Year Renewed:	
Location:	<b>Sidewalk</b>	Tape/Media #:	
Purpose:	<b>Maintenance Related</b>	Dia/Height:	<b>8"</b>
Use:	<b>Sanitary</b>	Material:	<b>PVC</b>
Drain Area:	<b>NA</b>	Lining:	<b>Cured in Place</b>
Category:	<b>NA</b>		
Comment:	<b>Flow direction wrong.</b>

Location Details:		Direction of Survey:	<b>Upstream</b>
US MH:	<b>M-708-106</b>	DS MH:	<b>M-708-120</b>
		Total Length Surveyed (ft):	<b>149.9</b>

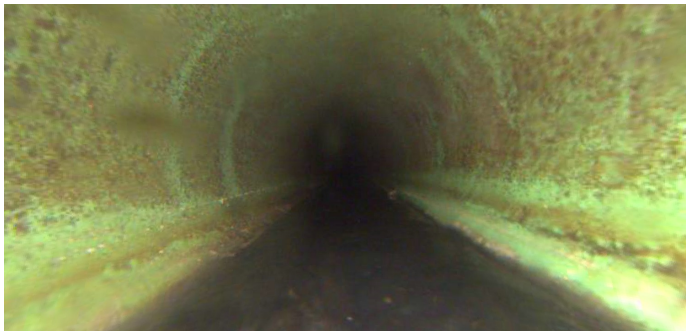
Code: **AMH**  
Description: **Manhole**

Distance (ft): **.0**  
Structural Grade: **0**  
O&M Grade: **0**  
Clock Start/From:  
Clock To:  
1st Value:  
2nd Value:  
Value Percent:  
Continuous Index:  
Within 8" of Joint: **NO**  
Remarks: **M-708-120**

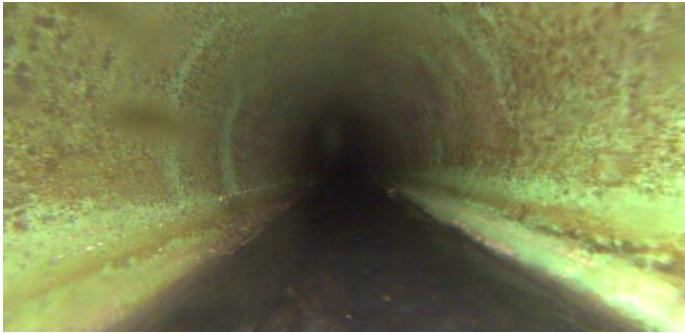
Code:	<b>MWL</b>
Description:	<b>Water Level</b>

Distance (ft):	<b>.0</b>
Structural Grade:	<b>0</b>
O&M Grade:	<b>0</b>
Clock Start/From:	
Clock To:	
1st Value:	
2nd Value:	
Value Percent:	<b>10.000</b>
Continuous Index:	
Within 8" of Joint:	<b>NO</b>
Remarks:

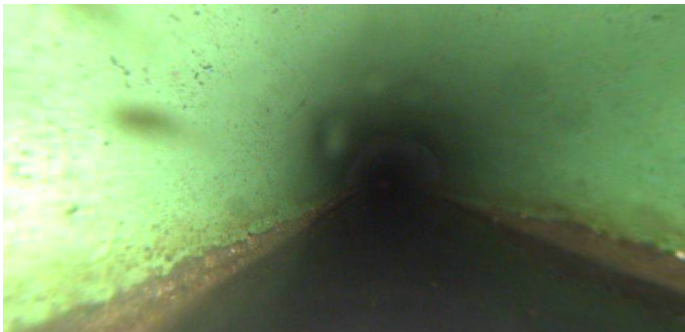
Code:	<b>MWL</b>
Description:	<b>Water Level</b>

Distance (ft):	<b>89.9</b>
Structural Grade:	<b>0</b>
O&M Grade:	<b>0</b>
Clock Start/From:	
Clock To:	
1st Value:	
2nd Value:	
Value Percent:	<b>40.000</b>
Continuous Index:	
Within 8" of Joint:	<b>NO</b>
Remarks:

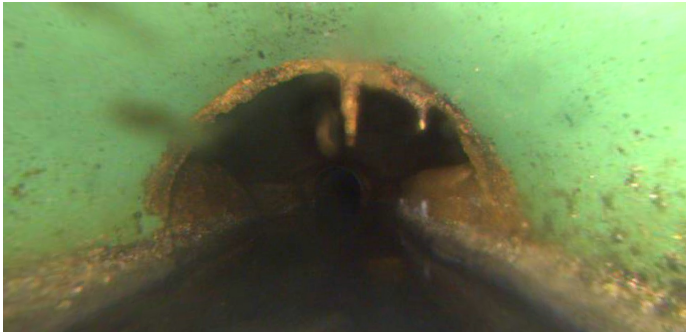
Code: **DAE**  
Description: **Deposits Attached Encrustation**

Distance (ft): **147.2**  
Structural Grade: **0**  
O&M Grade: **2**  
Clock Start/From: **8**  
Clock To: **4**  
1st Value:  
2nd Value:  
Value Percent: **5.000**  
Continuous Index:  
Within 8" of Joint: **YES**  
Remarks: **AT MH**

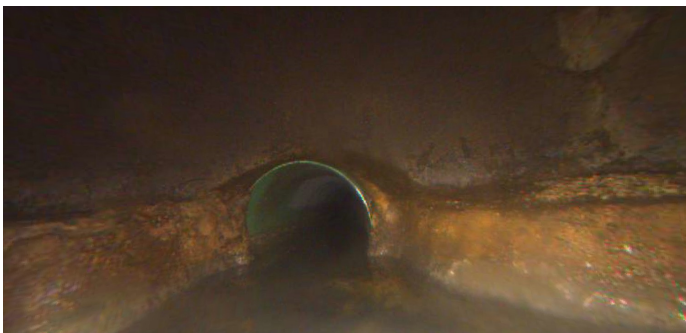
Code: **AMH**  
Description: **Manhole**

Distance (ft): **149.9**  
Structural Grade: **0**  
O&M Grade: **0**  
Clock Start/From:  
Clock To:  
1st Value:  
2nd Value:  
Value Percent:  
Continuous Index:  
Within 8" of Joint: **NO**  
Remarks: **M-708-106**
