Profile/Photo Observation Report

Street:	BRACKEN PKWY & 16TH ST	Flow Control:	Not Controlled
City:	Hobart, IN	Year Renewed:	
Location:	Sidewalk	Tape/Media #:	
Purpose:	Maintenance Related	Dia/Height:	8"
Use:	Sanitary	Material:	PVC
Drain Area:	NA	Lining:	Cured in Place
Category:	NA		
Comment:

Location Details:		Direction of Survey:	Downstream
US MH:	M-708-106	DS MH:	M-708-160
		Total Length Surveyed (ft):	187.0

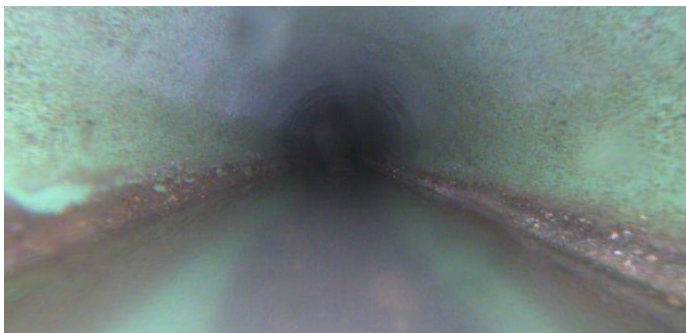
Code: **AMH**
Description: **Manhole**

Distance (ft): **.0**
Structural Grade: **0**
O&M Grade: **0**
Clock Start/From:
Clock To:
1st Value:
2nd Value:
Value Percent:
Continuous Index:
Within 8" of Joint: **NO**
Remarks: **M-708-106**

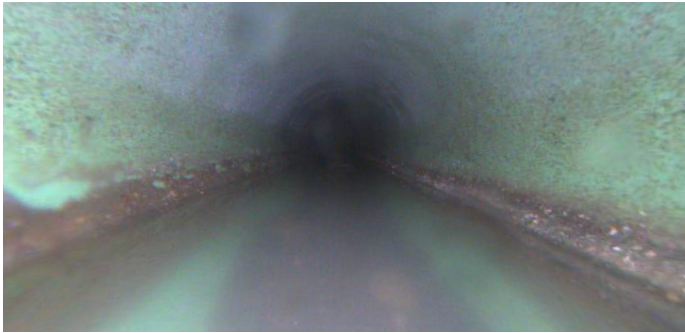
Code:	MWL
Description:	Water Level

Distance (ft):	.0
Structural Grade:	0
O&M Grade:	0
Clock Start/From:	
Clock To:	
1st Value:	
2nd Value:	
Value Percent:	20.000
Continuous Index:	
Within 8" of Joint:	NO
Remarks:

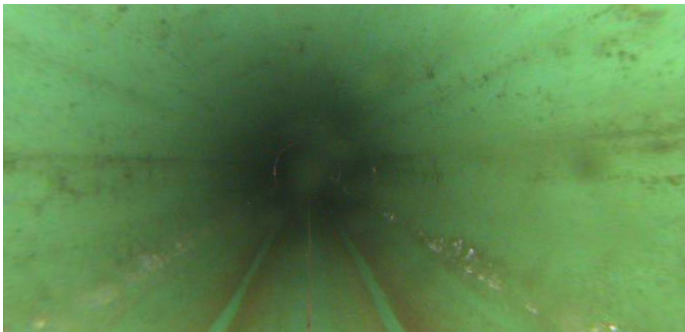
Code:	MGO
Description:	General Observation

Distance (ft):	41.4
Structural Grade:	0
O&M Grade:	0
Clock Start/From:	
Clock To:	
1st Value:	
2nd Value:	
Value Percent:	
Continuous Index:	
Within 8" of Joint:	NO
Remarks:	rear camera

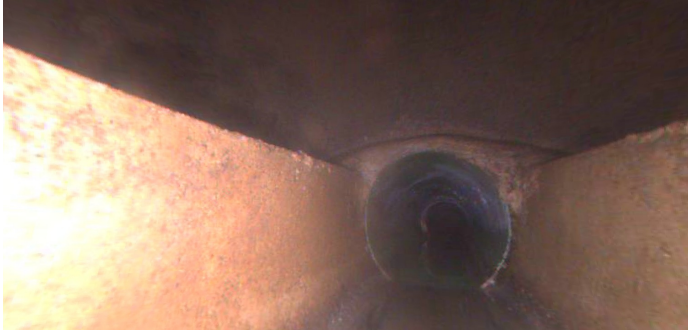
Code:	AMH
Description:	Manhole
Distance (ft):	187.0
Structural Grade:	0
O&M Grade:	0
Clock Start/From:	
Clock To:	
1st Value:	
2nd Value:	
Value Percent:	
Continuous Index:	
Within 8" of Joint:	NO
Remarks:	M-708-160
