Date:	04/04/2018	Weather:		Coding:	PACP 6.0
		Owner:	NA	Pre Clean:	Not Known
Pipe Length (ft P.O.#:). 220.1		Jen Costello	Pre clean. PSR:	P-708-160-106
		Surveyor: Clean Date:			
Customer:		Clean Date:	01/01/1900	Shape:	C
Street:	16th		Flow Control:	Not Controlle	d
City:	Hobart, IN		Year Renewed:		
Location:	Sidewalk		Tape/Media #:		
Purpose:	Maintenance Rela	ted	Dia/Height:	8"	
Use:	Sanitary		Material:	PVC	
Drain Area:	NA		Lining:	Cured in Place	2
Category:	NA				
Comment:					
Location Detail	s:		Direction of Surv	ey: Downstream	
US MH:	M-708-106	DS MH:	M-708-160	Total Length Surveyed (fi	:): 187.0
D&M Index:	0.00	O&M Quick:	000	0 O&M Rating:	0.00
Structural Index:	0.00	Structural Q	uick: 000		. 0.00
Overall Index:	0.00	Overall Quic	k. 000	0 Overall Rating:	0.00

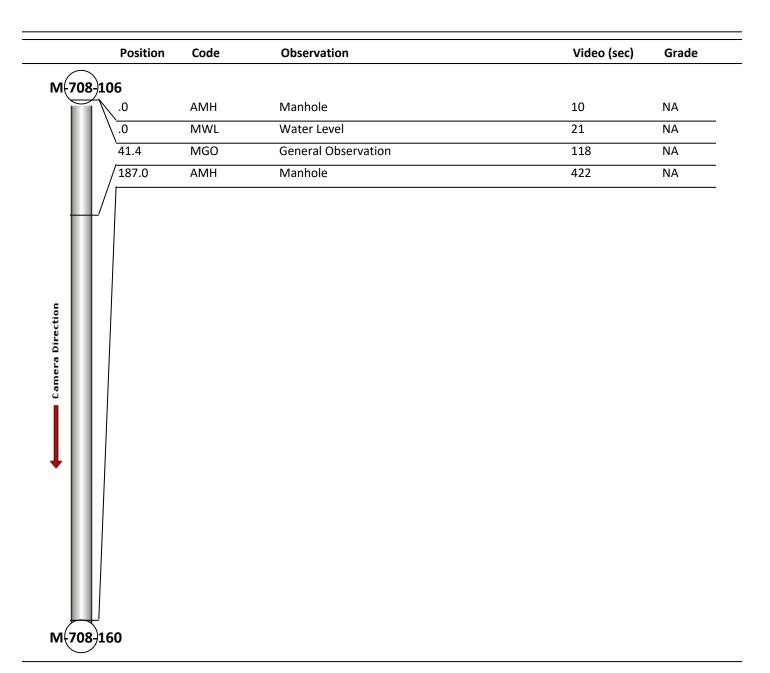
Code: Description:	AMH Manhole
Distance (ft):	.0
Structural Grade:	.0 0
O&M Grade:	0
	U
Clock Start/From:	
Clock To:	
1st Value:	
2nd Value:	
Value Percent:	
Continuous Index:	
Within 8" of Joint:	NO
Remarks:	M-708-106
