Profile/Ph	oto Observatio	n Report				RedZon R 0 B 0 T I C S
Date:	04/04/2018	Weather:			Coding:	PACP 6.0
Pipe Length (ft)	): <b>175.1</b>	Owner:	NA		Pre Clean:	Not Known
P.O.#:		Surveyor:	Jen Costello	)	PSR:	P-708-107-106
Customer:		Clean Date	: 01/01/1900		Shape:	C
Street:	BRACKEN PKWY & TAMARACK DR		Flow Control:		Not Controlled	
City:	Hobart, IN		Year Renewe	d:		
Location:	Sidewalk		Tape/Media	#:		
Purpose:	Maintenance Rela	ated	Dia/Height:		12"	
Use:	Sanitary		Material:		PVC	
Drain Area:	NA		Lining:		Cured in Place	
Category:	NA					
Comment:						
Location Detail	S:		Direction of S	urvey:	Upstream	
US MH:	M-708-107	DS MH:	M-708-106	Тс	otal Length Surveyed (ft)	: <b>185.7</b>
0&M Index:	0.00	O&M Quick	: (	0000	O&M Rating:	0.00
Structural Index:	0.00	Structural C	luick:	0000	Structural Rating:	0.00
Overall Index:	0.00	Overall Qui	ck:	0000	Overall Rating:	0.00

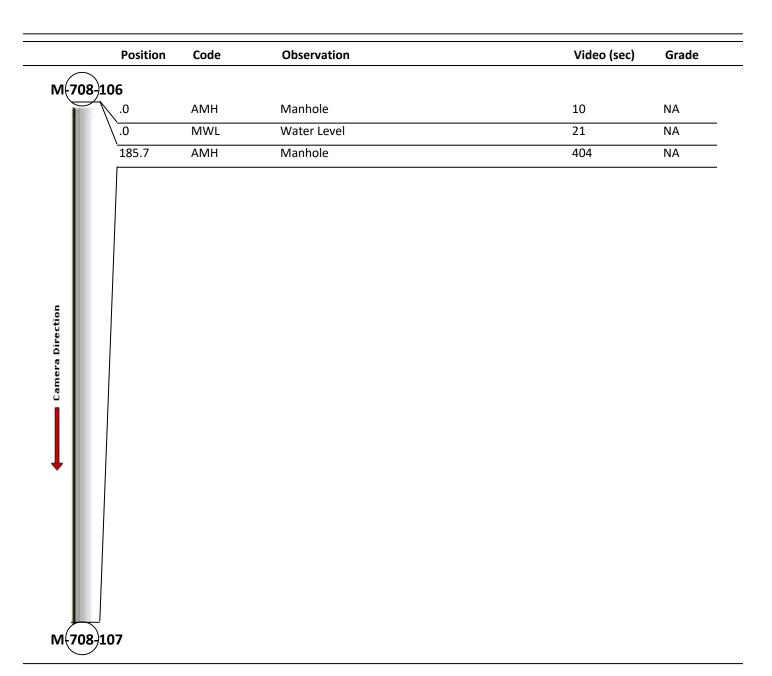
Code: Description:	AMH Manhole
Distance (ft):	.0
Structural Grade:	0
O&M Grade:	0
Clock Start/From:	
Clock To:	
1st Value:	
2nd Value:	
Value Percent:	
Continuous Index:	
Within 8" of Joint:	NO
Remarks:	M-708-106
