Profile/Photo Observation Report

Street:	Bracken	Flow Control:	Not Controlled
City:	Hobart, IN	Year Renewed:	
Location:	Sidewalk	Tape/Media #:	
Purpose:	Maintenance Related	Dia/Height:	12"
Use:	Sanitary	Material:	PVC
Drain Area:	NA	Lining:	Cured in Place
Category:	NA		
Comment:

Location Details:		Direction of Survey:	Upstream
US MH:	M-708-107	DS MH:	M-708-106
		Total Length Surveyed (ft):	185.7

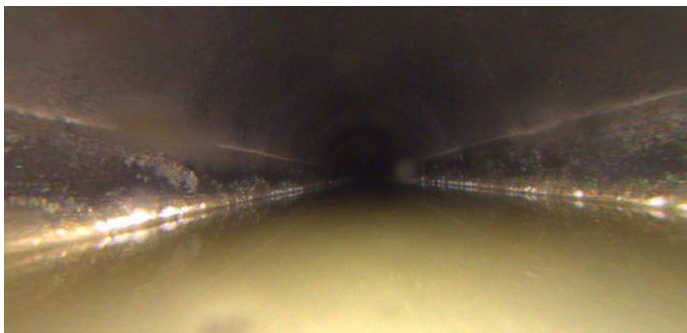
Code: **AMH**
Description: **Manhole**

Distance (ft): **.0**
Structural Grade: **0**
O&M Grade: **0**
Clock Start/From:
Clock To:
1st Value:
2nd Value:
Value Percent:
Continuous Index:
Within 8" of Joint: **NO**
Remarks: **M-708-106**

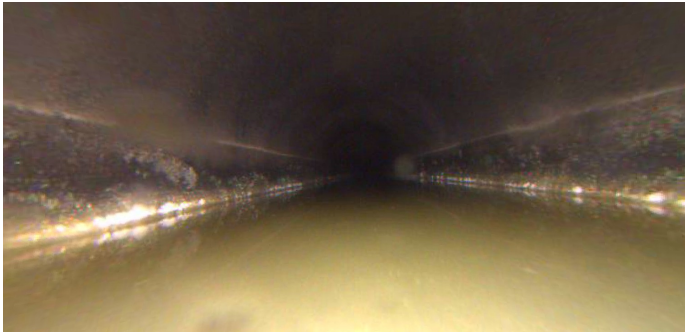
Code:	MWL
Description:	Water Level

Distance (ft):	.0
Structural Grade:	0
O&M Grade:	0
Clock Start/From:	
Clock To:	
1st Value:	
2nd Value:	
Value Percent:	40.000
Continuous Index:	
Within 8" of Joint:	NO
Remarks:
