Profile/Photo Observation Report

Street:	Off Bracken Parkway	Flow Control:	
City:	Hobart, IN	Year Renewed:	
Location:	Sidewalk	Tape/Media #:	949
Purpose:	Routine Assessment	Dia/Height:	12"
Use:	Sanitary	Material:	PVC
Drain Area:		Lining:	
Category:	NA		
Comment:

Location Details:		Direction of Survey:	Downstream
US MH:	M-708-108	DS MH:	M-708-107
		Total Length Surveyed (ft):	135.6

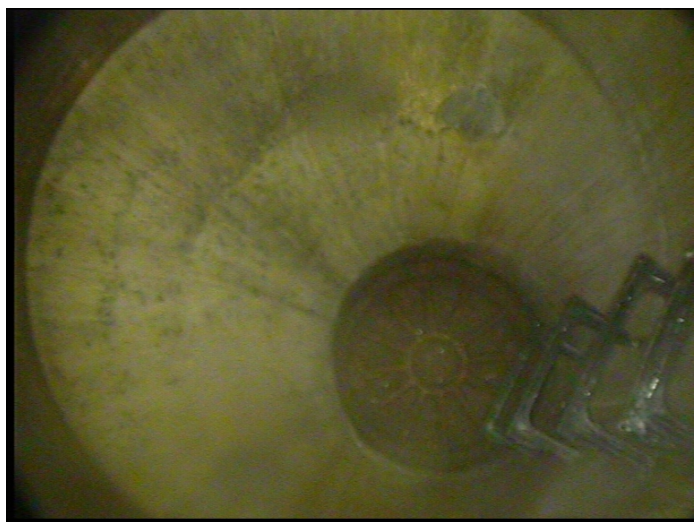
Code: **AMH**
Description: **Manhole**

Distance (ft): **.0**
Structural Grade: **0**
O&M Grade: **0**
Clock Start/From:
Clock To:
1st Value:
2nd Value:
Value Percent:
Continuous Index:
Within 8" of Joint: **NO**
Remarks: **M-708-108**

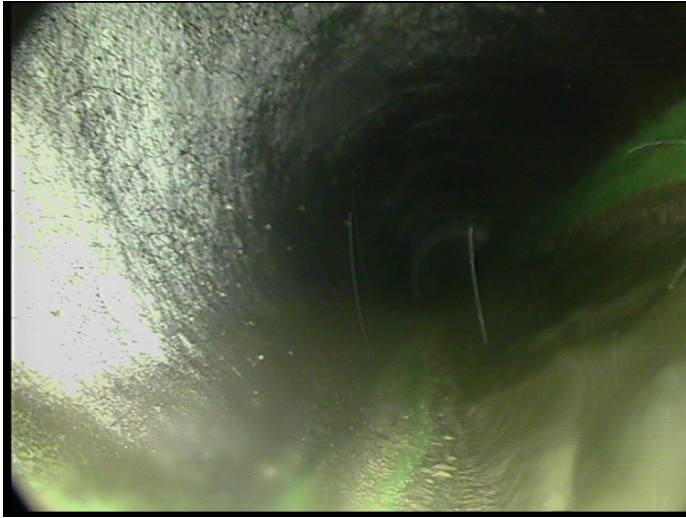
Code: **MWL**
Description: **Water Level**

Distance (ft): **.0**
Structural Grade: **0**
O&M Grade: **0**
Clock Start/From:
Clock To:
1st Value:
2nd Value:
Value Percent: **10.000**
Continuous Index:
Within 8" of Joint: **NO**
Remarks:

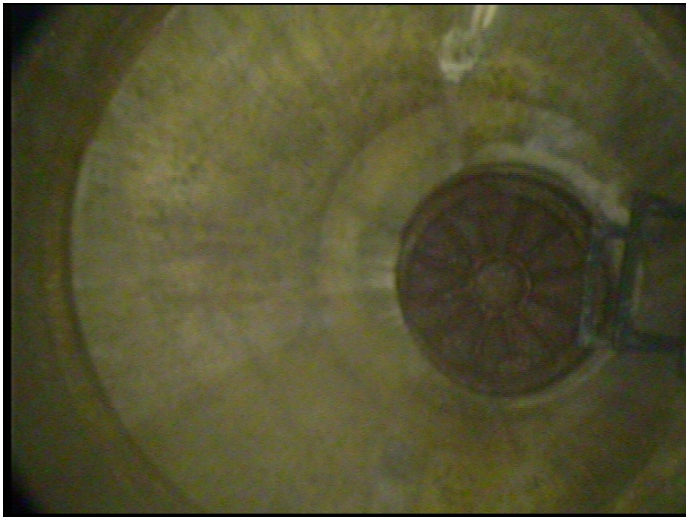
Code: **AMH**
Description: **Manhole**

Distance (ft): **135.6**
Structural Grade: **0**
O&M Grade: **0**
Clock Start/From:
Clock To:
1st Value:
2nd Value:
Value Percent:
Continuous Index:
Within 8" of Joint: **NO**
Remarks: **M-708-107**
