Profile/Photo Observation Report

Street:	Off Bracken Parkway	Flow Control:	
City:	Hobart, IN	Year Renewed:	
Location:	Sidewalk	Tape/Media #:	949
Purpose:	Routine Assessment	Dia/Height:	12"
Use:	Sanitary	Material:	PVC
Drain Area:		Lining:	
Category:	NA		
Comment:

Location Details:		Direction of Survey:	Downstream
US MH:	M-708-109	DS MH:	M-708-108
		Total Length Surveyed (ft):	149.6

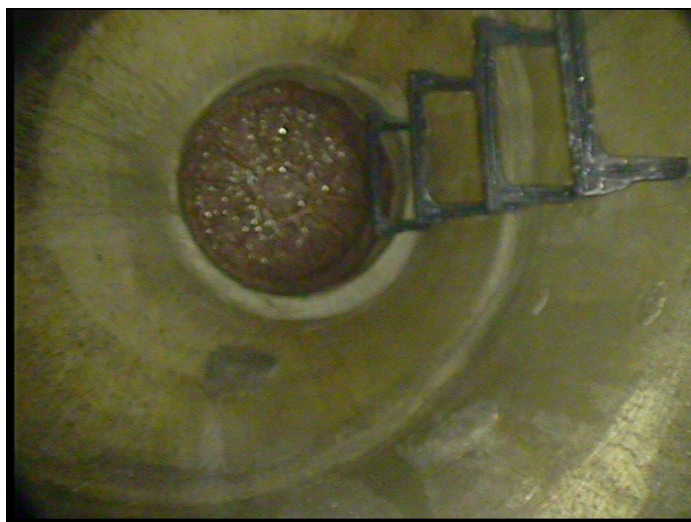
Code: **AMH**
 Description: **Manhole**

Distance (ft): **.0**
 Structural Grade: **0**
 O&M Grade: **0**
 Clock Start/From:
 Clock To:
 1st Value:
 2nd Value:
 Value Percent:
 Continuous Index:
 Within 8" of Joint: **NO**
 Remarks: **M-708-109**

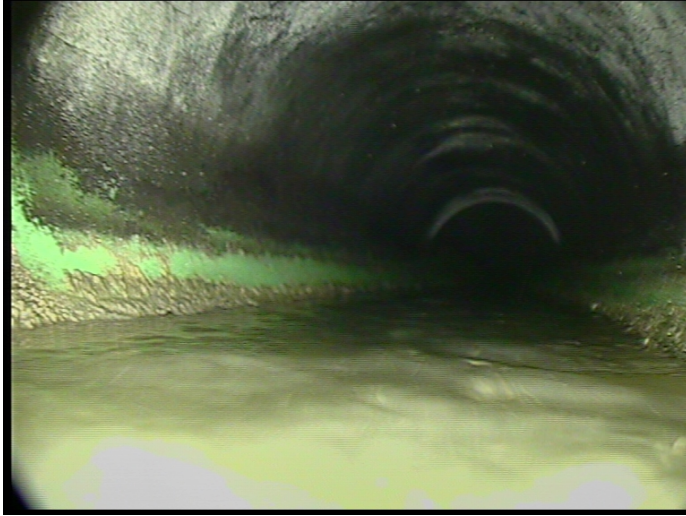
Code:	MWL
Description:	Water Level
Distance (ft):	.0
Structural Grade:	0
O&M Grade:	0
Clock Start/From:	
Clock To:	
1st Value:	
2nd Value:	
Value Percent:	15.000
Continuous Index:	
Within 8" of Joint:	NO
Remarks:

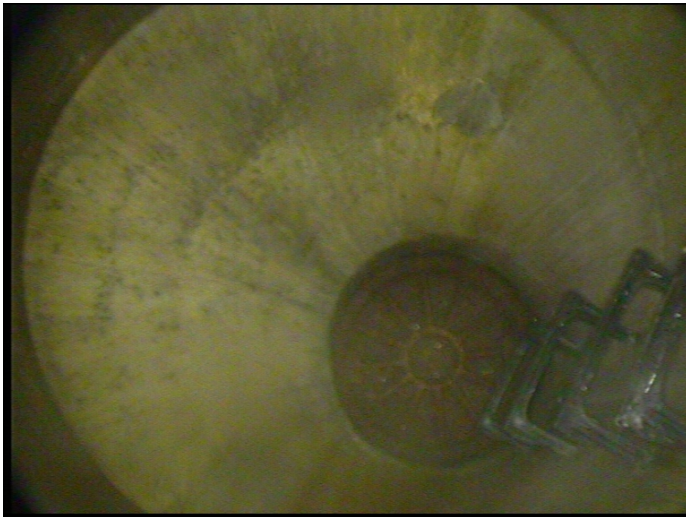
Code:	AMH
Description:	Manhole
Distance (ft):	149.6
Structural Grade:	0
O&M Grade:	0
Clock Start/From:	
Clock To:	
1st Value:	
2nd Value:	
Value Percent:	
Continuous Index:	
Within 8" of Joint:	NO
Remarks:	M-708-108
