Date:	04/03/2018	Weather:		Coding:	PACP 6.0
Pipe Length (ft		Owner:	NA	Pre Clean:	Not Known
P.O.#:		Surveyor:	Jen Costello	PSR:	P-708-110-109
Customer:		Clean Date:	01/01/1900	Shape:	C
Street:	Bracken		Flow Control:	Not Controlled	1
City:	Hobart, IN		Year Renewed:		
Location:	Sidewalk		Tape/Media #:		
Purpose:	Maintenance Rela	ted	Dia/Height:	8"	
Use:	Sanitary		Material:	PVC	
Drain Area:	NA		Lining:	Cured in Place	
Category:	NA				
Comment:					
Location Detail	s:		Direction of Surv	ey: Downstream	
US MH:	M-708-110	DS MH:	M-708-109	Total Length Surveyed (ft	): <b>10.9</b>
D&M Index:	2.00	O&M Quick:	220	0 O&M Rating:	4.00
Structural Index:	0.00	Structural Q	uick: 000		0.00
Overall Index:	2.00	Overall Quic		<b>0</b> Overall Rating:	4.00

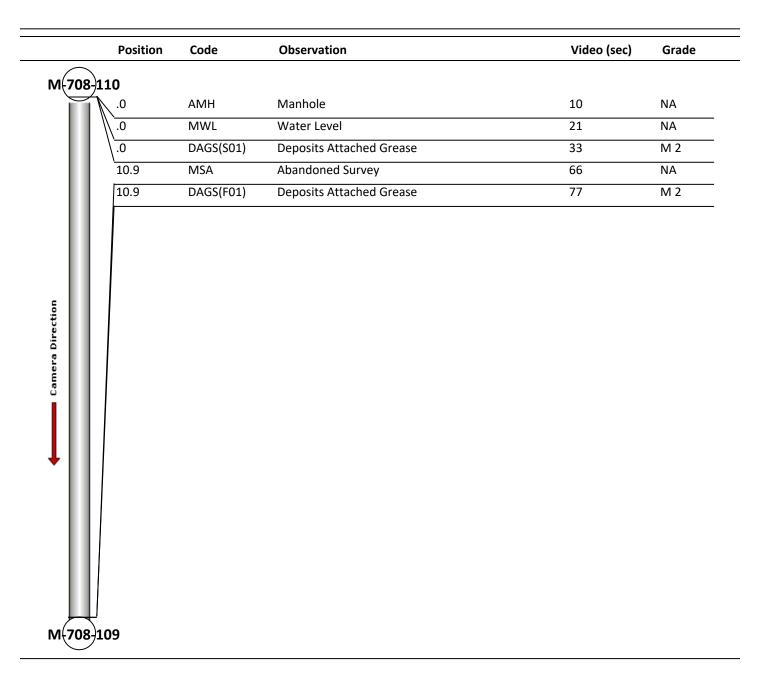
Code: Description:	AMH Manhole
Distance (ft):	.0
Structural Grade:	0
O&M Grade:	0
Clock Start/From:	
Clock To:	
1st Value:	
2nd Value:	
Value Percent:	
Continuous Index:	
Within 8" of Joint:	NO
Remarks:	M-708-110

Code:	DAGS
Description:	<b>Deposits Attached Grease</b>

Distance (ft):	.0
Structural Grade:	0
O&M Grade:	2
Clock Start/From:	7
Clock To:	5
1st Value:	
2nd Value:	
Value Percent:	5.000
Continuous Index:	S01
Within 8" of Joint:	NO
Remarks:

Code:MSADescription:Abandoned Survey

Distance (ft):	10.9
Structural Grade:	0
O&M Grade:	0
Clock Start/From:	
Clock To:	
1st Value:	
2nd Value:	
Value Percent:	
Continuous Index:	
Within 8" of Joint:	NO
Remarks:	overturned

Code: Description: DAGS Deposits Attached Grease

Distance (ft):	10.9
Structural Grade:	0
O&M Grade:	2
Clock Start/From:	7
Clock To:	5
1st Value:	
2nd Value:	
Value Percent:	5.000
Continuous Index:	F01
Within 8" of Joint:	NO
Remarks:
