## Profile/Photo Observation Report

Street:	<b>BRACKEN PKWY</b>	Flow Control:	<b>Not Controlled</b>
City:	<b>Hobart, IN</b>	Year Renewed:	
Location:	<b>Light Highway</b>	Tape/Media #:	
Purpose:	<b>Routine Assessment</b>	Dia/Height:	<b>12"</b>
Use:	<b>Sanitary</b>	Material:	<b>PVC</b>
Drain Area:	<b>NA</b>	Lining:	
Category:	<b>NA</b>		
Comment:

Location Details:		Direction of Survey:	<b>Downstream</b>
US MH:	<b>M-708-110</b>	DS MH:	<b>M-708-109</b>
		Total Length Surveyed (ft):	<b>310.9</b>

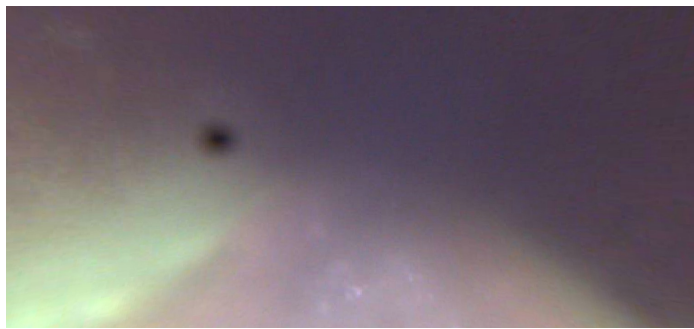
Code: **AMH**  
Description: **Manhole**

Distance (ft): **.0**  
Structural Grade: **0**  
O&M Grade: **0**  
Clock Start/From:  
Clock To:  
1st Value:  
2nd Value:  
Value Percent:  
Continuous Index:  
Within 8" of Joint: **NO**  
Remarks: **M-708-110**

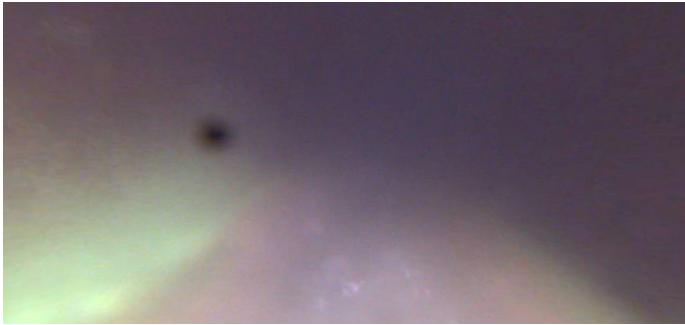
Code:	<b>MWL</b>
Description:	<b>Water Level</b>

Distance (ft):	<b>.0</b>
Structural Grade:	<b>0</b>
O&M Grade:	<b>0</b>
Clock Start/From:	
Clock To:	
1st Value:	
2nd Value:	
Value Percent:	<b>5.000</b>
Continuous Index:	
Within 8" of Joint:	<b>NO</b>
Remarks:

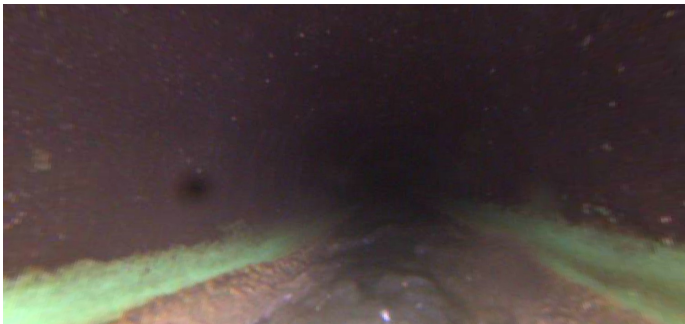
Code:	<b>AMH</b>
Description:	<b>Manhole</b>

Distance (ft):	<b>310.9</b>
Structural Grade:	<b>0</b>
O&M Grade:	<b>0</b>
Clock Start/From:	
Clock To:	
1st Value:	
2nd Value:	
Value Percent:	
Continuous Index:	
Within 8" of Joint:	<b>NO</b>
Remarks:	<b>M-708-109</b>
