Profile/Photo Observation Report

Street:	Bracken Pkwy.	Flow Control:	Not Controlled
City:	Hobart, IN	Year Renewed:	
Location:	Light Highway	Tape/Media #:	
Purpose:	Routine Assessment	Dia/Height:	12"
Use:	Sanitary	Material:	PVC
Drain Area:	NA	Lining:	
Category:	NA		
Comment:

Location Details:		Direction of Survey:	Downstream
US MH:	M-708-110	DS MH:	M-708-109
		Total Length Surveyed (ft):	310.9

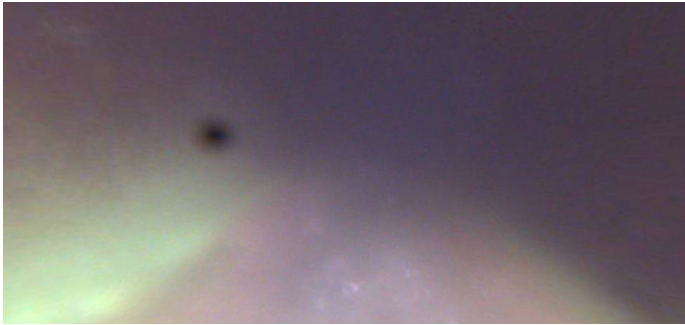
Code:	MWL
Description:	Water Level

Distance (ft):	.0
Structural Grade:	0
O&M Grade:	0
Clock Start/From:	
Clock To:	
1st Value:	
2nd Value:	
Value Percent:	5.000
Continuous Index:	
Within 8" of Joint:	NO
Remarks:

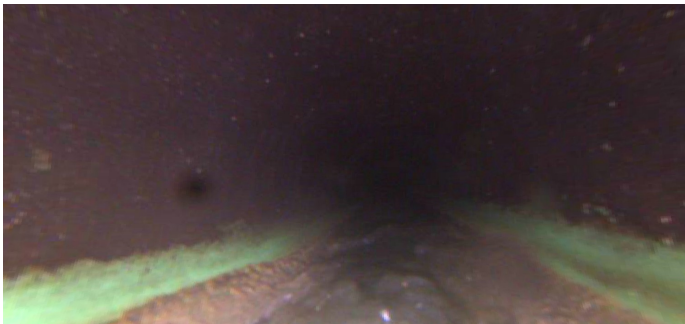
Code:	AMH
Description:	Manhole

Distance (ft):	310.9
Structural Grade:	0
O&M Grade:	0
Clock Start/From:	
Clock To:	
1st Value:	
2nd Value:	
Value Percent:	
Continuous Index:	
Within 8" of Joint:	NO
Remarks:	M-708-109
