Data	04/02/2018	\M/aatham		Coding:	
Date:	04/03/2018	Weather:		Coding:	PACP 6.0
Pipe Length (ft	:): 126.4	Owner:	NA	Pre Clean:	Not Known
P.O.#:		Surveyor:	Jen Costello	PSR:	P-708-111-110
Customer:		Clean Date:	01/01/1900	Shape:	С
Street:	Bracken		Flow Control:	Not Controlled	d
City:	Hobart, IN		Year Renewed:		
Location:	Sidewalk		Tape/Media #:		
Purpose:	Maintenance Rela	ated	Dia/Height:	8"	
Use:	Sanitary		Material:	PVC	
Drain Area:	NA		Lining:	Cured in Place	!
Category:	NA				
Comment:					
Location Detai	ls:		Direction of Surv	ey: Upstream	
US MH:	M-708-111	DS MH:	M-708-110	Total Length Surveyed (ft	:): 25.2
D&M Index:	2.00	O&M Quick:	220	0 O&M Rating:	4.00
Structural Index	0.00	 Structural Q	uick: 000		0.00
Overall Index:	2.00	Overall Quic		0 Overall Rating:	4.00

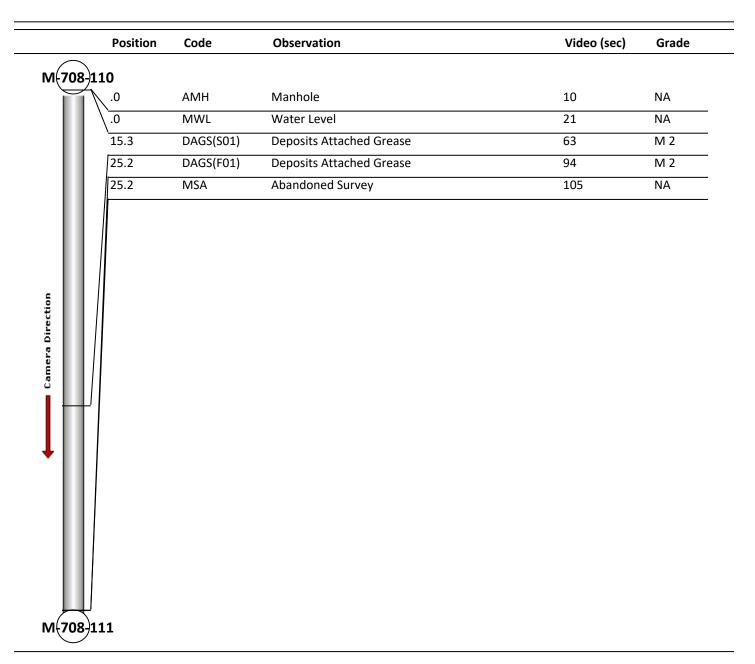
Code: Description:	AMH Manhole
Distance (ft):	.0
Structural Grade:	0
O&M Grade:	0
Clock Start/From:	
Clock To:	
1st Value:	
2nd Value:	
Value Percent:	
Continuous Index:	
Within 8" of Joint:	NO
Remarks:	M-708-110
