## Profile/Photo Observation Report

Street:	<b>Bracken</b>	Flow Control:	<b>Not Controlled</b>
City:	<b>Hobart, IN</b>	Year Renewed:	
Location:	<b>Sidewalk</b>	Tape/Media #:	
Purpose:	<b>Maintenance Related</b>	Dia/Height:	<b>8"</b>
Use:	<b>Sanitary</b>	Material:	<b>PVC</b>
Drain Area:	<b>NA</b>	Lining:	<b>Cured in Place</b>
Category:	<b>NA</b>		
Comment:	<b>Reverse setup.</b>

Location Details:		Direction of Survey:	<b>Downstream</b>
US MH:	<b>M-708-111</b>	DS MH:	<b>M-708-110</b>
		Total Length Surveyed (ft):	<b>133.9</b>

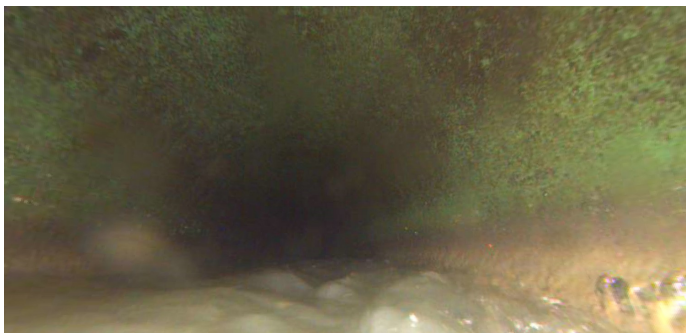
Code: **AMH**  
Description: **Manhole**

Distance (ft): **.0**  
Structural Grade: **0**  
O&M Grade: **0**  
Clock Start/From:  
Clock To:  
1st Value:  
2nd Value:  
Value Percent:  
Continuous Index:  
Within 8" of Joint: **NO**  
Remarks: **M-708-111**

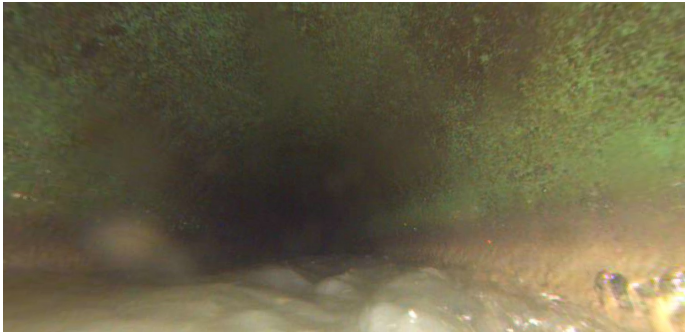
Code:	<b>MWL</b>
Description:	<b>Water Level</b>

Distance (ft):	<b>.0</b>
Structural Grade:	<b>0</b>
O&M Grade:	<b>0</b>
Clock Start/From:	
Clock To:	
1st Value:	
2nd Value:	
Value Percent:	<b>30.000</b>
Continuous Index:	
Within 8" of Joint:	<b>NO</b>
Remarks:

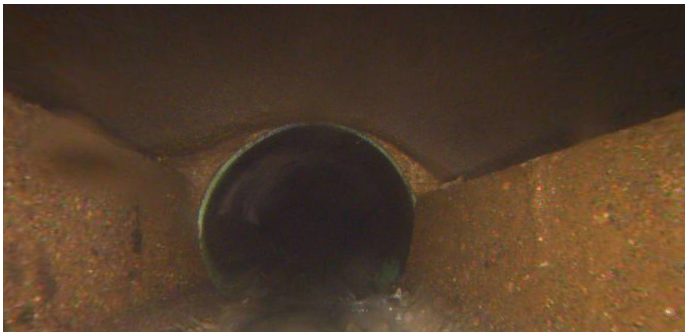
Code:	<b>AMH</b>
Description:	<b>Manhole</b>

Distance (ft):	<b>133.9</b>
Structural Grade:	<b>0</b>
O&M Grade:	<b>0</b>
Clock Start/From:	
Clock To:	
1st Value:	
2nd Value:	
Value Percent:	
Continuous Index:	
Within 8" of Joint:	<b>NO</b>
Remarks:	<b>M-708-110</b>
