## Profile/Photo Observation Report

Street:	<b>LINCOLN ST &amp; BRACKEN PKWY</b>	Flow Control:	<b>Not Controlled</b>
City:	<b>Hobart, IN</b>	Year Renewed:	
Location:	<b>Sidewalk</b>	Tape/Media #:	
Purpose:	<b>Maintenance Related</b>	Dia/Height:	<b>8"</b>
Use:	<b>Sanitary</b>	Material:	<b>PVC</b>
Drain Area:	<b>NA</b>	Lining:	<b>Cured in Place</b>
Category:	<b>NA</b>		
Comment:	<b>Flow direction wrong.</b>

Location Details:		Direction of Survey:	<b>Upstream</b>
US MH:	<b>M-708-111</b>	DS MH:	<b>M-708-165</b>
		Total Length Surveyed (ft):	<b>296.4</b>

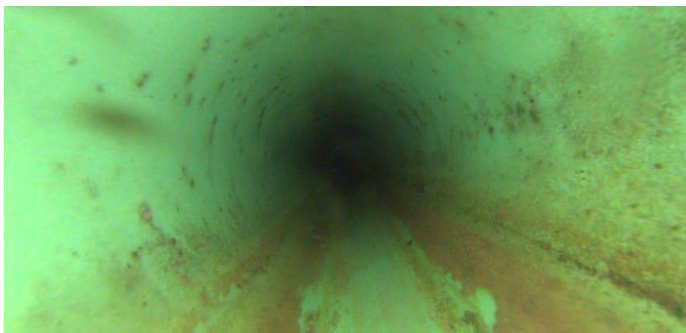
Code: **AMH**  
Description: **Manhole**

Distance (ft): **.0**  
Structural Grade: **0**  
O&M Grade: **0**  
Clock Start/From:  
Clock To:  
1st Value:  
2nd Value:  
Value Percent:  
Continuous Index:  
Within 8" of Joint: **NO**  
Remarks: **M-708-165**

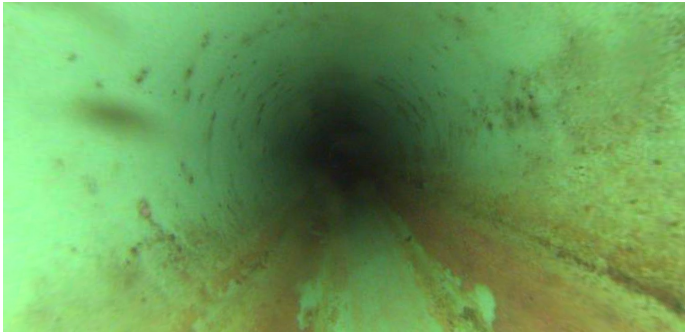
Code:	<b>MWL</b>
Description:	<b>Water Level</b>

Distance (ft):	<b>.0</b>
Structural Grade:	<b>0</b>
O&M Grade:	<b>0</b>
Clock Start/From:	
Clock To:	
1st Value:	
2nd Value:	
Value Percent:	<b>5.000</b>
Continuous Index:	
Within 8" of Joint:	<b>NO</b>
Remarks:

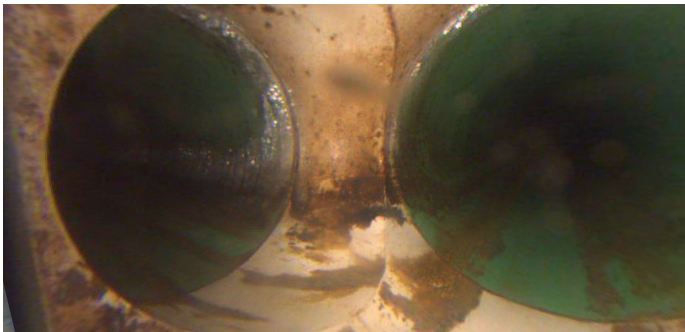
Code:	<b>TF</b>
Description:	<b>Tap Factory</b>

Distance (ft):	<b>7.8</b>
Structural Grade:	<b>0</b>
O&M Grade:	<b>0</b>
Clock Start/From:	<b>9</b>
Clock To:	
1st Value:	<b>4.000</b>
2nd Value:	
Value Percent:	
Continuous Index:	
Within 8" of Joint:	
Remarks:

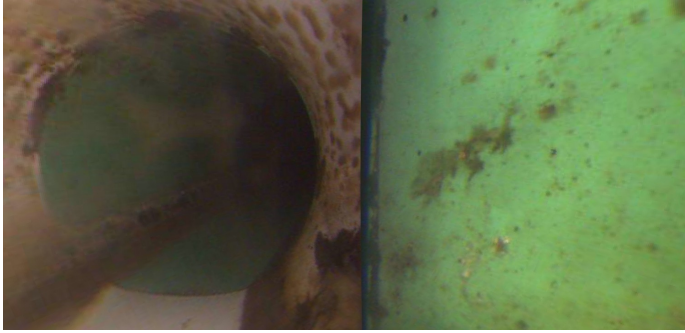
Code: **TFA**  
Description: **Tap Factory Active**

Distance (ft): **101.7**  
Structural Grade: **0**  
O&M Grade: **0**  
Clock Start/From: **9**  
Clock To:  
1st Value: **4.000**  
2nd Value:  
Value Percent:  
Continuous Index:  
Within 8" of Joint:  
Remarks:

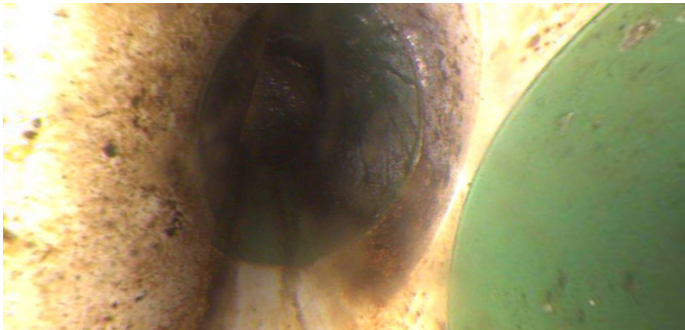
Code: **TF**  
Description: **Tap Factory**

Distance (ft): **103.4**  
Structural Grade: **0**  
O&M Grade: **0**  
Clock Start/From: **3**  
Clock To:  
1st Value: **4.000**  
2nd Value:  
Value Percent:  
Continuous Index:  
Within 8" of Joint:  
Remarks:

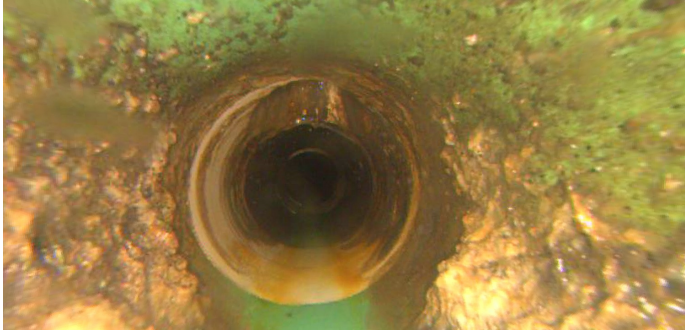
Code: **DAGS**  
Description: **Deposits Attached Grease**

Distance (ft): **222.0**  
Structural Grade: **0**  
O&M Grade: **2**  
Clock Start/From: **8**  
Clock To: **4**  
1st Value:  
2nd Value:  
Value Percent: **10.000**  
Continuous Index:  
Within 8" of Joint: **NO**  
Remarks:

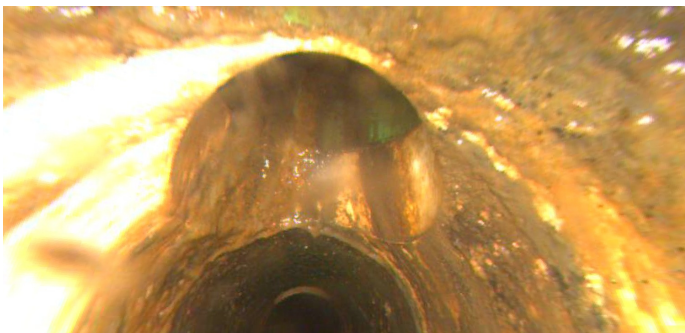
Code: **TF**  
Description: **Tap Factory**

Distance (ft): **222.6**  
Structural Grade: **0**  
O&M Grade: **0**  
Clock Start/From: **12**  
Clock To:  
1st Value: **4.000**  
2nd Value:  
Value Percent:  
Continuous Index:  
Within 8" of Joint:  
Remarks:

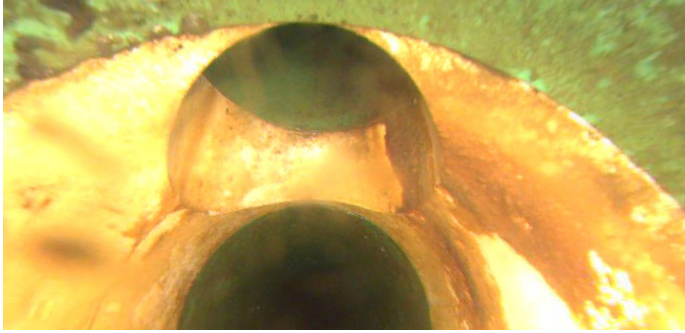
Code: **TF**  
Description: **Tap Factory**

Distance (ft): **224.7**  
Structural Grade: **0**  
O&M Grade: **0**  
Clock Start/From: **12**  
Clock To:  
1st Value: **4.000**  
2nd Value:  
Value Percent:  
Continuous Index:  
Within 8" of Joint:  
Remarks:

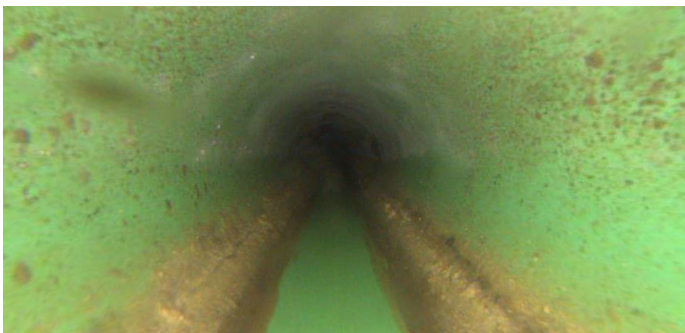
Code: **DAGS**  
Description: **Deposits Attached Grease**

Distance (ft): **272.0**  
Structural Grade: **0**  
O&M Grade: **2**  
Clock Start/From: **4**  
Clock To: **8**  
1st Value:  
2nd Value:  
Value Percent: **5.000**  
Continuous Index: **S01**  
Within 8" of Joint: **NO**  
Remarks:

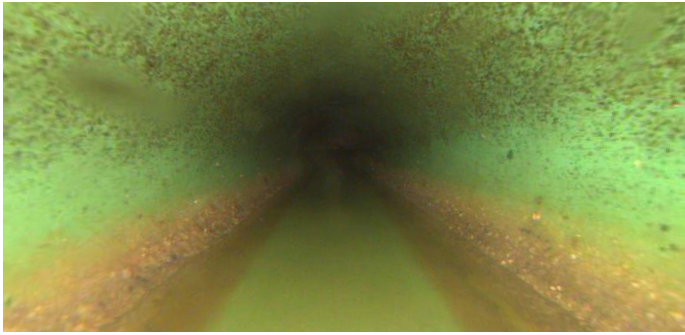
Code: **DAGS**  
Description: **Deposits Attached Grease**

Distance (ft): **291.2**  
Structural Grade: **0**  
O&M Grade: **2**  
Clock Start/From: **4**  
Clock To: **8**  
1st Value:  
2nd Value:  
Value Percent: **5.000**  
Continuous Index: **F01**  
Within 8" of Joint: **NO**  
Remarks:

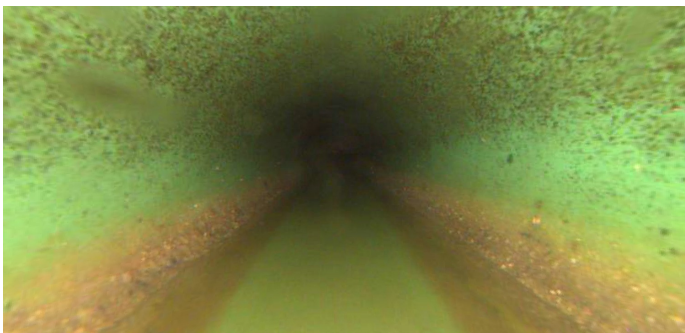
Code: **MWL**  
Description: **Water Level**

Distance (ft): **291.2**  
Structural Grade: **0**  
O&M Grade: **0**  
Clock Start/From:  
Clock To:  
1st Value:  
2nd Value:  
Value Percent: **10.000**  
Continuous Index:  
Within 8" of Joint: **NO**  
Remarks:
