## Profile/Photo Observation Report

Street:	<b>BRACKEN PKWY &amp; LINCOLN ST</b>	Flow Control:	<b>Not Controlled</b>
City:	<b>Hobart, IN</b>	Year Renewed:	
Location:	<b>Sidewalk</b>	Tape/Media #:	
Purpose:	<b>Maintenance Related</b>	Dia/Height:	<b>8"</b>
Use:	<b>Sanitary</b>	Material:	<b>PVC</b>
Drain Area:	<b>NA</b>	Lining:	<b>Cured in Place</b>
Category:	<b>NA</b>		
Comment:

Location Details:		Direction of Survey:	<b>Downstream</b>
US MH:	<b>M-708-112</b>	DS MH:	<b>M-708-111</b>
		Total Length Surveyed (ft):	<b>152.8</b>

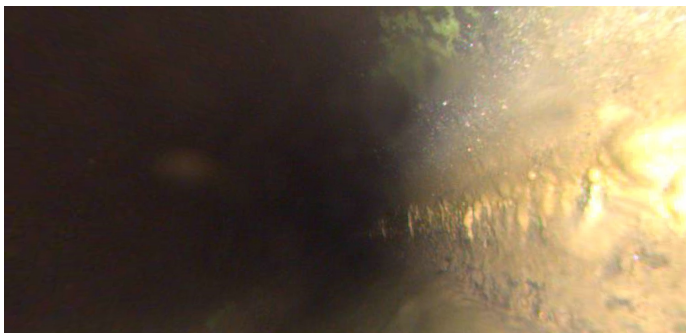
Code: **AMH**  
Description: **Manhole**

Distance (ft): **.0**  
Structural Grade: **0**  
O&M Grade: **0**  
Clock Start/From:  
Clock To:  
1st Value:  
2nd Value:  
Value Percent:  
Continuous Index:  
Within 8" of Joint: **NO**  
Remarks: **M-708-112**

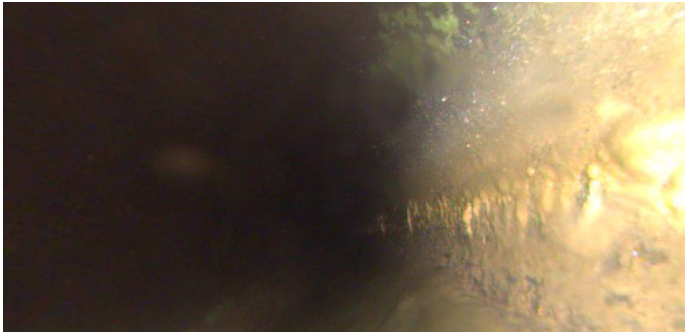
Code:	<b>MWL</b>
Description:	<b>Water Level</b>

Distance (ft):	<b>.0</b>
Structural Grade:	<b>0</b>
O&M Grade:	<b>0</b>
Clock Start/From:	
Clock To:	
1st Value:	
2nd Value:	
Value Percent:	<b>5.000</b>
Continuous Index:	
Within 8" of Joint:	<b>NO</b>
Remarks:

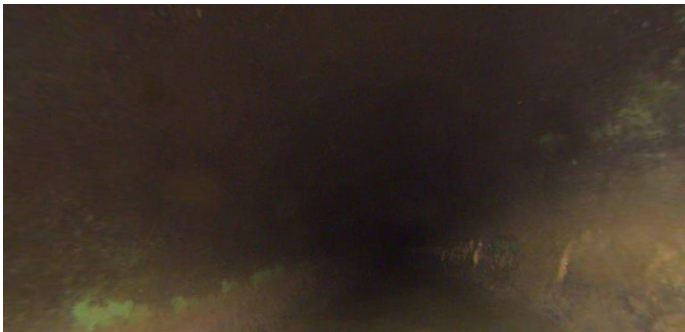
Code:	<b>DAGS</b>
Description:	<b>Deposits Attached Grease</b>

Distance (ft):	<b>1.6</b>
Structural Grade:	<b>0</b>
O&M Grade:	<b>2</b>
Clock Start/From:	<b>8</b>
Clock To:	<b>4</b>
1st Value:	
2nd Value:	
Value Percent:	<b>5.000</b>
Continuous Index:	<b>S01</b>
Within 8" of Joint:	<b>NO</b>
Remarks:

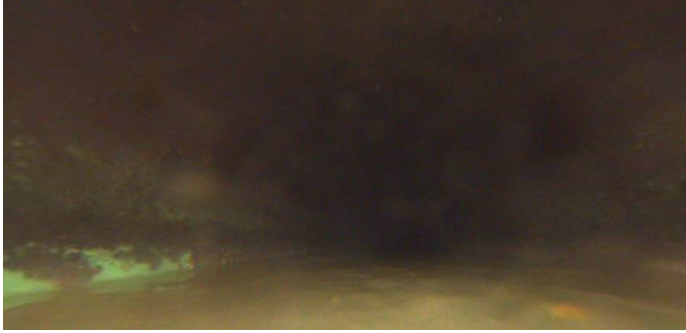
Code: **MWL**  
Description: **Water Level**

Distance (ft): **140.9**  
Structural Grade: **0**  
O&M Grade: **0**  
Clock Start/From:  
Clock To:  
1st Value:  
2nd Value:  
Value Percent: **40.000**  
Continuous Index:  
Within 8" of Joint: **NO**  
Remarks:

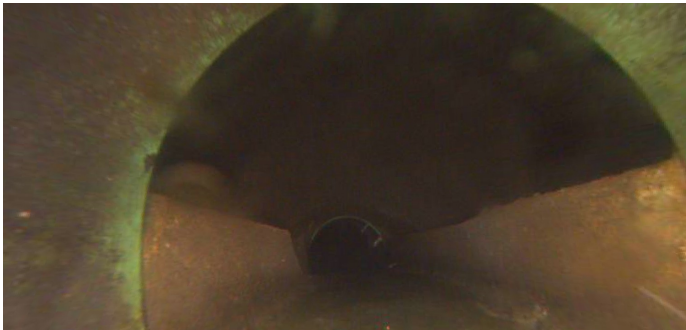
Code: **DAGS**  
Description: **Deposits Attached Grease**

Distance (ft): **150.7**  
Structural Grade: **0**  
O&M Grade: **2**  
Clock Start/From: **8**  
Clock To: **4**  
1st Value:  
2nd Value:  
Value Percent: **5.000**  
Continuous Index: **F01**  
Within 8" of Joint: **NO**  
Remarks:

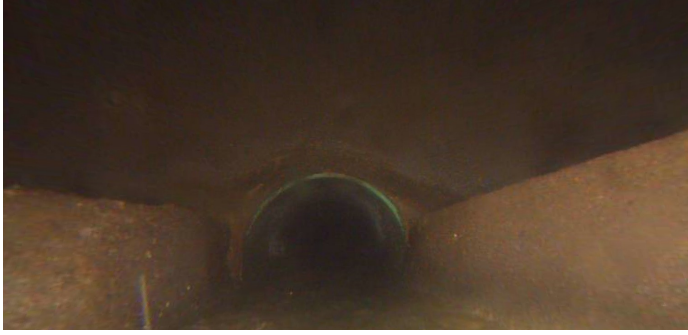
Code:	<b>AMH</b>
Description:	<b>Manhole</b>
Distance (ft):	<b>152.8</b>
Structural Grade:	<b>0</b>
O&M Grade:	<b>0</b>
Clock Start/From:	
Clock To:	
1st Value:	
2nd Value:	
Value Percent:	
Continuous Index:	
Within 8" of Joint:	<b>NO</b>
Remarks:	<b>M-708-111</b>
