## Profile/Photo Observation Report

Date:	<b>04/03/2018</b>	Weather:		Coding:	<b>PACP 6.0</b>
Pipe Length (ft):	<b>161.0</b>	Owner:	<b>NA</b>	Pre Clean:	<b>Not Known</b>
P.O.#:		Surveyor:	<b>Jen Costello</b>	PSR:	<b>P-708-113-112</b>
Customer:		Clean Date:	<b>01/01/1900</b>	Shape:	<b>C</b>

Street:	<b>BRACKEN PKWY &amp; WOODWARD TRL</b>	Flow Control:	<b>Not Controlled</b>
City:	<b>Hobart, IN</b>	Year Renewed:	
Location:	<b>Sidewalk</b>	Tape/Media #:	
Purpose:	<b>Maintenance Related</b>	Dia/Height:	<b>8"</b>
Use:	<b>Sanitary</b>	Material:	<b>PVC</b>
Drain Area:	<b>NA</b>	Lining:	<b>Cured in Place</b>
Category:	<b>NA</b>		
Comment:	<b>Flow direction wrong. Redeployment.</b>		
Location Details:		Direction of Survey:	<b>Downstream</b>
US MH:	<b>M-708-113</b>	DS MH:	<b>M-708-112</b>
		Total Length Surveyed (ft):	<b>29.4</b>

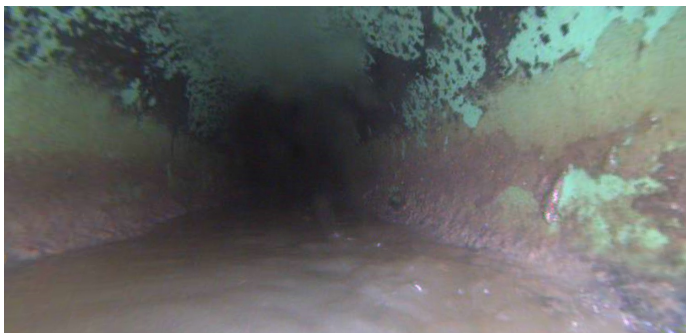
Code: **AMH**  
Description: **Manhole**

Distance (ft): **.0**  
Structural Grade: **0**  
O&M Grade: **0**  
Clock Start/From:  
Clock To:  
1st Value:  
2nd Value:  
Value Percent:  
Continuous Index:  
Within 8" of Joint: **NO**  
Remarks: **M-708-113**

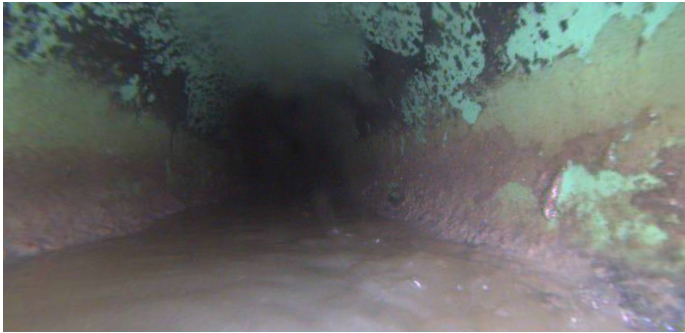
Code:	<b>MWL</b>
Description:	<b>Water Level</b>

Distance (ft):	<b>.0</b>
Structural Grade:	<b>0</b>
O&M Grade:	<b>0</b>
Clock Start/From:	
Clock To:	
1st Value:	
2nd Value:	
Value Percent:	<b>40.000</b>
Continuous Index:	
Within 8" of Joint:	<b>NO</b>
Remarks:

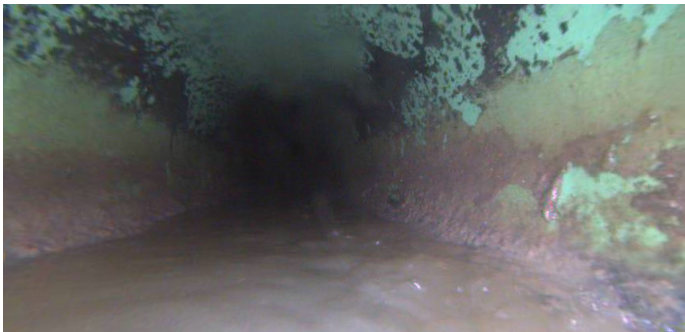
Code:	<b>DAGS</b>
Description:	<b>Deposits Attached Grease</b>

Distance (ft):	<b>.0</b>
Structural Grade:	<b>0</b>
O&M Grade:	<b>2</b>
Clock Start/From:	<b>8</b>
Clock To:	<b>4</b>
1st Value:	
2nd Value:	
Value Percent:	<b>5.000</b>
Continuous Index:	<b>S01</b>
Within 8" of Joint:	<b>NO</b>
Remarks:

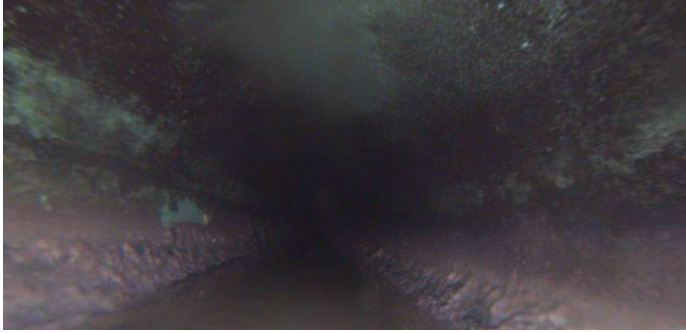
Code: **MSA**  
Description: **Abandoned Survey**

Distance (ft): **29.4**  
Structural Grade: **0**  
O&M Grade: **0**  
Clock Start/From:  
Clock To:  
1st Value:  
2nd Value:  
Value Percent:  
Continuous Index:  
Within 8" of Joint: **NO**  
Remarks: **DAGS**

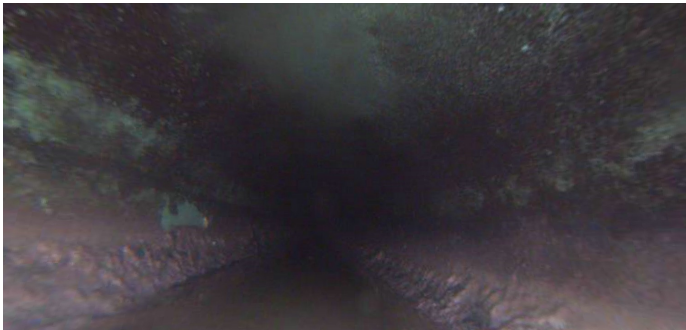
Code: **DAGS**  
Description: **Deposits Attached Grease**

Distance (ft): **29.4**  
Structural Grade: **0**  
O&M Grade: **2**  
Clock Start/From: **8**  
Clock To: **4**  
1st Value:  
2nd Value:  
Value Percent: **5.000**  
Continuous Index: **F01**  
Within 8" of Joint: **NO**  
Remarks:
