Profile/Photo Observation Report

Date:	04/03/2018	Weather:		Coding:	PACP 6.0
Pipe Length (ft):	161.0	Owner:	NA	Pre Clean:	Not Known
P.O.#:		Surveyor:	Jen Costello	PSR:	P-708-113-112
Customer:		Clean Date:	01/01/1900	Shape:	C

Street:	Tamarack	Flow Control:	Not Controlled
City:	Hobart, IN	Year Renewed:	
Location:	Sidewalk	Tape/Media #:	
Purpose:	Maintenance Related	Dia/Height:	8"
Use:	Sanitary	Material:	PVC
Drain Area:	NA	Lining:	Cured in Place
Category:	NA		
Comment:	Flow direction wrong. Redeployment.		
Location Details:		Direction of Survey:	Downstream
US MH:	M-708-113	DS MH:	M-708-112
		Total Length Surveyed (ft):	29.4

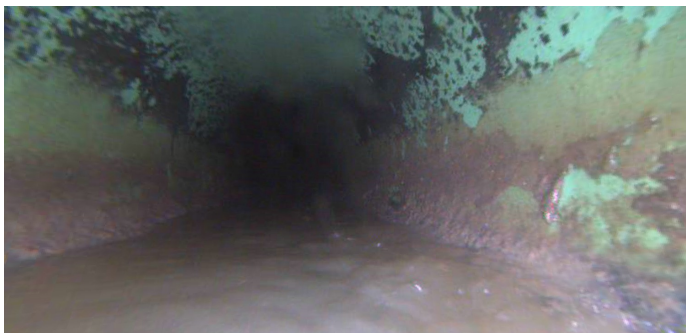
Code: **AMH**
Description: **Manhole**

Distance (ft): **.0**
Structural Grade: **0**
O&M Grade: **0**
Clock Start/From:
Clock To:
1st Value:
2nd Value:
Value Percent:
Continuous Index:
Within 8" of Joint: **NO**
Remarks: **M-708-113**

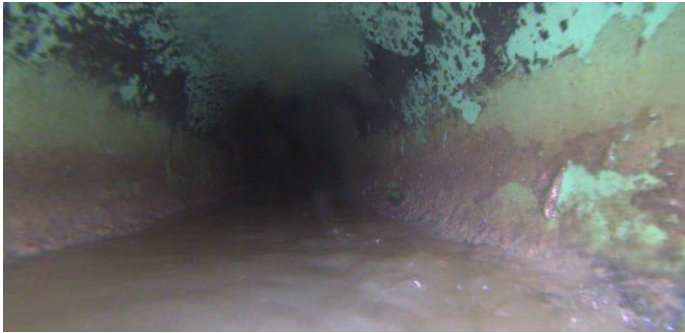
Code:	MWL
Description:	Water Level

Distance (ft):	.0
Structural Grade:	0
O&M Grade:	0
Clock Start/From:	
Clock To:	
1st Value:	
2nd Value:	
Value Percent:	40.000
Continuous Index:	
Within 8" of Joint:	NO
Remarks:

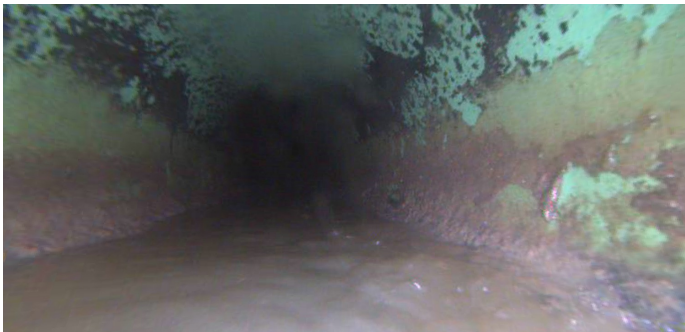
Code:	DAGS
Description:	Deposits Attached Grease

Distance (ft):	.0
Structural Grade:	0
O&M Grade:	2
Clock Start/From:	8
Clock To:	4
1st Value:	
2nd Value:	
Value Percent:	5.000
Continuous Index:	S01
Within 8" of Joint:	NO
Remarks:

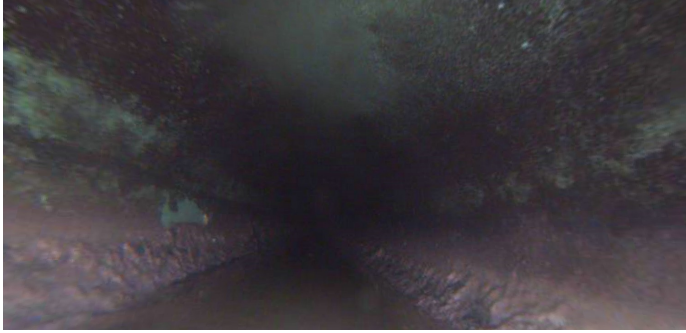
Code: **MSA**
Description: **Abandoned Survey**

Distance (ft): **29.4**
Structural Grade: **0**
O&M Grade: **0**
Clock Start/From:
Clock To:
1st Value:
2nd Value:
Value Percent:
Continuous Index:
Within 8" of Joint: **NO**
Remarks: **DAGS**

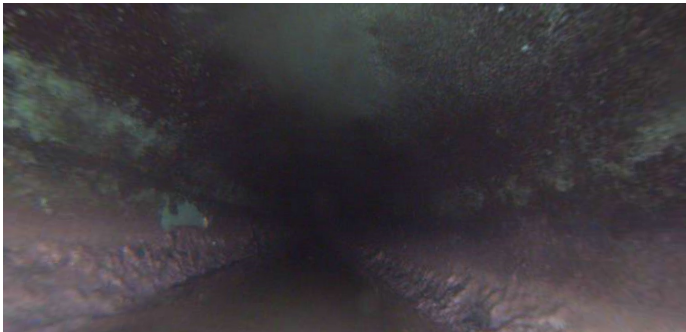
Code: **DAGS**
Description: **Deposits Attached Grease**

Distance (ft): **29.4**
Structural Grade: **0**
O&M Grade: **2**
Clock Start/From: **8**
Clock To: **4**
1st Value:
2nd Value:
Value Percent: **5.000**
Continuous Index: **F01**
Within 8" of Joint: **NO**
Remarks:
