Profile/Photo Observation Report

Date:	04/03/2018	Weather:		Coding:	PACP 6.0
Pipe Length (ft):	161.0	Owner:	NA	Pre Clean:	Not Known
P.O.#:		Surveyor:	Jen Costello	PSR:	P-708-113-112
Customer:		Clean Date:	01/01/1900	Shape:	C

Street:	BRACKEN PKWY & WOODWARD TRL	Flow Control:	Not Controlled
City:	Hobart, IN	Year Renewed:	
Location:	Sidewalk	Tape/Media #:	
Purpose:	Maintenance Related	Dia/Height:	8"
Use:	Sanitary	Material:	PVC
Drain Area:	NA	Lining:	Cured in Place
Category:	NA		
Comment:	Reverse setup. False manhole.		
Location Details:		Direction of Survey:	Upstream
US MH:	M-708-113	DS MH:	M-708-112
		Total Length Surveyed (ft):	150.5

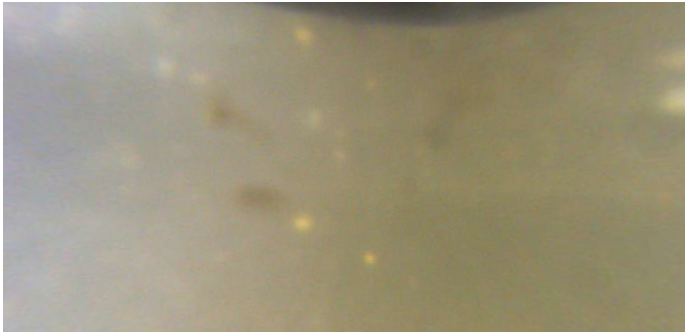
Code:	MWL
Description:	Water Level

Distance (ft):	.0
Structural Grade:	0
O&M Grade:	0
Clock Start/From:	
Clock To:	
1st Value:	
2nd Value:	
Value Percent:	60.000
Continuous Index:	
Within 8" of Joint:	NO
Remarks:

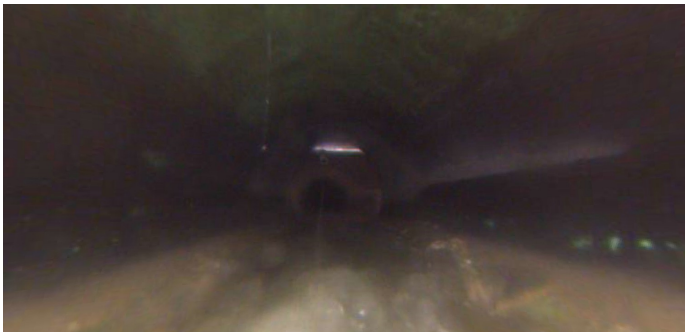
Code:	MGO
Description:	General Observation

Distance (ft):	2.6
Structural Grade:	0
O&M Grade:	0
Clock Start/From:	
Clock To:	
1st Value:	
2nd Value:	
Value Percent:	
Continuous Index:	
Within 8" of Joint:	NO
Remarks:	rear camera

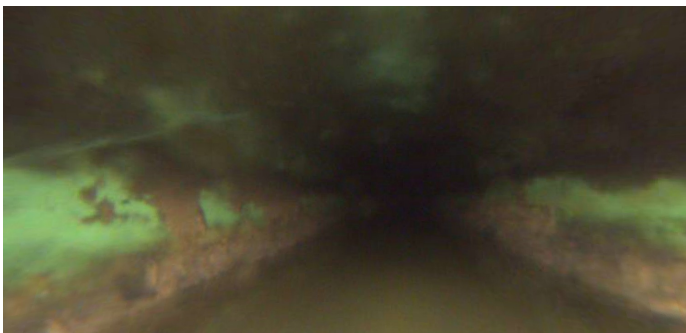
Code: **MSA**
Description: **Abandoned Survey**

Distance (ft): **150.5**
Structural Grade: **0**
O&M Grade: **0**
Clock Start/From:
Clock To:
1st Value:
2nd Value:
Value Percent:
Continuous Index:
Within 8" of Joint: **NO**
Remarks: **unknown**

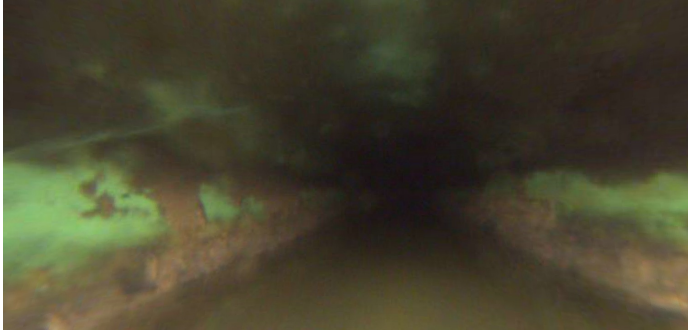
Code:	DAGS
Description:	Deposits Attached Grease
Distance (ft):	150.5
Structural Grade:	0
O&M Grade:	2
Clock Start/From:	8
Clock To:	4
1st Value:	
2nd Value:	
Value Percent:	5.000
Continuous Index:	F01
Within 8" of Joint:	NO
Remarks:
