Profile/Photo Observation Report

Street:	Tamarack	Flow Control:	Not Controlled
City:	Hobart, IN	Year Renewed:	
Location:	Sidewalk	Tape/Media #:	
Purpose:	Maintenance Related	Dia/Height:	8"
Use:	Sanitary	Material:	PVC
Drain Area:	NA	Lining:	Cured in Place
Category:	NA		
Comment:	Reverse setup. False manhole.

Location Details:		Direction of Survey:	Upstream
US MH:	M-708-113	DS MH:	M-708-112
		Total Length Surveyed (ft):	150.5

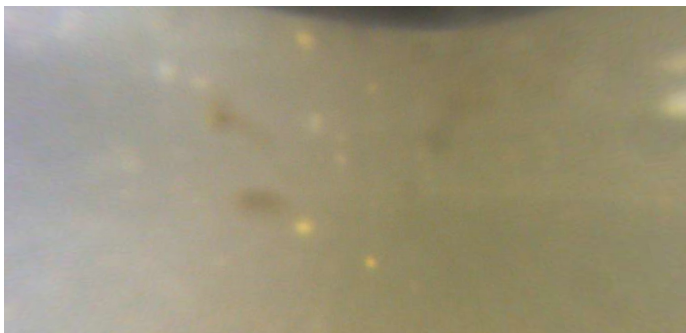
Code: **AMH**
Description: **Manhole**

Distance (ft): **.0**
Structural Grade: **0**
O&M Grade: **0**
Clock Start/From:
Clock To:
1st Value:
2nd Value:
Value Percent:
Continuous Index:
Within 8" of Joint: **NO**
Remarks: **M-708-112**

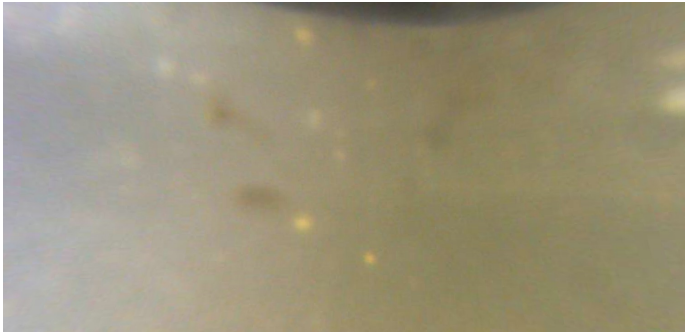
Code:	MWL
Description:	Water Level

Distance (ft):	.0
Structural Grade:	0
O&M Grade:	0
Clock Start/From:	
Clock To:	
1st Value:	
2nd Value:	
Value Percent:	60.000
Continuous Index:	
Within 8" of Joint:	NO
Remarks:

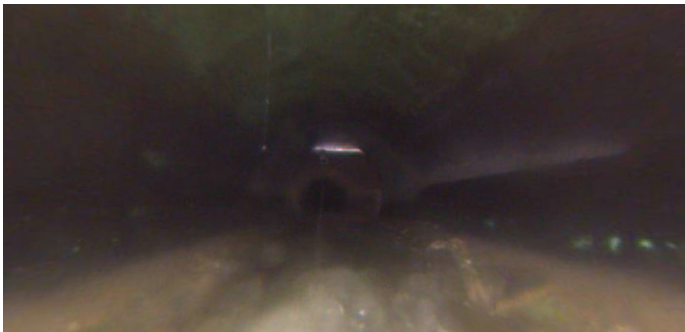
Code:	MGO
Description:	General Observation

Distance (ft):	2.6
Structural Grade:	0
O&M Grade:	0
Clock Start/From:	
Clock To:	
1st Value:	
2nd Value:	
Value Percent:	
Continuous Index:	
Within 8" of Joint:	NO
Remarks:	rear camera

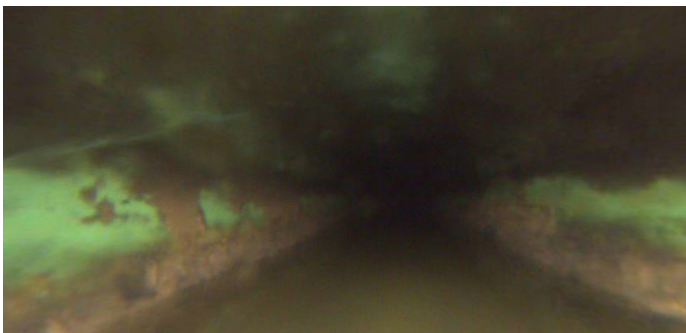
Code: **MSA**
Description: **Abandoned Survey**

Distance (ft): **150.5**
Structural Grade: **0**
O&M Grade: **0**
Clock Start/From:
Clock To:
1st Value:
2nd Value:
Value Percent:
Continuous Index:
Within 8" of Joint: **NO**
Remarks: **unknown**

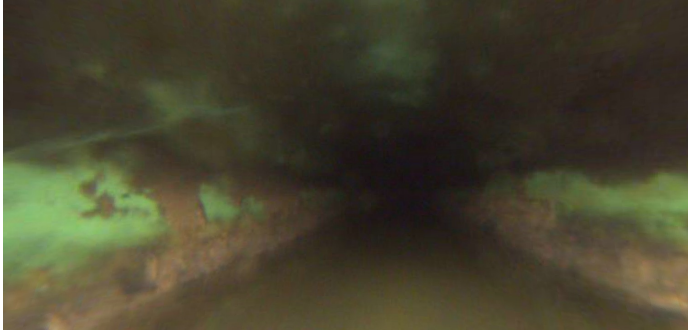
Code:	DAGS
Description:	Deposits Attached Grease
Distance (ft):	150.5
Structural Grade:	0
O&M Grade:	2
Clock Start/From:	8
Clock To:	4
1st Value:	
2nd Value:	
Value Percent:	5.000
Continuous Index:	F01
Within 8" of Joint:	NO
Remarks:
