## Profile/Photo Observation Report

Date:	<b>04/03/2018</b>	Weather:		Coding:	<b>PACP 6.0</b>
Pipe Length (ft):	<b>144.6</b>	Owner:	<b>NA</b>	Pre Clean:	<b>Not Known</b>
P.O.#:		Surveyor:	<b>Jen Costello</b>	PSR:	<b>P-708-114-113</b>
Customer:		Clean Date:	<b>01/01/1900</b>	Shape:	<b>C</b>

Street:	<b>BRACKEN PKWY &amp; WOODWARD TRL</b>	Flow Control:	<b>Not Controlled</b>
City:	<b>Hobart, IN</b>	Year Renewed:	
Location:	<b>Sidewalk</b>	Tape/Media #:	
Purpose:	<b>Maintenance Related</b>	Dia/Height:	<b>8"</b>
Use:	<b>Sanitary</b>	Material:	<b>PVC</b>
Drain Area:	<b>NA</b>	Lining:	<b>Cured in Place</b>
Category:	<b>NA</b>		
Comment:	<b>Flow direction wrong. Reverse setup.</b>		
Location Details:		Direction of Survey:	<b>Upstream</b>
US MH:	<b>M-708-113</b>	DS MH:	<b>M-708-114</b>
		Total Length Surveyed (ft):	<b>32.1</b>

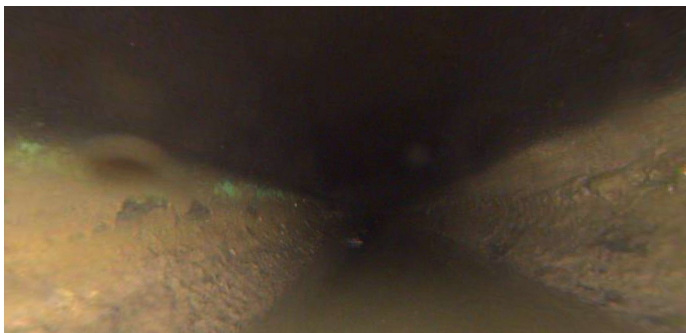
Code: **AMH**  
Description: **Manhole**

Distance (ft): **.0**  
Structural Grade: **0**  
O&M Grade: **0**  
Clock Start/From:  
Clock To:  
1st Value:  
2nd Value:  
Value Percent:  
Continuous Index:  
Within 8" of Joint: **NO**  
Remarks: **M-708-114**

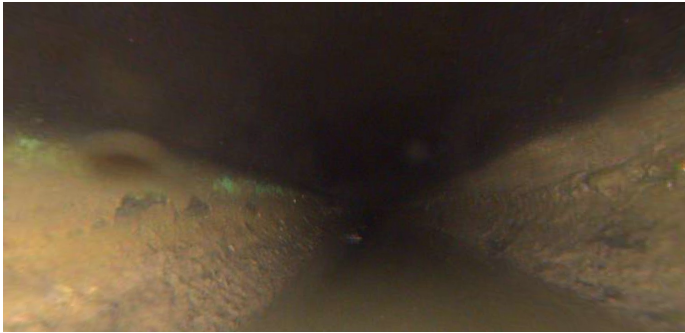
Code:	<b>MWL</b>
Description:	<b>Water Level</b>

Distance (ft):	<b>.0</b>
Structural Grade:	<b>0</b>
O&M Grade:	<b>0</b>
Clock Start/From:	
Clock To:	
1st Value:	
2nd Value:	
Value Percent:	<b>5.000</b>
Continuous Index:	
Within 8" of Joint:	<b>NO</b>
Remarks:

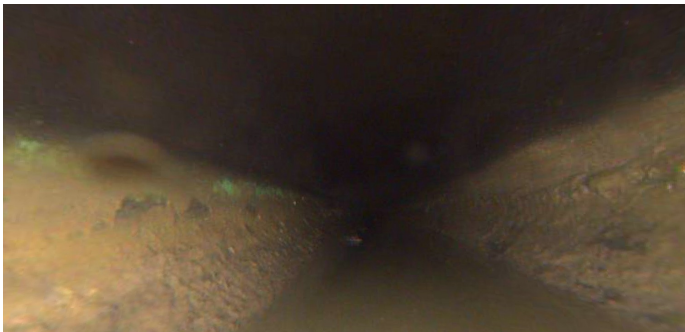
Code:	<b>DAGS</b>
Description:	<b>Deposits Attached Grease</b>

Distance (ft):	<b>.0</b>
Structural Grade:	<b>0</b>
O&M Grade:	<b>2</b>
Clock Start/From:	<b>7</b>
Clock To:	<b>5</b>
1st Value:	
2nd Value:	
Value Percent:	<b>5.000</b>
Continuous Index:	<b>S01</b>
Within 8" of Joint:	<b>NO</b>
Remarks:
