Profile/Photo Observation Report

Street:	BRACKEN PKWY & WOODWARD TRL	Flow Control:	Not Controlled
City:	Hobart, IN	Year Renewed:	
Location:	Sidewalk	Tape/Media #:	
Purpose:	Maintenance Related	Dia/Height:	8"
Use:	Sanitary	Material:	PVC
Drain Area:	NA	Lining:	Cured in Place
Category:	NA		
Comment:	Flow direction wrong.

Location Details:		Direction of Survey:	Downstream
US MH:	M-708-113	DS MH:	M-708-114
		Total Length Surveyed (ft):	111.2

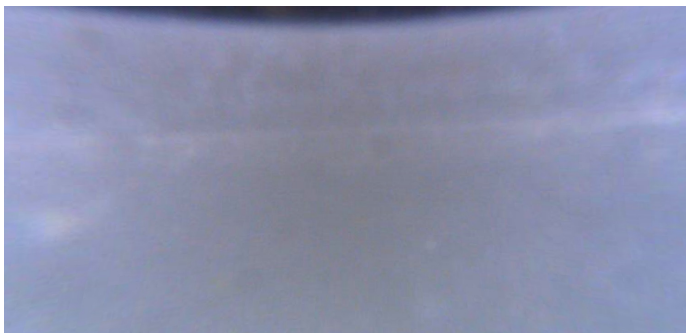
Code: **AMH**
Description: **Manhole**

Distance (ft): **.0**
Structural Grade: **0**
O&M Grade: **0**
Clock Start/From:
Clock To:
1st Value:
2nd Value:
Value Percent:
Continuous Index:
Within 8" of Joint: **NO**
Remarks: **M-708-113**

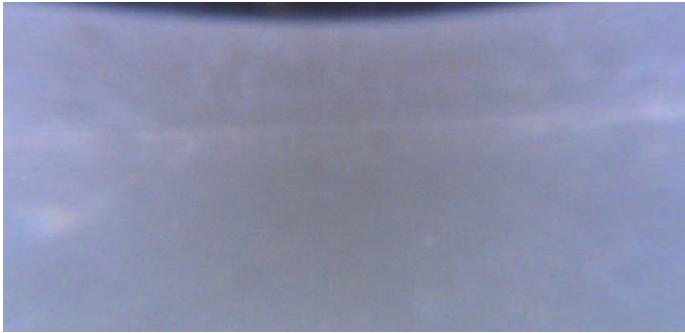
Code:	MWL
Description:	Water Level

Distance (ft):	.0
Structural Grade:	0
O&M Grade:	0
Clock Start/From:	
Clock To:	
1st Value:	
2nd Value:	
Value Percent:	70.000
Continuous Index:	
Within 8" of Joint:	NO
Remarks:

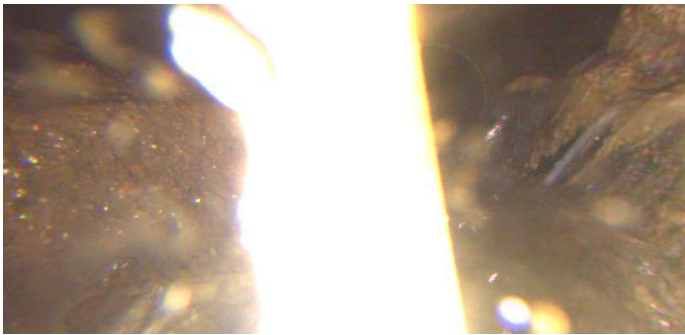
Code:	MGO
Description:	General Observation

Distance (ft):	.0
Structural Grade:	0
O&M Grade:	0
Clock Start/From:	
Clock To:	
1st Value:	
2nd Value:	
Value Percent:	
Continuous Index:	
Within 8" of Joint:	NO
Remarks:	REAR CAMERA

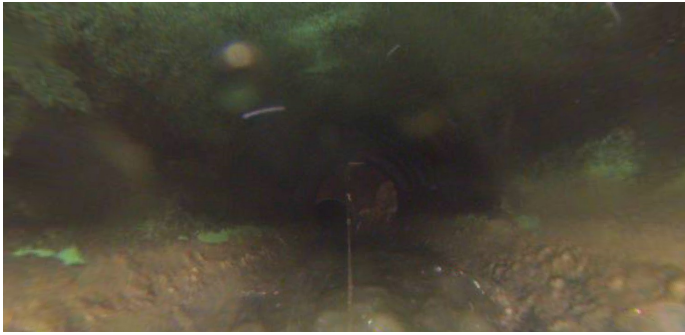
Code: **DAGS**
Description: **Deposits Attached Grease**

Distance (ft): **2.8**
Structural Grade: **0**
O&M Grade: **2**
Clock Start/From: **8**
Clock To: **4**
1st Value:
2nd Value:
Value Percent: **5.000**
Continuous Index: **S01**
Within 8" of Joint: **NO**
Remarks:

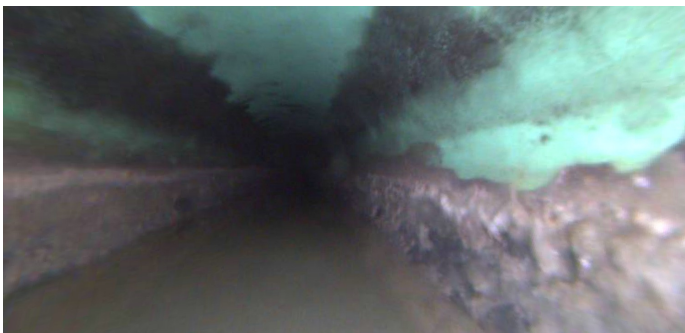
Code: **MSA**
Description: **Abandoned Survey**

Distance (ft): **109.9**
Structural Grade: **0**
O&M Grade: **0**
Clock Start/From:
Clock To:
1st Value:
2nd Value:
Value Percent:
Continuous Index:
Within 8" of Joint: **NO**
Remarks: **UNKNOWN**

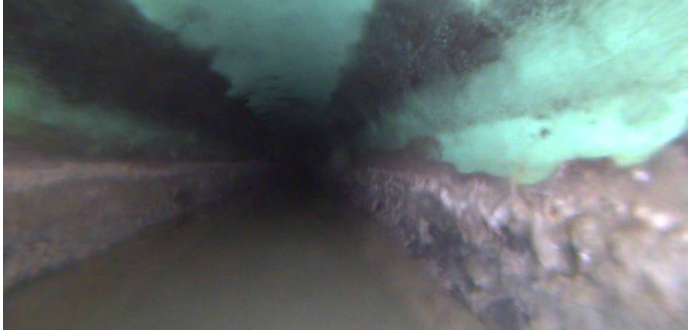
Code:	DAGS
Description:	Deposits Attached Grease
Distance (ft):	109.9
Structural Grade:	0
O&M Grade:	2
Clock Start/From:	8
Clock To:	4
1st Value:	
2nd Value:	
Value Percent:	5.000
Continuous Index:	F01
Within 8" of Joint:	NO
Remarks:
