Profile/Photo Observation Report

Street:	Bracken	Flow Control:	Not Controlled
City:	Hobart, IN	Year Renewed:	
Location:	Sidewalk	Tape/Media #:	
Purpose:	Maintenance Related	Dia/Height:	8"
Use:	Sanitary	Material:	PVC
Drain Area:	NA	Lining:	Cured in Place
Category:	NA		
Comment:	Flow direction wrong.

Location Details:		Direction of Survey:	Downstream
US MH:	M-708-113	DS MH:	M-708-114
		Total Length Surveyed (ft):	111.2

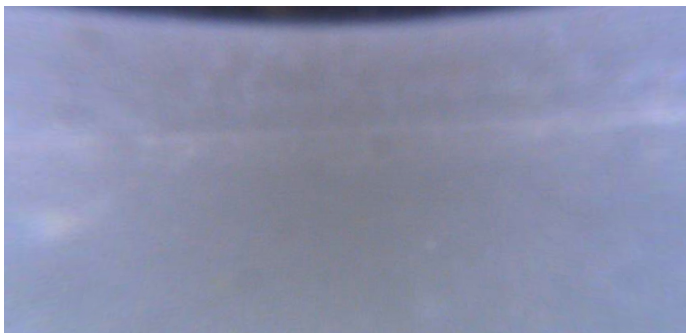
Code: **AMH**
Description: **Manhole**

Distance (ft): **.0**
Structural Grade: **0**
O&M Grade: **0**
Clock Start/From:
Clock To:
1st Value:
2nd Value:
Value Percent:
Continuous Index:
Within 8" of Joint: **NO**
Remarks: **M-708-113**

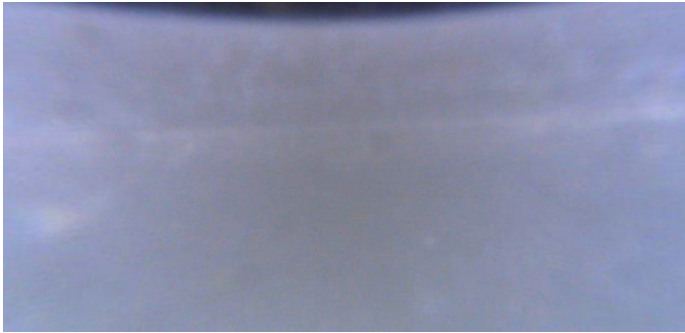
Code:	MWL
Description:	Water Level

Distance (ft):	.0
Structural Grade:	0
O&M Grade:	0
Clock Start/From:	
Clock To:	
1st Value:	
2nd Value:	
Value Percent:	70.000
Continuous Index:	
Within 8" of Joint:	NO
Remarks:

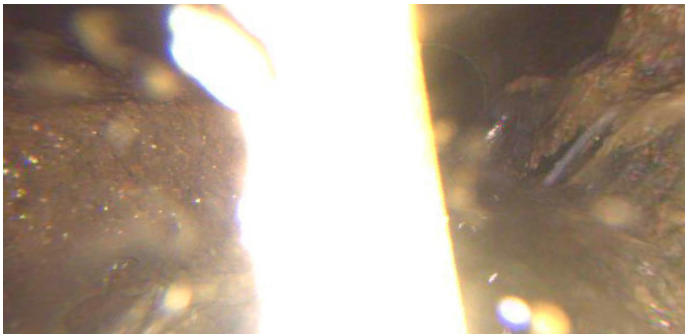
Code:	MGO
Description:	General Observation

Distance (ft):	.0
Structural Grade:	0
O&M Grade:	0
Clock Start/From:	
Clock To:	
1st Value:	
2nd Value:	
Value Percent:	
Continuous Index:	
Within 8" of Joint:	NO
Remarks:	REAR CAMERA

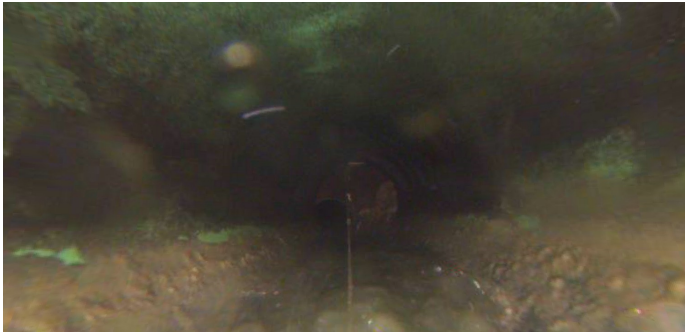
Code: **DAGS**
Description: **Deposits Attached Grease**

Distance (ft): **2.8**
Structural Grade: **0**
O&M Grade: **2**
Clock Start/From: **8**
Clock To: **4**
1st Value:
2nd Value:
Value Percent: **5.000**
Continuous Index: **S01**
Within 8" of Joint: **NO**
Remarks:

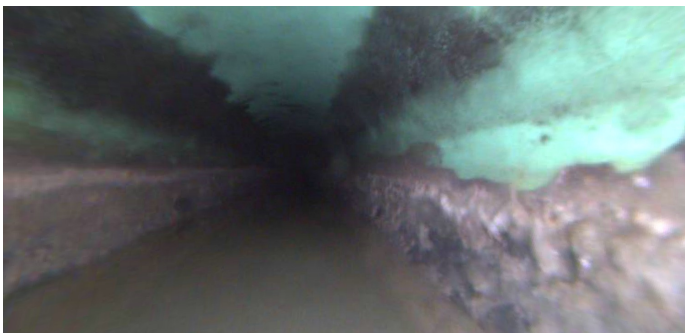
Code: **MSA**
Description: **Abandoned Survey**

Distance (ft): **109.9**
Structural Grade: **0**
O&M Grade: **0**
Clock Start/From:
Clock To:
1st Value:
2nd Value:
Value Percent:
Continuous Index:
Within 8" of Joint: **NO**
Remarks: **UNKNOWN**

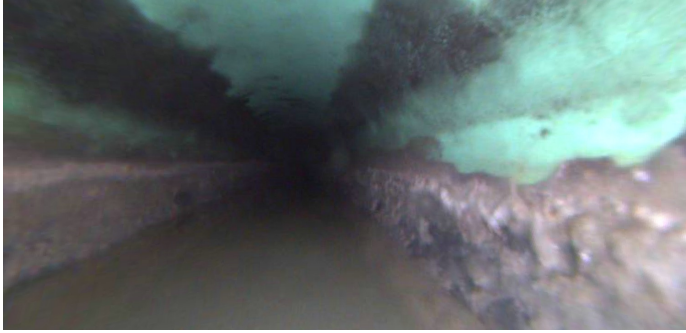
Code:	DAGS
Description:	Deposits Attached Grease
Distance (ft):	109.9
Structural Grade:	0
O&M Grade:	2
Clock Start/From:	8
Clock To:	4
1st Value:	
2nd Value:	
Value Percent:	5.000
Continuous Index:	F01
Within 8" of Joint:	NO
Remarks:
