Profile/Photo Observation Report

Street:	BRACKEN PKWY & LINCOLN ST	Flow Control:	Not Controlled
City:	Hobart, IN	Year Renewed:	
Location:	Sidewalk	Tape/Media #:	
Purpose:	Maintenance Related	Dia/Height:	12"
Use:	Sanitary	Material:	PVC
Drain Area:	NA	Lining:	Cured in Place
Category:	NA		
Comment:			
Location Details:		Direction of Survey:	Downstream
US MH:	M-708-115	DS MH:	M-708-114
		Total Length Surveyed (ft):	134.8

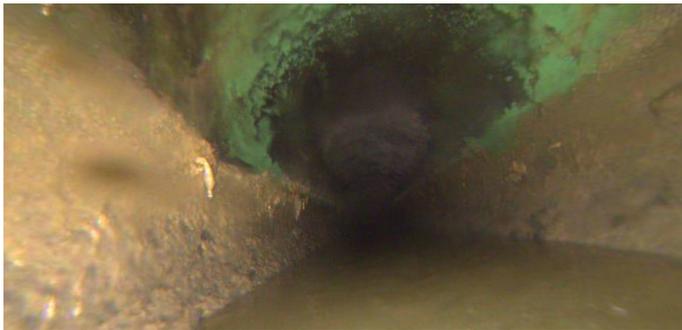
Code: **AMH**
Description: **Manhole**

Distance (ft): **.0**
Structural Grade: **0**
O&M Grade: **0**
Clock Start/From:
Clock To:
1st Value:
2nd Value:
Value Percent:
Continuous Index:
Within 8" of Joint: **NO**
Remarks: **M-708-115**

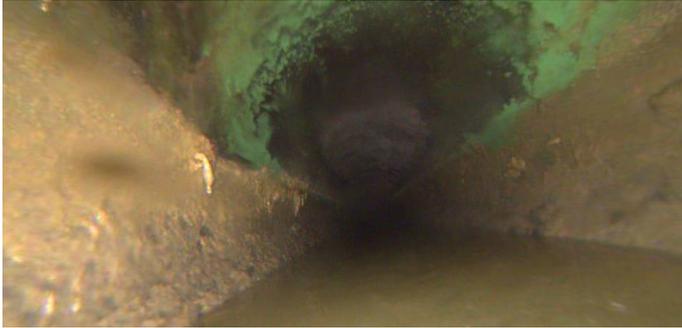
Code: **MWL**
Description: **Water Level**

Distance (ft): **.0**
Structural Grade: **0**
O&M Grade: **0**
Clock Start/From:
Clock To:
1st Value:
2nd Value:
Value Percent: **20.000**
Continuous Index:
Within 8" of Joint: **NO**
Remarks:

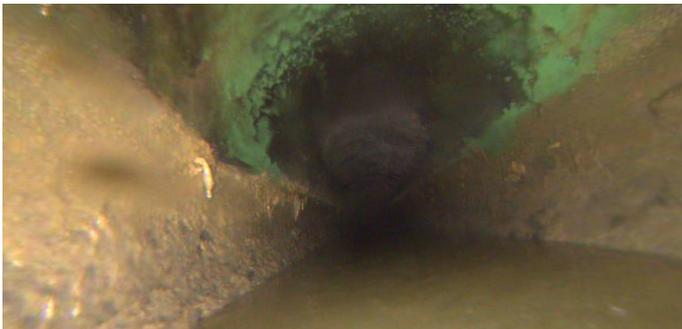
Code: **DAGS**
Description: **Deposits Attached Grease**

Distance (ft): **.0**
Structural Grade: **0**
O&M Grade: **2**
Clock Start/From: **8**
Clock To: **4**
1st Value:
2nd Value:
Value Percent: **5.000**
Continuous Index: **S01**
Within 8" of Joint: **NO**
Remarks:

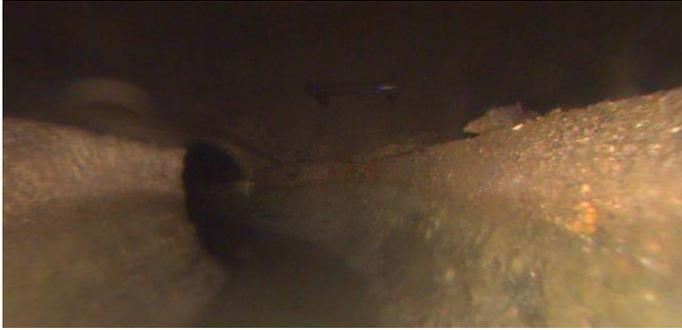
Code: **DAGS**
Description: **Deposits Attached Grease**

Distance (ft): **133.0**
Structural Grade: **0**
O&M Grade: **2**
Clock Start/From: **8**
Clock To: **4**
1st Value:
2nd Value:
Value Percent: **5.000**
Continuous Index: **F01**
Within 8" of Joint: **NO**
Remarks:

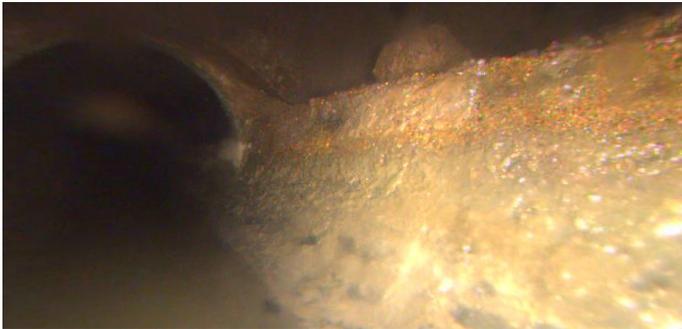
Code: **AMH**
Description: **Manhole**

Distance (ft): **134.8**
Structural Grade: **0**
O&M Grade: **0**
Clock Start/From:
Clock To:
1st Value:
2nd Value:
Value Percent:
Continuous Index:
Within 8" of Joint: **NO**
Remarks: **M-708-114**
