Profile/Photo Observation Report

Street:	Bracken	Flow Control:	Not Controlled
City:	Hobart, IN	Year Renewed:	
Location:	Sidewalk	Tape/Media #:	
Purpose:	Maintenance Related	Dia/Height:	12"
Use:	Sanitary	Material:	PVC
Drain Area:	NA	Lining:	Cured in Place
Category:	NA		
Comment:

Location Details:		Direction of Survey:	Downstream
US MH:	M-708-115	DS MH:	M-708-114
		Total Length Surveyed (ft):	134.8

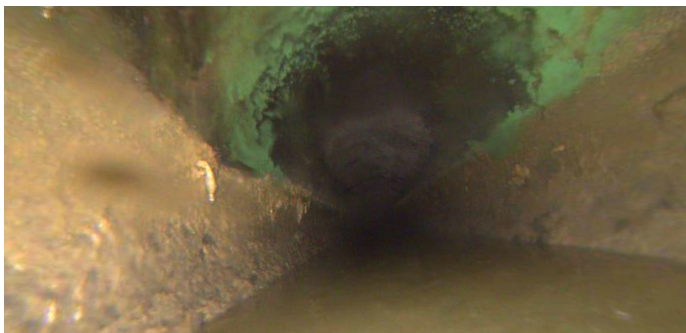
Code: **AMH**
Description: **Manhole**

Distance (ft): **.0**
Structural Grade: **0**
O&M Grade: **0**
Clock Start/From:
Clock To:
1st Value:
2nd Value:
Value Percent:
Continuous Index:
Within 8" of Joint: **NO**
Remarks: **M-708-115**

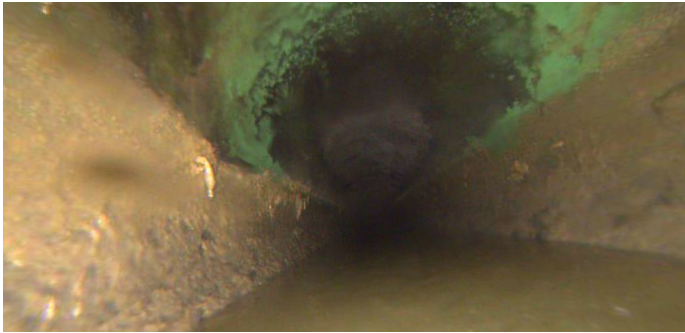
Code:	MWL
Description:	Water Level

Distance (ft):	.0
Structural Grade:	0
O&M Grade:	0
Clock Start/From:	
Clock To:	
1st Value:	
2nd Value:	
Value Percent:	20.000
Continuous Index:	
Within 8" of Joint:	NO
Remarks:

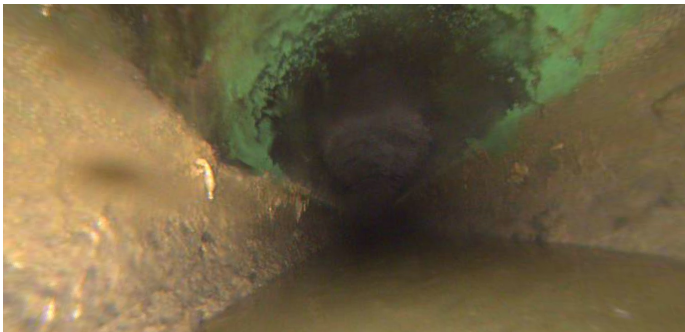
Code:	DAGS
Description:	Deposits Attached Grease

Distance (ft):	.0
Structural Grade:	0
O&M Grade:	2
Clock Start/From:	8
Clock To:	4
1st Value:	
2nd Value:	
Value Percent:	5.000
Continuous Index:	S01
Within 8" of Joint:	NO
Remarks:

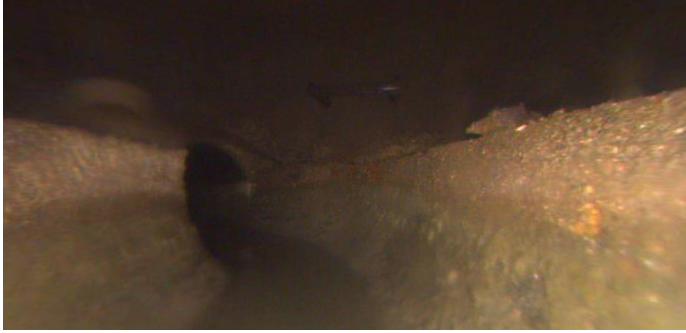
Code: **DAGS**
Description: **Deposits Attached Grease**

Distance (ft): **133.0**
Structural Grade: **0**
O&M Grade: **2**
Clock Start/From: **8**
Clock To: **4**
1st Value:
2nd Value:
Value Percent: **5.000**
Continuous Index: **F01**
Within 8" of Joint: **NO**
Remarks:

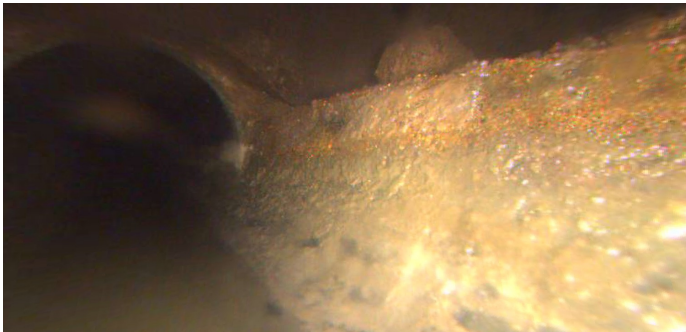
Code: **AMH**
Description: **Manhole**

Distance (ft): **134.8**
Structural Grade: **0**
O&M Grade: **0**
Clock Start/From:
Clock To:
1st Value:
2nd Value:
Value Percent:
Continuous Index:
Within 8" of Joint: **NO**
Remarks: **M-708-114**
