Profile/Photo Observation Report

Date:	04/03/2018	Weather:		Coding:	PACP 6.0
Pipe Length (ft):	205.0	Owner:	NA	Pre Clean:	Not Known
P.O.#:		Surveyor:	Jen Costello	PSR:	P-708-167-115
Customer:		Clean Date:	01/01/1900	Shape:	C

Street:	LINCOLN ST & BRACKEN PKWY	Flow Control:	Not Controlled
City:	Hobart, IN	Year Renewed:	
Location:	Sidewalk	Tape/Media #:	
Purpose:	Maintenance Related	Dia/Height:	8"
Use:	Sanitary	Material:	PVC
Drain Area:	NA	Lining:	Cured in Place
Category:	NA		
Comment:

Location Details:		Direction of Survey:	Downstream
US MH:	M-708-115	DS MH:	M-708-167
		Total Length Surveyed (ft):	199.6

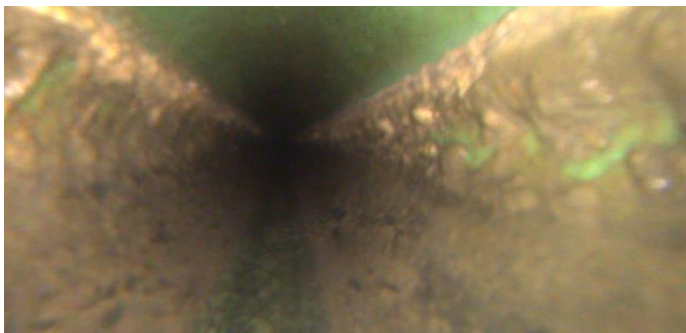
Code: **AMH**
Description: **Manhole**

Distance (ft): **.0**
Structural Grade: **0**
O&M Grade: **0**
Clock Start/From:
Clock To:
1st Value:
2nd Value:
Value Percent:
Continuous Index:
Within 8" of Joint: **NO**
Remarks: **M-708-115**

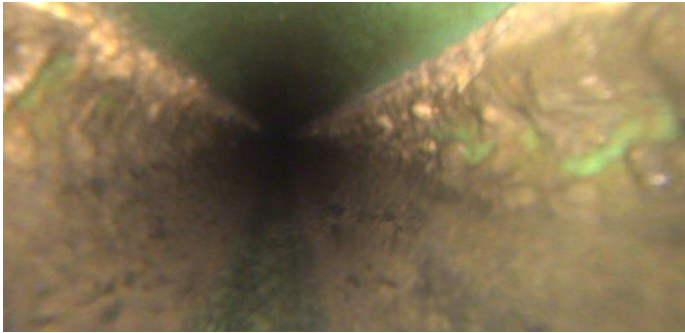
Code:	MWL
Description:	Water Level

Distance (ft):	.0
Structural Grade:	0
O&M Grade:	0
Clock Start/From:	
Clock To:	
1st Value:	
2nd Value:	
Value Percent:	5.000
Continuous Index:	
Within 8" of Joint:	NO
Remarks:

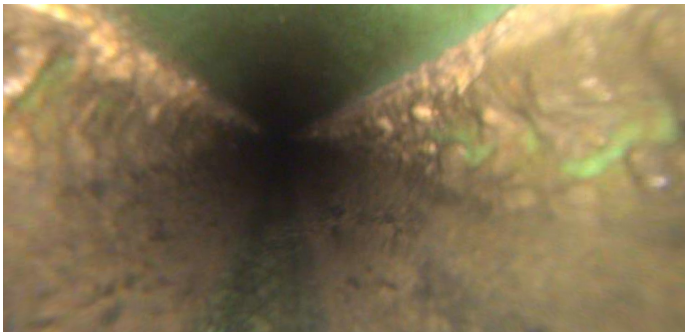
Code:	DAGS
Description:	Deposits Attached Grease

Distance (ft):	.0
Structural Grade:	0
O&M Grade:	2
Clock Start/From:	7
Clock To:	5
1st Value:	
2nd Value:	
Value Percent:	5.000
Continuous Index:	S01
Within 8" of Joint:	NO
Remarks:

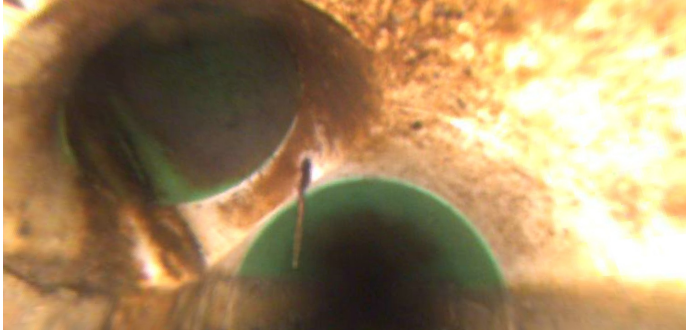
Code: **TF**
Description: **Tap Factory**

Distance (ft): **36.2**
Structural Grade: **0**
O&M Grade: **0**
Clock Start/From: **11**
Clock To:
1st Value: **4.000**
2nd Value:
Value Percent:
Continuous Index:
Within 8" of Joint:
Remarks:

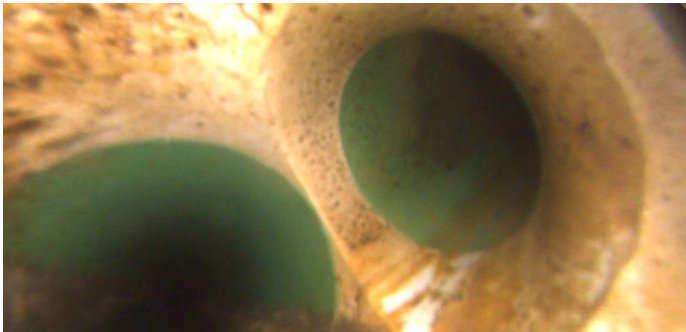
Code: **TF**
Description: **Tap Factory**

Distance (ft): **55.7**
Structural Grade: **0**
O&M Grade: **0**
Clock Start/From: **2**
Clock To:
1st Value: **4.000**
2nd Value:
Value Percent:
Continuous Index:
Within 8" of Joint:
Remarks:

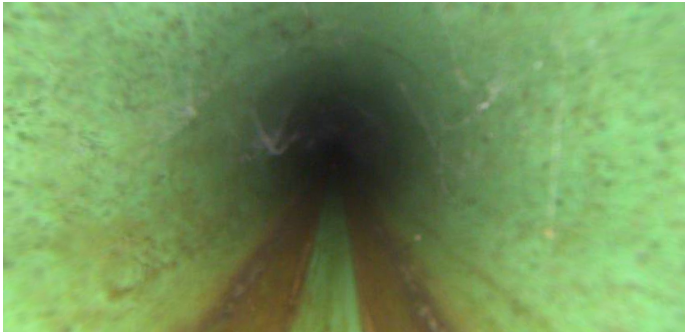
Code: **DAGS**
Description: **Deposits Attached Grease**

Distance (ft): **121.5**
Structural Grade: **0**
O&M Grade: **2**
Clock Start/From: **7**
Clock To: **5**
1st Value:
2nd Value:
Value Percent: **5.000**
Continuous Index: **F01**
Within 8" of Joint: **NO**
Remarks:

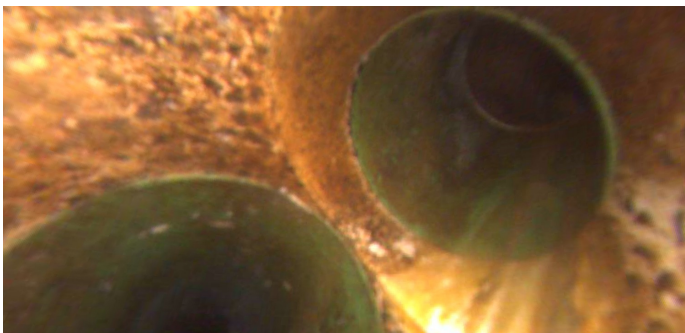
Code: **TF**
Description: **Tap Factory**

Distance (ft): **145.0**
Structural Grade: **0**
O&M Grade: **0**
Clock Start/From: **1**
Clock To:
1st Value: **4.000**
2nd Value:
Value Percent:
Continuous Index:
Within 8" of Joint:
Remarks:

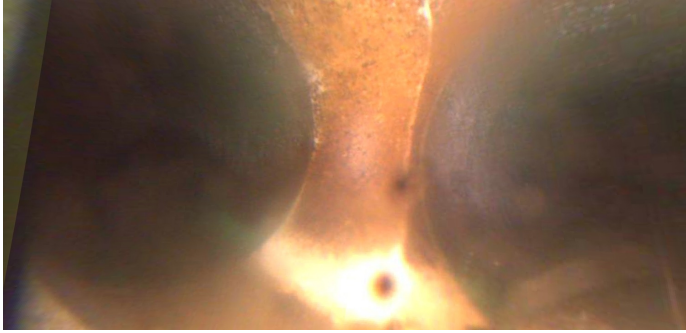
Code: **TFA**
Description: **Tap Factory Active**

Distance (ft): **191.2**
Structural Grade: **0**
O&M Grade: **0**
Clock Start/From: **3**
Clock To:
1st Value: **4.000**
2nd Value:
Value Percent:
Continuous Index:
Within 8" of Joint:
Remarks:

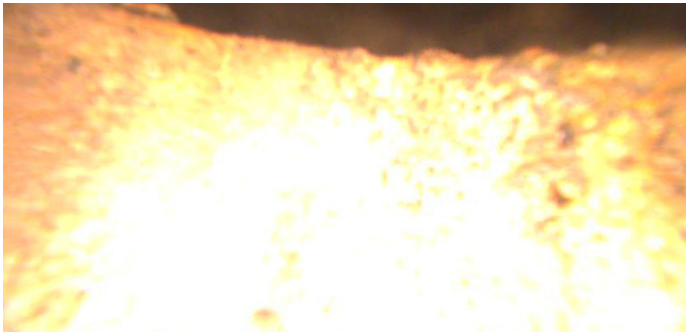
Code: **AMH**
Description: **Manhole**

Distance (ft): **198.8**
Structural Grade: **0**
O&M Grade: **0**
Clock Start/From:
Clock To:
1st Value:
2nd Value:
Value Percent:
Continuous Index:
Within 8" of Joint: **NO**
Remarks: **M-708-167**
