## Profile/Photo Observation Report

Street:	<b>Capitol</b>	Flow Control:	<b>Not Controlled</b>
City:	<b>Hobart, IN</b>	Year Renewed:	
Location:	<b>Sidewalk</b>	Tape/Media #:	
Purpose:	<b>Maintenance Related</b>	Dia/Height:	<b>8"</b>
Use:	<b>Sanitary</b>	Material:	<b>PVC</b>
Drain Area:	<b>NA</b>	Lining:	<b>Cured in Place</b>
Category:	<b>NA</b>		
Comment:

Location Details:		Direction of Survey:	<b>Downstream</b>
US MH:	<b>M-708-115</b>	DS MH:	<b>M-708-167</b>
		Total Length Surveyed (ft):	<b>199.6</b>

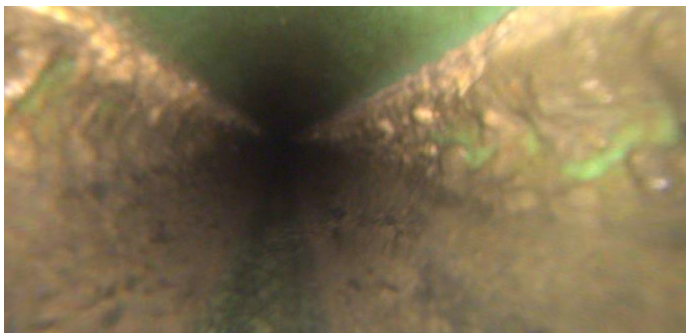
Code: **AMH**  
Description: **Manhole**

Distance (ft): **.0**  
Structural Grade: **0**  
O&M Grade: **0**  
Clock Start/From:  
Clock To:  
1st Value:  
2nd Value:  
Value Percent:  
Continuous Index:  
Within 8" of Joint: **NO**  
Remarks: **M-708-115**

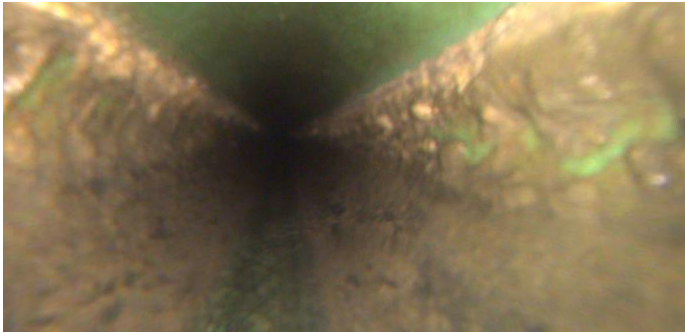
Code:	<b>MWL</b>
Description:	<b>Water Level</b>

Distance (ft):	<b>.0</b>
Structural Grade:	<b>0</b>
O&M Grade:	<b>0</b>
Clock Start/From:	
Clock To:	
1st Value:	
2nd Value:	
Value Percent:	<b>5.000</b>
Continuous Index:	
Within 8" of Joint:	<b>NO</b>
Remarks:

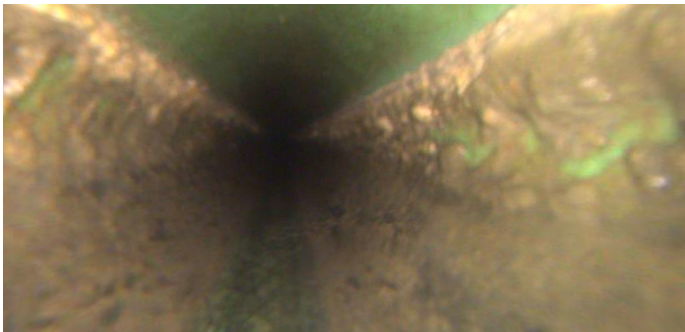
Code:	<b>DAGS</b>
Description:	<b>Deposits Attached Grease</b>

Distance (ft):	<b>.0</b>
Structural Grade:	<b>0</b>
O&M Grade:	<b>2</b>
Clock Start/From:	<b>7</b>
Clock To:	<b>5</b>
1st Value:	
2nd Value:	
Value Percent:	<b>5.000</b>
Continuous Index:	<b>S01</b>
Within 8" of Joint:	<b>NO</b>
Remarks:

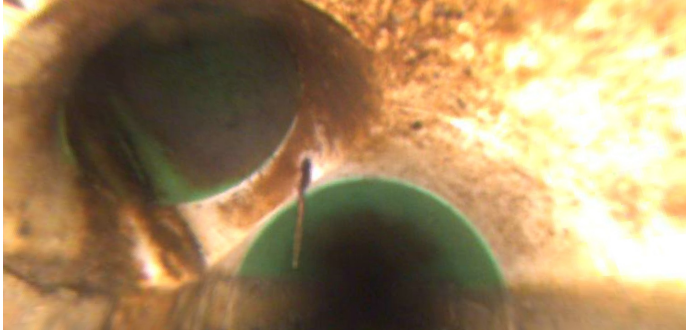
Code: **TF**  
Description: **Tap Factory**

Distance (ft): **36.2**  
Structural Grade: **0**  
O&M Grade: **0**  
Clock Start/From: **11**  
Clock To:  
1st Value: **4.000**  
2nd Value:  
Value Percent:  
Continuous Index:  
Within 8" of Joint:  
Remarks:

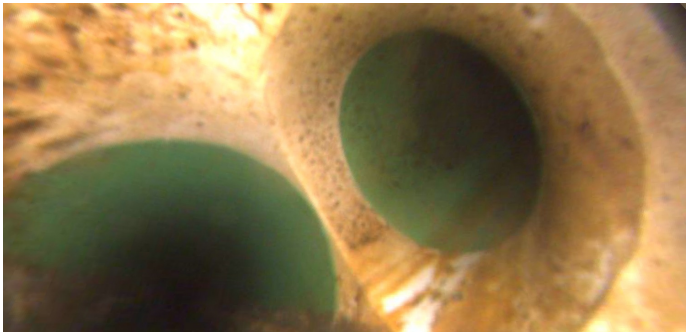
Code: **TF**  
Description: **Tap Factory**

Distance (ft): **55.7**  
Structural Grade: **0**  
O&M Grade: **0**  
Clock Start/From: **2**  
Clock To:  
1st Value: **4.000**  
2nd Value:  
Value Percent:  
Continuous Index:  
Within 8" of Joint:  
Remarks:

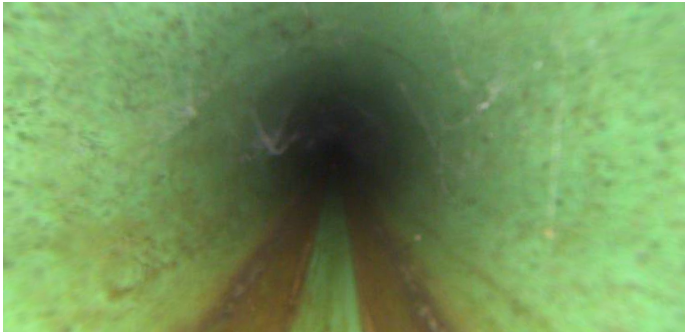
Code: **DAGS**  
Description: **Deposits Attached Grease**

Distance (ft): **121.5**  
Structural Grade: **0**  
O&M Grade: **2**  
Clock Start/From: **7**  
Clock To: **5**  
1st Value:  
2nd Value:  
Value Percent: **5.000**  
Continuous Index: **F01**  
Within 8" of Joint: **NO**  
Remarks:

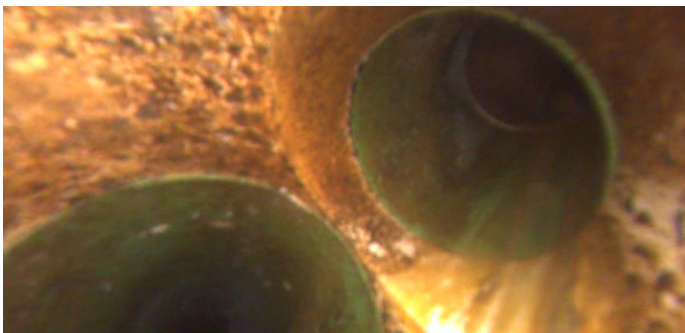
Code: **TF**  
Description: **Tap Factory**

Distance (ft): **145.0**  
Structural Grade: **0**  
O&M Grade: **0**  
Clock Start/From: **1**  
Clock To:  
1st Value: **4.000**  
2nd Value:  
Value Percent:  
Continuous Index:  
Within 8" of Joint:  
Remarks:

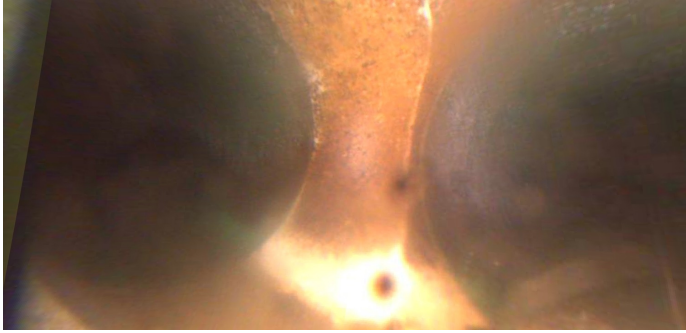
Code: **TFA**  
Description: **Tap Factory Active**

Distance (ft): **191.2**  
Structural Grade: **0**  
O&M Grade: **0**  
Clock Start/From: **3**  
Clock To:  
1st Value: **4.000**  
2nd Value:  
Value Percent:  
Continuous Index:  
Within 8" of Joint:  
Remarks:

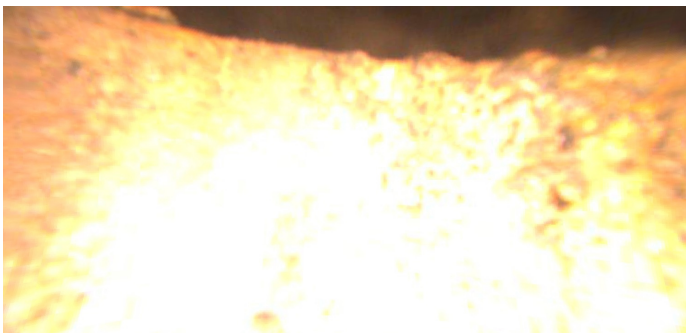
Code: **AMH**  
Description: **Manhole**

Distance (ft): **198.8**  
Structural Grade: **0**  
O&M Grade: **0**  
Clock Start/From:  
Clock To:  
1st Value:  
2nd Value:  
Value Percent:  
Continuous Index:  
Within 8" of Joint: **NO**  
Remarks: **M-708-167**
