## Profile/Photo Observation Report

Street:	<b>Magnolia</b>	Flow Control:	<b>Not Controlled</b>
City:	<b>Hobart, IN</b>	Year Renewed:	
Location:	<b>Sidewalk</b>	Tape/Media #:	
Purpose:	<b>Maintenance Related</b>	Dia/Height:	<b>8"</b>
Use:	<b>Sanitary</b>	Material:	<b>PVC</b>
Drain Area:	<b>NA</b>	Lining:	<b>Cured in Place</b>
Category:	<b>NA</b>		
Comment:	<b>Flow direction wrong.</b>

Location Details:		Direction of Survey:	<b>Downstream</b>
US MH:	<b>M-708-120</b>	DS MH:	<b>M-708-121</b>
		Total Length Surveyed (ft):	<b>125.7</b>

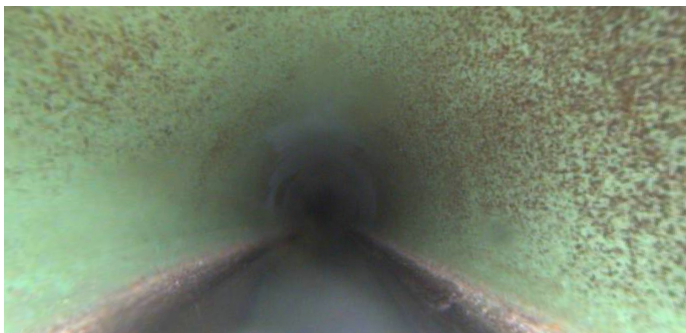
Code: **AMH**  
Description: **Manhole**

Distance (ft): **.0**  
Structural Grade: **0**  
O&M Grade: **0**  
Clock Start/From:  
Clock To:  
1st Value:  
2nd Value:  
Value Percent:  
Continuous Index:  
Within 8" of Joint: **NO**  
Remarks: **M-708-120**

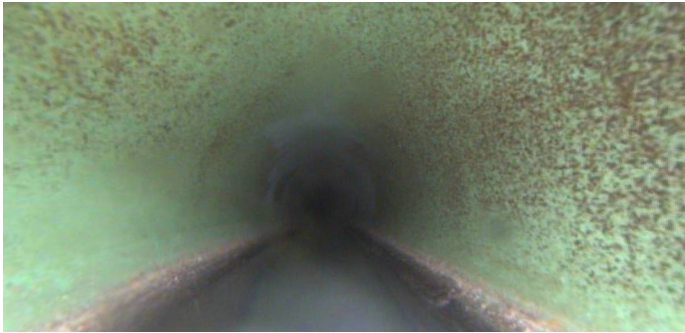
Code:	<b>MWL</b>
Description:	<b>Water Level</b>

Distance (ft):	<b>.0</b>
Structural Grade:	<b>0</b>
O&M Grade:	<b>0</b>
Clock Start/From:	
Clock To:	
1st Value:	
2nd Value:	
Value Percent:	<b>10.000</b>
Continuous Index:	
Within 8" of Joint:	<b>NO</b>
Remarks:

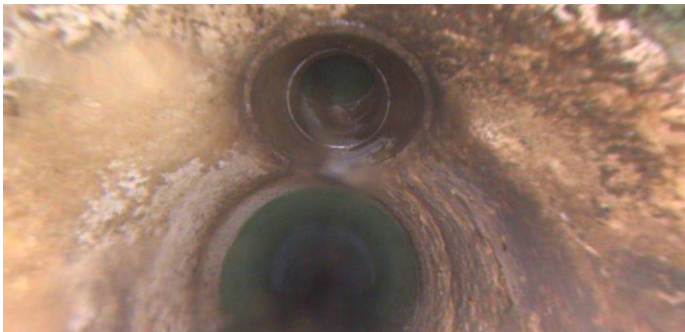
Code:	<b>TF</b>
Description:	<b>Tap Factory</b>

Distance (ft):	<b>65.2</b>
Structural Grade:	<b>0</b>
O&M Grade:	<b>0</b>
Clock Start/From:	<b>12</b>
Clock To:	
1st Value:	<b>4.000</b>
2nd Value:	
Value Percent:	
Continuous Index:	
Within 8" of Joint:	
Remarks:

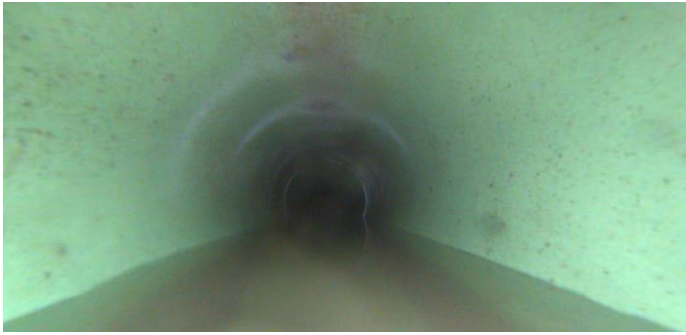
Code: **MWL**  
Description: **Water Level**

Distance (ft): **95.9**  
Structural Grade: **0**  
O&M Grade: **0**  
Clock Start/From:  
Clock To:  
1st Value:  
2nd Value:  
Value Percent: **25.000**  
Continuous Index:  
Within 8" of Joint: **NO**  
Remarks:

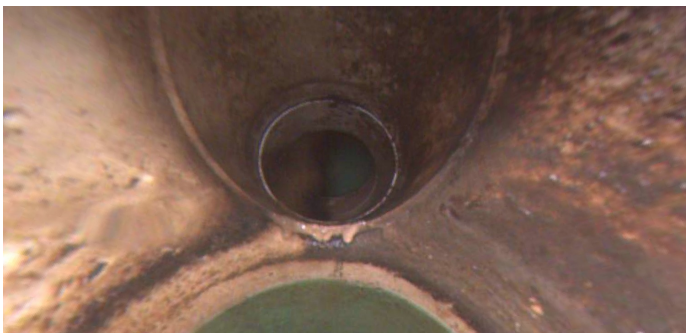
Code: **TFA**  
Description: **Tap Factory Active**

Distance (ft): **113.4**  
Structural Grade: **0**  
O&M Grade: **0**  
Clock Start/From: **12**  
Clock To:  
1st Value: **4.000**  
2nd Value:  
Value Percent:  
Continuous Index:  
Within 8" of Joint:  
Remarks:

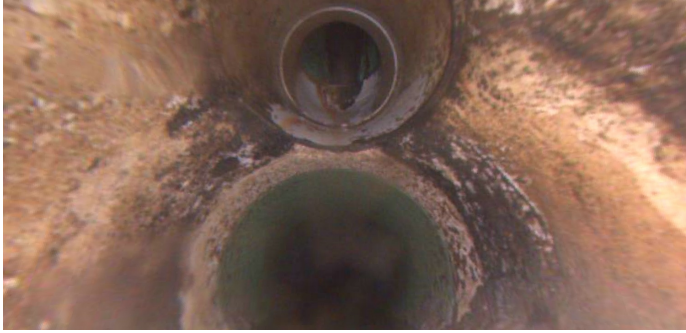
Code: **TF**  
Description: **Tap Factory**

Distance (ft): **116.1**  
Structural Grade: **0**  
O&M Grade: **0**  
Clock Start/From: **12**  
Clock To:  
1st Value: **4.000**  
2nd Value:  
Value Percent:  
Continuous Index:  
Within 8" of Joint:  
Remarks:

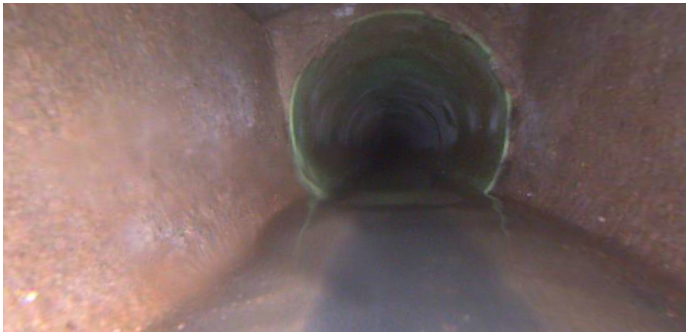
Code: **AMH**  
Description: **Manhole**

Distance (ft): **125.7**  
Structural Grade: **0**  
O&M Grade: **0**  
Clock Start/From:  
Clock To:  
1st Value:  
2nd Value:  
Value Percent:  
Continuous Index:  
Within 8" of Joint: **NO**  
Remarks: **M-708-121**
