## Profile/Photo Observation Report

Street:	<b>TAMARACK DR</b>	Flow Control:	<b>Not Controlled</b>
City:	<b>Hobart, IN</b>	Year Renewed:	
Location:	<b>Sidewalk</b>	Tape/Media #:	
Purpose:	<b>Maintenance Related</b>	Dia/Height:	<b>8"</b>
Use:	<b>Sanitary</b>	Material:	<b>PVC</b>
Drain Area:	<b>NA</b>	Lining:	<b>Cured in Place</b>
Category:	<b>NA</b>		
Comment:	<b>Flow direction wrong.</b>

Location Details:		Direction of Survey:	<b>Downstream</b>
US MH:	<b>M-708-121</b>	DS MH:	<b>M-708-122</b>
		Total Length Surveyed (ft):	<b>119.6</b>

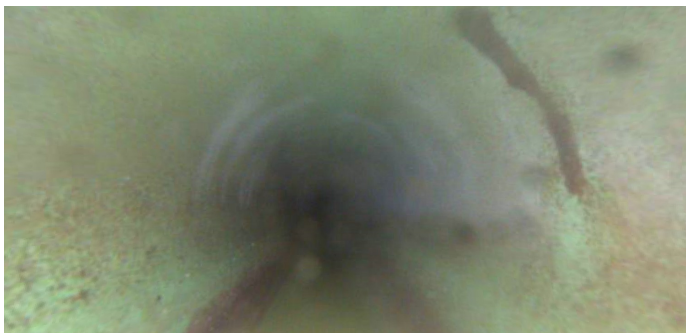
Code: **AMH**  
Description: **Manhole**

Distance (ft): **.0**  
Structural Grade: **0**  
O&M Grade: **0**  
Clock Start/From:  
Clock To:  
1st Value:  
2nd Value:  
Value Percent:  
Continuous Index:  
Within 8" of Joint: **NO**  
Remarks: **M-708-121**

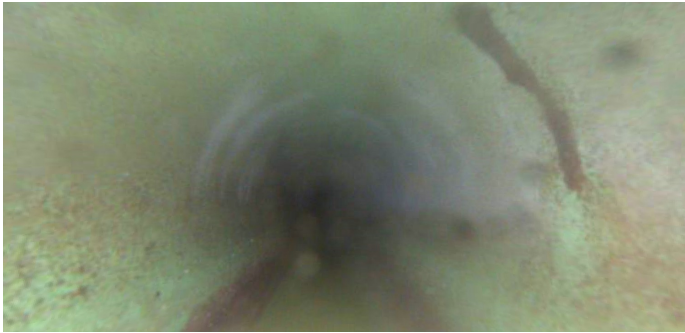
Code:	<b>MWL</b>
Description:	<b>Water Level</b>

Distance (ft):	<b>.0</b>
Structural Grade:	<b>0</b>
O&M Grade:	<b>0</b>
Clock Start/From:	
Clock To:	
1st Value:	
2nd Value:	
Value Percent:	<b>5.000</b>
Continuous Index:	
Within 8" of Joint:	<b>NO</b>
Remarks:

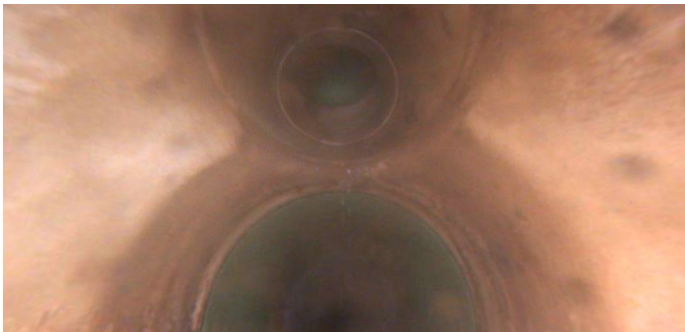
Code:	<b>TFA</b>
Description:	<b>Tap Factory Active</b>

Distance (ft):	<b>34.6</b>
Structural Grade:	<b>0</b>
O&M Grade:	<b>0</b>
Clock Start/From:	<b>12</b>
Clock To:	
1st Value:	<b>4.000</b>
2nd Value:	
Value Percent:	
Continuous Index:	
Within 8" of Joint:	
Remarks:

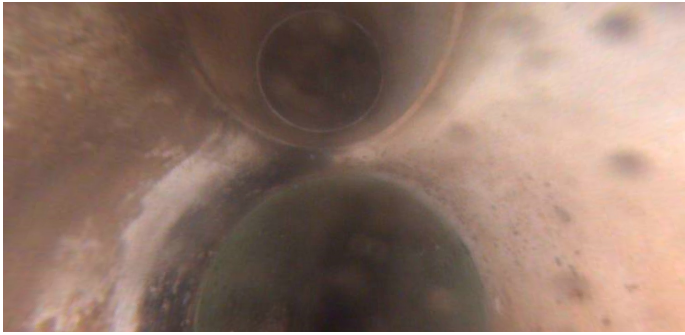
Code: **TF**  
Description: **Tap Factory**

Distance (ft): **77.9**  
Structural Grade: **0**  
O&M Grade: **0**  
Clock Start/From: **12**  
Clock To:  
1st Value: **4.000**  
2nd Value:  
Value Percent:  
Continuous Index:  
Within 8" of Joint:  
Remarks:

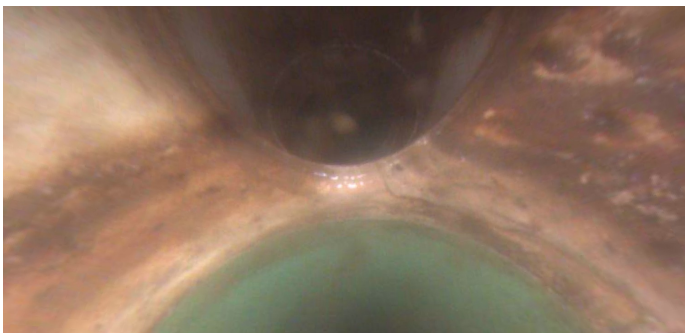
Code: **TF**  
Description: **Tap Factory**

Distance (ft): **81.0**  
Structural Grade: **0**  
O&M Grade: **0**  
Clock Start/From: **12**  
Clock To:  
1st Value: **4.000**  
2nd Value:  
Value Percent:  
Continuous Index:  
Within 8" of Joint:  
Remarks:

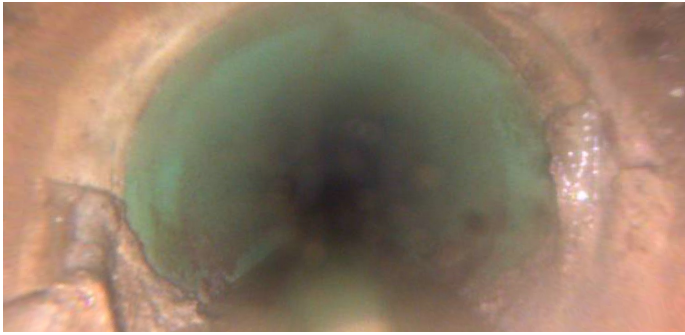
Code: **DAGS**  
Description: **Deposits Attached Grease**

Distance (ft): **81.0**  
Structural Grade: **0**  
O&M Grade: **2**  
Clock Start/From: **8**  
Clock To: **4**  
1st Value:  
2nd Value:  
Value Percent: **5.000**  
Continuous Index:  
Within 8" of Joint: **YES**  
Remarks:

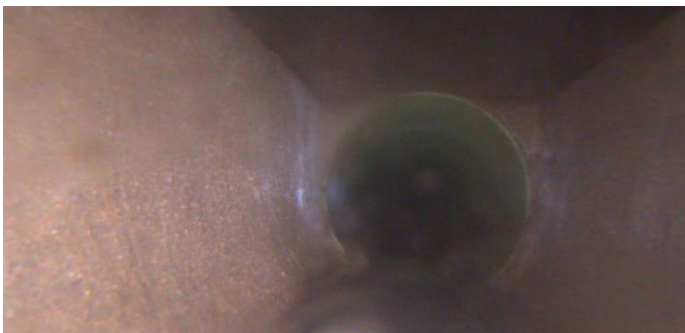
Code: **AMH**  
Description: **Manhole**

Distance (ft): **119.6**  
Structural Grade: **0**  
O&M Grade: **0**  
Clock Start/From:  
Clock To:  
1st Value:  
2nd Value:  
Value Percent:  
Continuous Index:  
Within 8" of Joint: **NO**  
Remarks: **M-708-122**
