Profile/Photo Observation Report

Street:	HEATHER LN & REDBUD DR	Flow Control:	Not Controlled
City:	Hobart, IN	Year Renewed:	
Location:	Sidewalk	Tape/Media #:	
Purpose:	Maintenance Related	Dia/Height:	8"
Use:	Sanitary	Material:	PVC
Drain Area:	NA	Lining:	Cured in Place
Category:	NA		
Comment:	Flow direction wrong.

Location Details:		Direction of Survey:	Upstream
US MH:	M-708-124	DS MH:	M-708-125
		Total Length Surveyed (ft):	90.0

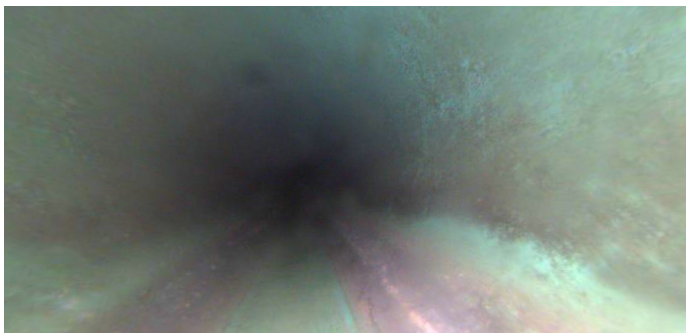
Code: **AMH**
Description: **Manhole**

Distance (ft): **.0**
Structural Grade: **0**
O&M Grade: **0**
Clock Start/From:
Clock To:
1st Value:
2nd Value:
Value Percent:
Continuous Index:
Within 8" of Joint: **NO**
Remarks: **M-708-125**

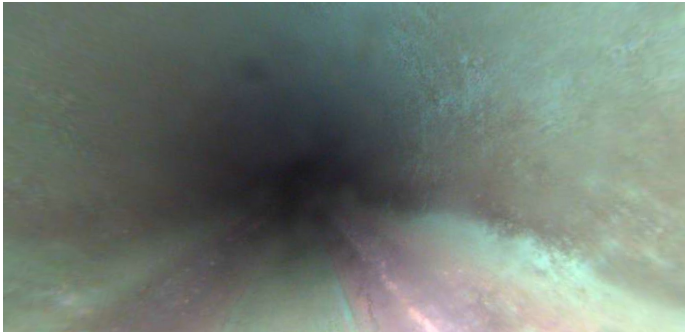
Code:	MWL
Description:	Water Level

Distance (ft):	.0
Structural Grade:	0
O&M Grade:	0
Clock Start/From:	
Clock To:	
1st Value:	
2nd Value:	
Value Percent:	5.000
Continuous Index:	
Within 8" of Joint:	NO
Remarks:

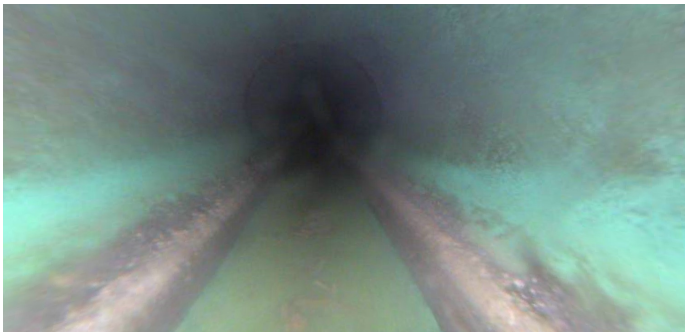
Code:	DAGS
Description:	Deposits Attached Grease

Distance (ft):	7.2
Structural Grade:	0
O&M Grade:	2
Clock Start/From:	7
Clock To:	5
1st Value:	
2nd Value:	
Value Percent:	5.000
Continuous Index:	S01
Within 8" of Joint:	NO
Remarks:

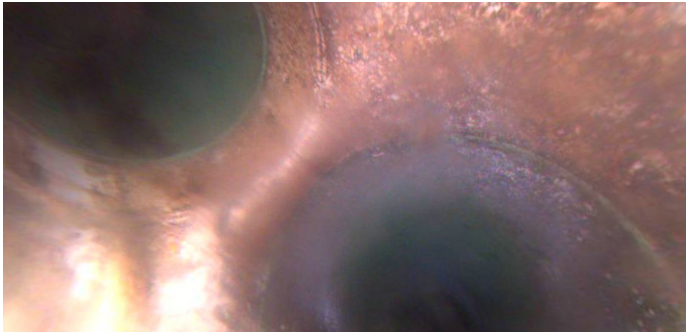
Code: **TF**
Description: **Tap Factory**

Distance (ft): **28.7**
Structural Grade: **0**
O&M Grade: **0**
Clock Start/From: **10**
Clock To:
1st Value: **4.000**
2nd Value:
Value Percent:
Continuous Index:
Within 8" of Joint:
Remarks:

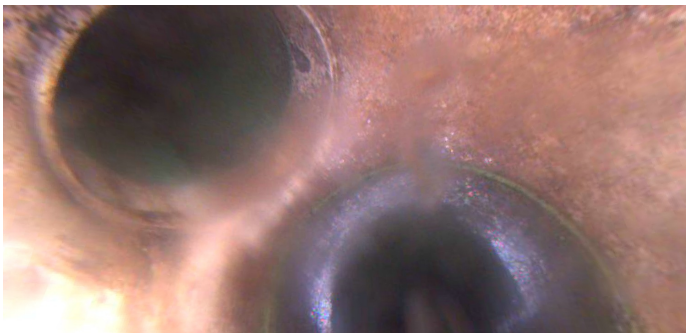
Code: **TF**
Description: **Tap Factory**

Distance (ft): **74.5**
Structural Grade: **0**
O&M Grade: **0**
Clock Start/From: **10**
Clock To:
1st Value: **4.000**
2nd Value:
Value Percent:
Continuous Index:
Within 8" of Joint:
Remarks:

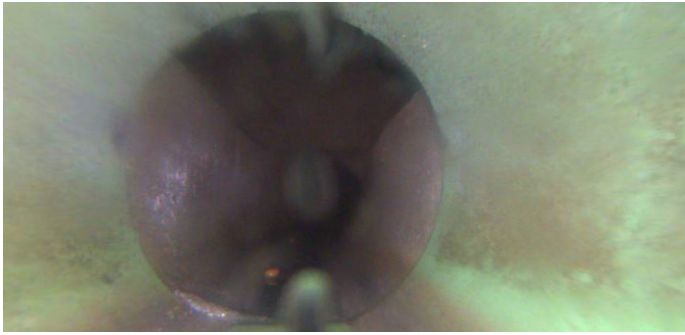
Code: **DAGS**
Description: **Deposits Attached Grease**

Distance (ft): **87.4**
Structural Grade: **0**
O&M Grade: **2**
Clock Start/From: **7**
Clock To: **5**
1st Value:
2nd Value:
Value Percent: **5.000**
Continuous Index: **F01**
Within 8" of Joint: **NO**
Remarks:

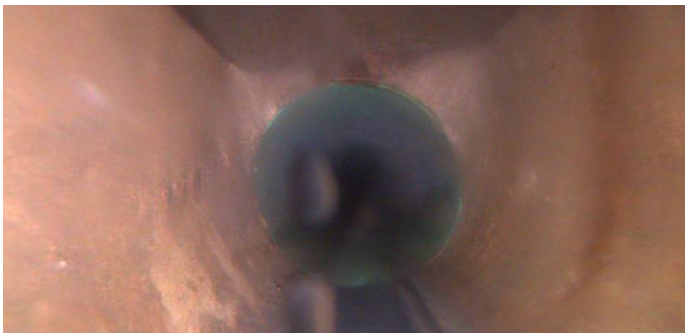
Code: **AMH**
Description: **Manhole**

Distance (ft): **90.0**
Structural Grade: **0**
O&M Grade: **0**
Clock Start/From:
Clock To:
1st Value:
2nd Value:
Value Percent:
Continuous Index:
Within 8" of Joint: **NO**
Remarks: **M-708-124**
