## Profile/Photo Observation Report

Street:	<b>REDBUD DR</b>	Flow Control:	<b>Not Controlled</b>
City:	<b>Hobart, IN</b>	Year Renewed:	
Location:	<b>Sidewalk</b>	Tape/Media #:	
Purpose:	<b>Maintenance Related</b>	Dia/Height:	<b>8"</b>
Use:	<b>Sanitary</b>	Material:	<b>PVC</b>
Drain Area:	<b>NA</b>	Lining:	<b>Cured in Place</b>
Category:	<b>NA</b>		
Comment:	<b>Flow direction wrong.</b>

Location Details:		Direction of Survey:	<b>Downstream</b>
US MH:	<b>M-708-125</b>	DS MH:	<b>M-708-126</b>
		Total Length Surveyed (ft):	<b>123.8</b>

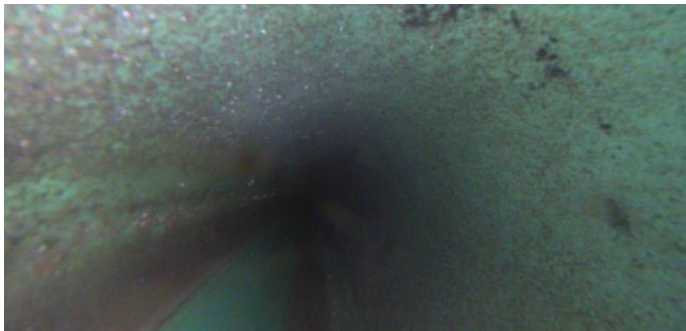
Code: **AMH**  
Description: **Manhole**

Distance (ft): **.0**  
Structural Grade: **0**  
O&M Grade: **0**  
Clock Start/From:  
Clock To:  
1st Value:  
2nd Value:  
Value Percent:  
Continuous Index:  
Within 8" of Joint: **NO**  
Remarks: **M-708-125**

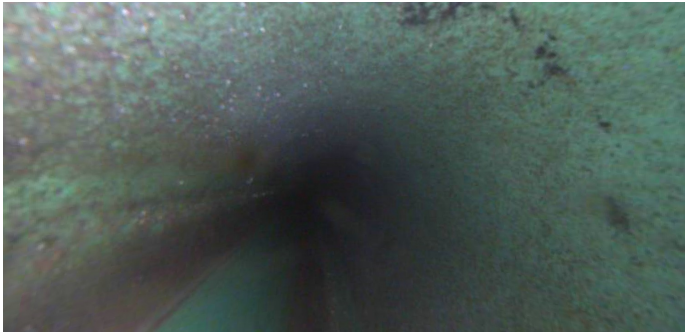
Code:	<b>MWL</b>
Description:	<b>Water Level</b>

Distance (ft):	<b>.0</b>
Structural Grade:	<b>0</b>
O&M Grade:	<b>0</b>
Clock Start/From:	
Clock To:	
1st Value:	
2nd Value:	
Value Percent:	<b>5.000</b>
Continuous Index:	
Within 8" of Joint:	<b>NO</b>
Remarks:

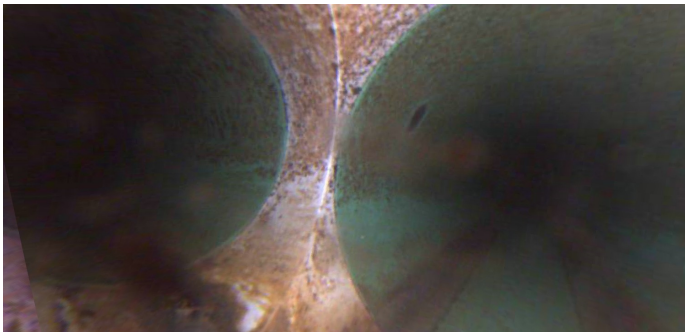
Code:	<b>TF</b>
Description:	<b>Tap Factory</b>

Distance (ft):	<b>36.0</b>
Structural Grade:	<b>0</b>
O&M Grade:	<b>0</b>
Clock Start/From:	<b>9</b>
Clock To:	
1st Value:	<b>4.000</b>
2nd Value:	
Value Percent:	
Continuous Index:	
Within 8" of Joint:	
Remarks:

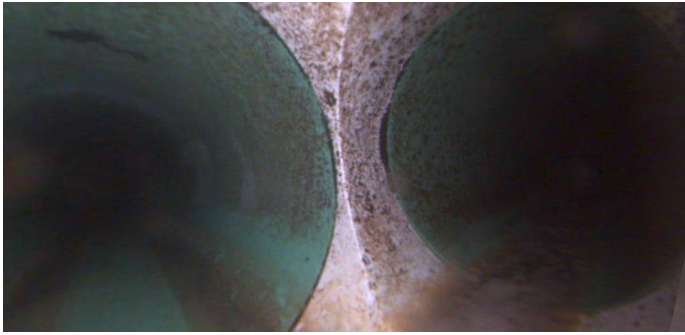
Code: **TFA**  
Description: **Tap Factory Active**

Distance (ft): **42.4**  
Structural Grade: **0**  
O&M Grade: **0**  
Clock Start/From: **3**  
Clock To:  
1st Value: **4.000**  
2nd Value:  
Value Percent:  
Continuous Index:  
Within 8" of Joint:  
Remarks:

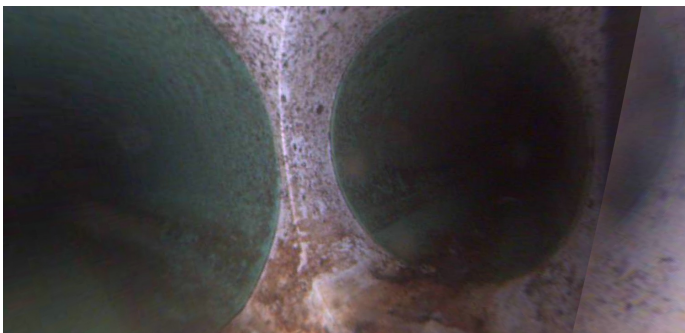
Code: **TF**  
Description: **Tap Factory**

Distance (ft): **79.8**  
Structural Grade: **0**  
O&M Grade: **0**  
Clock Start/From: **3**  
Clock To:  
1st Value: **4.000**  
2nd Value:  
Value Percent:  
Continuous Index:  
Within 8" of Joint:  
Remarks:

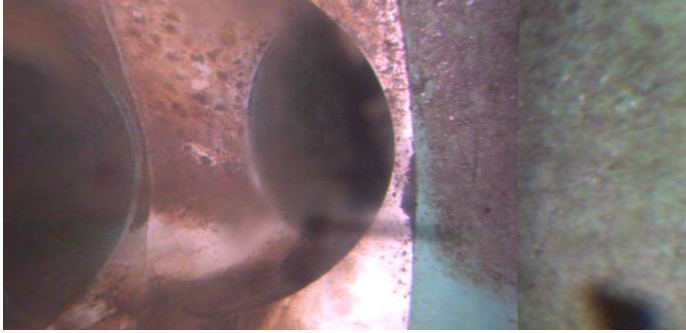
Code: **TF**  
Description: **Tap Factory**

Distance (ft): **115.9**  
Structural Grade: **0**  
O&M Grade: **0**  
Clock Start/From: **9**  
Clock To:  
1st Value: **4.000**  
2nd Value:  
Value Percent:  
Continuous Index:  
Within 8" of Joint:  
Remarks:

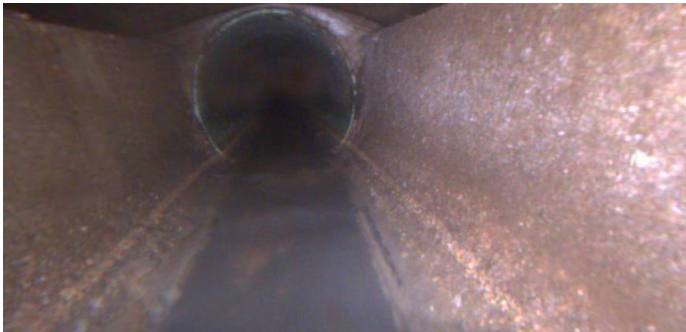
Code: **AMH**  
Description: **Manhole**

Distance (ft): **123.8**  
Structural Grade: **0**  
O&M Grade: **0**  
Clock Start/From:  
Clock To:  
1st Value:  
2nd Value:  
Value Percent:  
Continuous Index:  
Within 8" of Joint: **NO**  
Remarks: **M-708-126**
