## Profile/Photo Observation Report

Street:	<b>Redbud</b>	Flow Control:	<b>Not Controlled</b>
City:	<b>Hobart, IN</b>	Year Renewed:	
Location:	<b>Sidewalk</b>	Tape/Media #:	
Purpose:	<b>Maintenance Related</b>	Dia/Height:	<b>8"</b>
Use:	<b>Sanitary</b>	Material:	<b>PVC</b>
Drain Area:	<b>NA</b>	Lining:	<b>Cured in Place</b>
Category:	<b>NA</b>		
Comment:	<b>Flow direction wrong.</b>

Location Details:		Direction of Survey:	<b>Downstream</b>
US MH:	<b>M-708-125</b>	DS MH:	<b>M-708-126</b>
		Total Length Surveyed (ft):	<b>123.8</b>

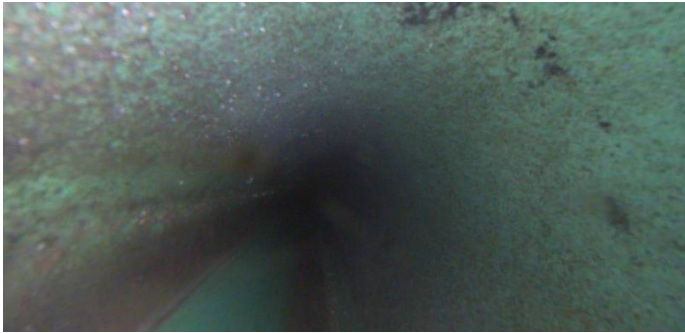
Code:	<b>MWL</b>
Description:	<b>Water Level</b>

Distance (ft):	<b>.0</b>
Structural Grade:	<b>0</b>
O&M Grade:	<b>0</b>
Clock Start/From:	
Clock To:	
1st Value:	
2nd Value:	
Value Percent:	<b>5.000</b>
Continuous Index:	
Within 8" of Joint:	<b>NO</b>
Remarks:

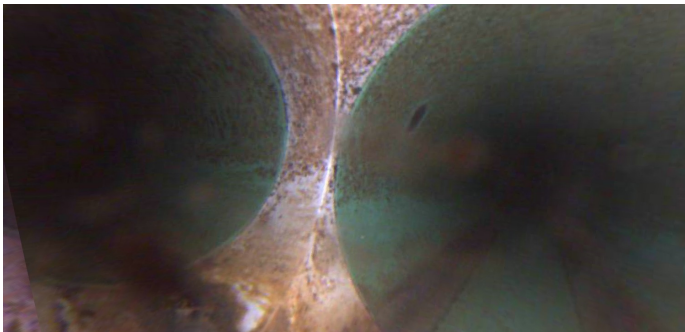
Code:	<b>TF</b>
Description:	<b>Tap Factory</b>

Distance (ft):	<b>36.0</b>
Structural Grade:	<b>0</b>
O&M Grade:	<b>0</b>
Clock Start/From:	<b>9</b>
Clock To:	
1st Value:	<b>4.000</b>
2nd Value:	
Value Percent:	
Continuous Index:	
Within 8" of Joint:	
Remarks:

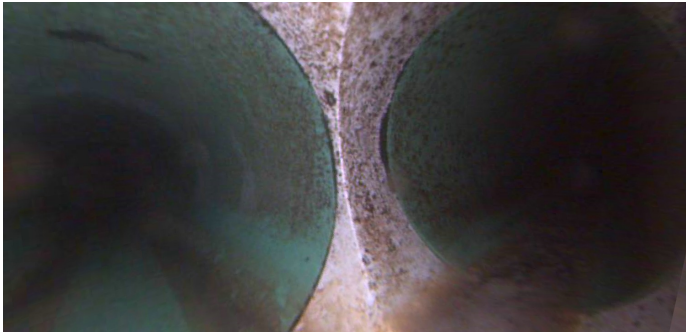
Code: **TFA**  
Description: **Tap Factory Active**

Distance (ft): **42.4**  
Structural Grade: **0**  
O&M Grade: **0**  
Clock Start/From: **3**  
Clock To:  
1st Value: **4.000**  
2nd Value:  
Value Percent:  
Continuous Index:  
Within 8" of Joint:  
Remarks:

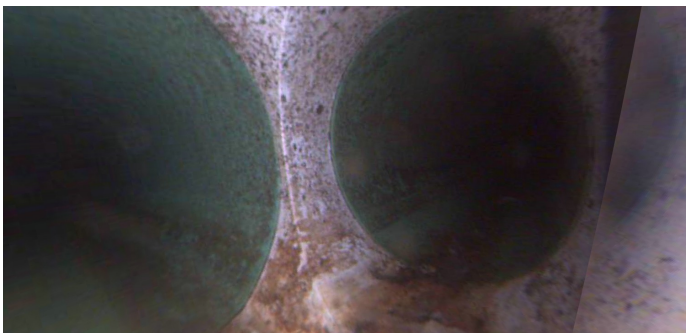
Code: **TF**  
Description: **Tap Factory**

Distance (ft): **79.8**  
Structural Grade: **0**  
O&M Grade: **0**  
Clock Start/From: **3**  
Clock To:  
1st Value: **4.000**  
2nd Value:  
Value Percent:  
Continuous Index:  
Within 8" of Joint:  
Remarks:

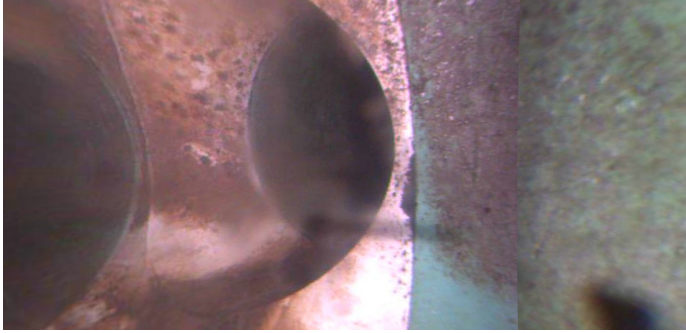
Code: **TF**  
Description: **Tap Factory**

Distance (ft): **115.9**  
Structural Grade: **0**  
O&M Grade: **0**  
Clock Start/From: **9**  
Clock To:  
1st Value: **4.000**  
2nd Value:  
Value Percent:  
Continuous Index:  
Within 8" of Joint:  
Remarks:

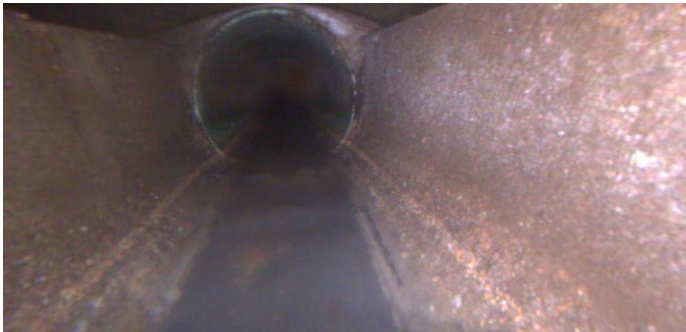
Code: **AMH**  
Description: **Manhole**

Distance (ft): **123.8**  
Structural Grade: **0**  
O&M Grade: **0**  
Clock Start/From:  
Clock To:  
1st Value:  
2nd Value:  
Value Percent:  
Continuous Index:  
Within 8" of Joint: **NO**  
Remarks: **M-708-126**
