Profile/Photo Observation Report

Street:	Redbud	Flow Control:	Not Controlled
City:	Hobart, IN	Year Renewed:	
Location:	Sidewalk	Tape/Media #:	
Purpose:	Maintenance Related	Dia/Height:	8"
Use:	Sanitary	Material:	PVC
Drain Area:	NA	Lining:	Cured in Place
Category:	NA		
Comment:	Flow direction wrong.

Location Details:		Direction of Survey:	Downstream
US MH:	M-708-126	DS MH:	M-708-127
		Total Length Surveyed (ft):	78.8

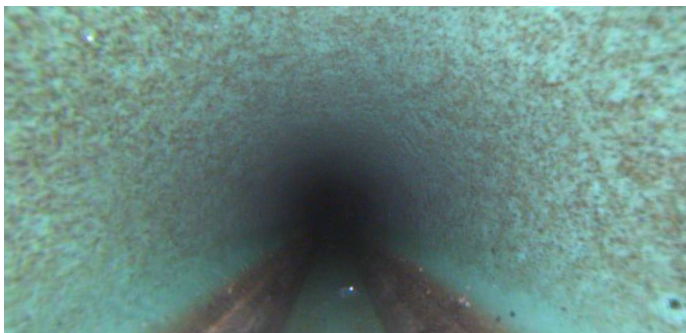
Code: **AMH**
Description: **Manhole**

Distance (ft): **.0**
Structural Grade: **0**
O&M Grade: **0**
Clock Start/From:
Clock To:
1st Value:
2nd Value:
Value Percent:
Continuous Index:
Within 8" of Joint: **NO**
Remarks: **M-708-126**

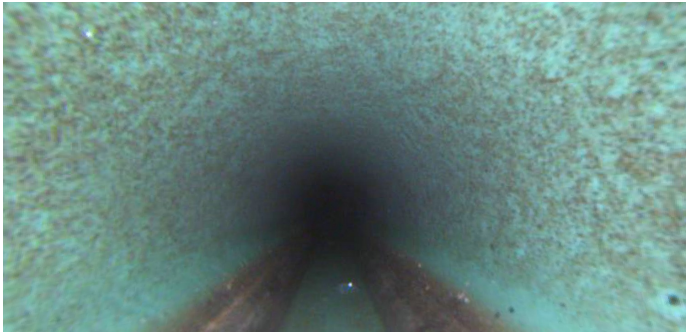
Code:	MWL
Description:	Water Level

Distance (ft):	.0
Structural Grade:	0
O&M Grade:	0
Clock Start/From:	
Clock To:	
1st Value:	
2nd Value:	
Value Percent:	5.000
Continuous Index:	
Within 8" of Joint:	NO
Remarks:

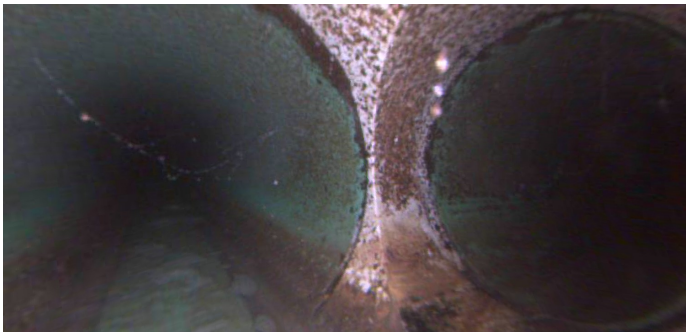
Code:	TF
Description:	Tap Factory

Distance (ft):	6.9
Structural Grade:	0
O&M Grade:	0
Clock Start/From:	3
Clock To:	
1st Value:	4.000
2nd Value:	
Value Percent:	
Continuous Index:	
Within 8" of Joint:	
Remarks:

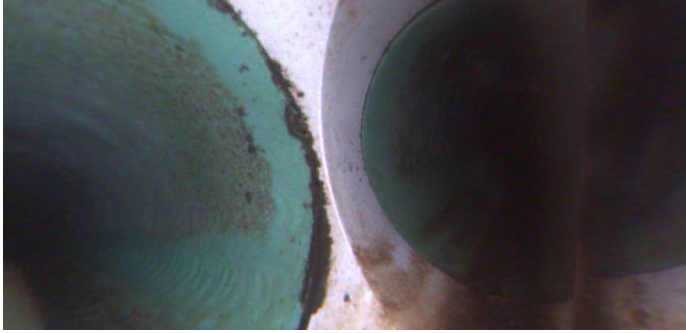
Code: **TF**
Description: **Tap Factory**

Distance (ft): **30.2**
Structural Grade: **0**
O&M Grade: **0**
Clock Start/From: **3**
Clock To:
1st Value: **4.000**
2nd Value:
Value Percent:
Continuous Index:
Within 8" of Joint:
Remarks:

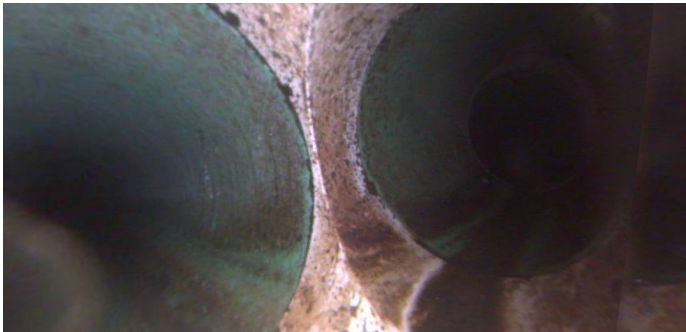
Code: **TF**
Description: **Tap Factory**

Distance (ft): **63.3**
Structural Grade: **0**
O&M Grade: **0**
Clock Start/From: **3**
Clock To:
1st Value: **4.000**
2nd Value:
Value Percent:
Continuous Index:
Within 8" of Joint:
Remarks:

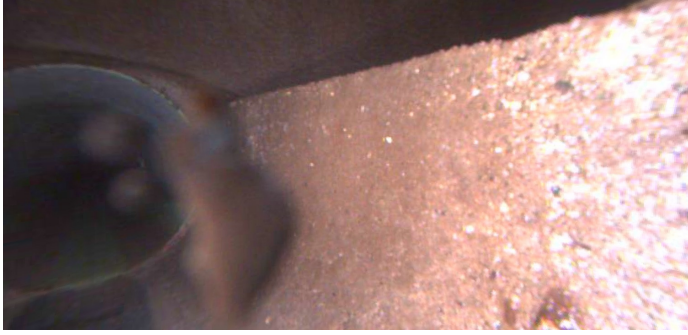
Code:	AMH
Description:	Manhole
Distance (ft):	78.8
Structural Grade:	0
O&M Grade:	0
Clock Start/From:	
Clock To:	
1st Value:	
2nd Value:	
Value Percent:	
Continuous Index:	
Within 8" of Joint:	NO
Remarks:	M-708-127
