## Profile/Photo Observation Report

Street:	<b>REDBUD DR</b>	Flow Control:	<b>Not Controlled</b>
City:	<b>Hobart, IN</b>	Year Renewed:	
Location:	<b>Light Highway</b>	Tape/Media #:	
Purpose:	<b>Routine Assessment</b>	Dia/Height:	<b>8"</b>
Use:	<b>Sanitary</b>	Material:	<b>PVC</b>
Drain Area:	<b>NA</b>	Lining:	
Category:	<b>NA</b>		
Comment:

Location Details:		Direction of Survey:	<b>Upstream</b>
US MH:	<b>M-708-127</b>	DS MH:	<b>M-708-128</b>
		Total Length Surveyed (ft):	<b>8.0</b>

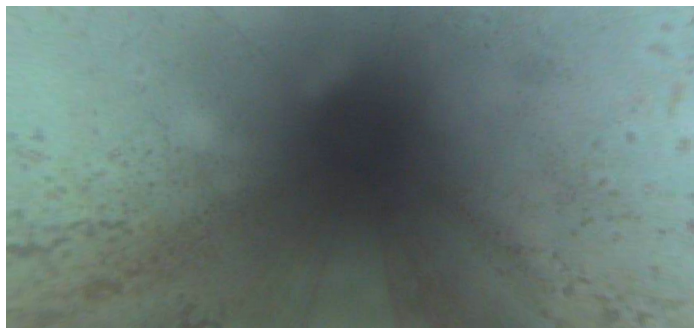
Code: **AMH**  
Description: **Manhole**

Distance (ft): **.0**  
Structural Grade: **0**  
O&M Grade: **0**  
Clock Start/From:  
Clock To:  
1st Value:  
2nd Value:  
Value Percent:  
Continuous Index:  
Within 8" of Joint: **NO**  
Remarks: **M-708-128**

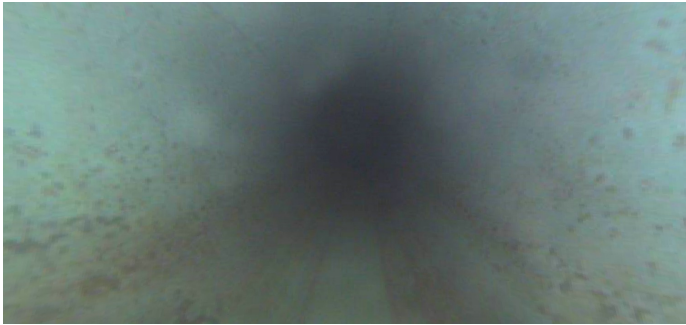
Code:	<b>MWL</b>
Description:	<b>Water Level</b>

Distance (ft):	<b>.0</b>
Structural Grade:	<b>0</b>
O&M Grade:	<b>0</b>
Clock Start/From:	
Clock To:	
1st Value:	
2nd Value:	
Value Percent:	<b>5.000</b>
Continuous Index:	
Within 8" of Joint:	<b>NO</b>
Remarks:
