Profile/Photo Observation Report

Street:	Magnolia Dr.	Flow Control:	Not Controlled
City:	Hobart, IN	Year Renewed:	
Location:	Light Highway	Tape/Media #:	
Purpose:	Routine Assessment	Dia/Height:	8"
Use:	Sanitary	Material:	PVC
Drain Area:	NA	Lining:	
Category:	NA		
Comment:

Location Details:		Direction of Survey:	Upstream
US MH:	M-708-127	DS MH:	M-708-128
		Total Length Surveyed (ft):	8.0

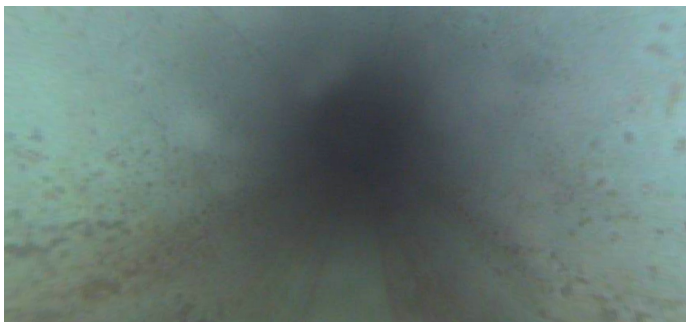
Code: **AMH**
Description: **Manhole**

Distance (ft): **.0**
Structural Grade: **0**
O&M Grade: **0**
Clock Start/From:
Clock To:
1st Value:
2nd Value:
Value Percent:
Continuous Index:
Within 8" of Joint: **NO**
Remarks: **M-708-128**

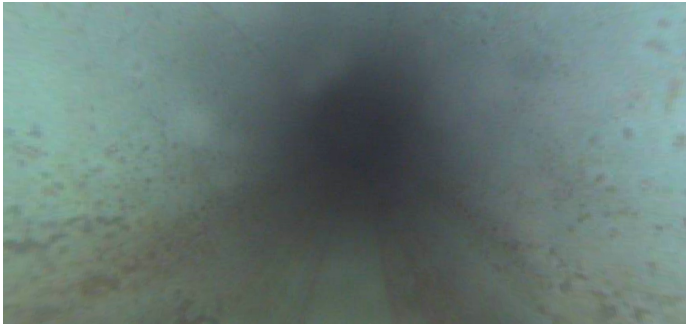
Code:	MWL
Description:	Water Level

Distance (ft):	.0
Structural Grade:	0
O&M Grade:	0
Clock Start/From:	
Clock To:	
1st Value:	
2nd Value:	
Value Percent:	5.000
Continuous Index:	
Within 8" of Joint:	NO
Remarks:
