Profile/Ph	oto Observation	Report				RedZone
Date:	10/12/2018	Weather:		Co	oding: F	PACP 6.0
Pipe Length (ft): 80.1	Owner:	NA	Pr	e Clean: 🛛 🛚	Not Known
P.O.#:		Surveyor:	Selasie Honu	PS	SR: F	P-708-128-127
Customer:		Clean Date:	01/01/1900	Sh	nape: (C
Street:	Magnolia Dr.		Flow Control:	No	ot Controlled	
City:	Hobart, IN		Year Renewed:			
Location:	Light Highway		Tape/Media #:			
Purpose:	Routine Assessmen	t	Dia/Height:	8"		
Use:	Sanitary		Material:	PV	'C	
Drain Area:	NA		Lining:			
Category:	NA					
Comment:						
Location Detai	ls:		Direction of Sur	vey: Up	ostream	
US MH:	M-708-127	DS MH:	M-708-128	Total Length	Surveyed (ft):	83.1
0&M Index:	0.00	O&M Quick:	00	00 O&M	I Rating:	0.00
tructural Index:	0.00	 Structural Qu	ick: 000	00 Struc	tural Rating:	0.00
Overall Index:	0.00	Overall Quick	. 000	00 Overa	all Rating:	0.00

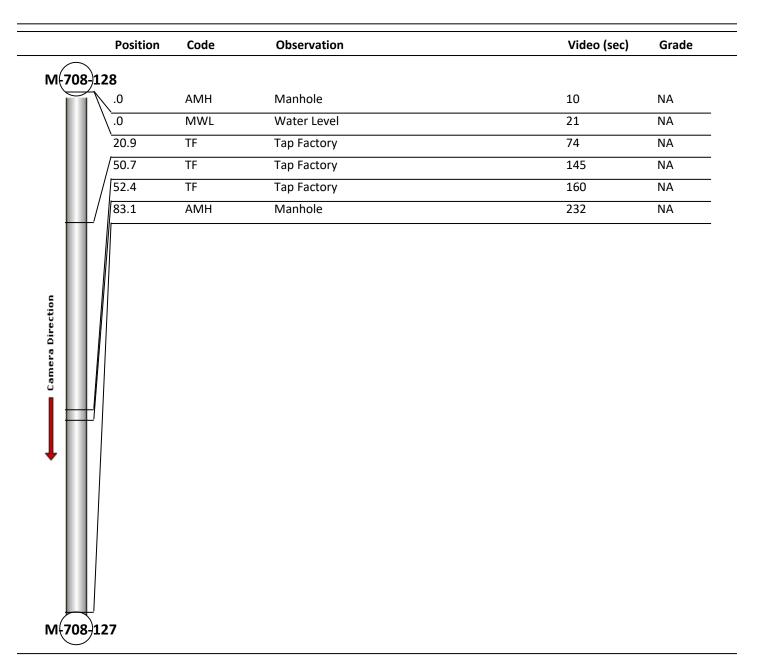
Code:	АМН
Description:	Manhole
Distance (ft):	.0
Structural Grade:	0
O&M Grade:	0
Clock Start/From:	
Clock To:	
1st Value:	
2nd Value:	
Value Percent:	
Continuous Index:	
Within 8" of Joint:	NO
Remarks:	M-708-128
