Profile/Photo Observation Report

Date:	04/02/2018	Weather:		Coding:	PACP 6.0
Pipe Length (ft):	152.2	Owner:	NA	Pre Clean:	Not Known
P.O.#:		Surveyor:	Jen Costello	PSR:	P-708-129-128
Customer:		Clean Date:	01/01/1900	Shape:	C

Street:	AZALEA DR	Flow Control:	Not Controlled
City:	Hobart, IN	Year Renewed:	
Location:	Sidewalk	Tape/Media #:	
Purpose:	Maintenance Related	Dia/Height:	8"
Use:	Sanitary	Material:	PVC
Drain Area:	NA	Lining:	Cured in Place
Category:	NA		
Comment:	Flow direction wrong.		
Location Details:		Direction of Survey:	Upstream
US MH:	M-708-128	DS MH:	M-708-129
		Total Length Surveyed (ft):	161.2

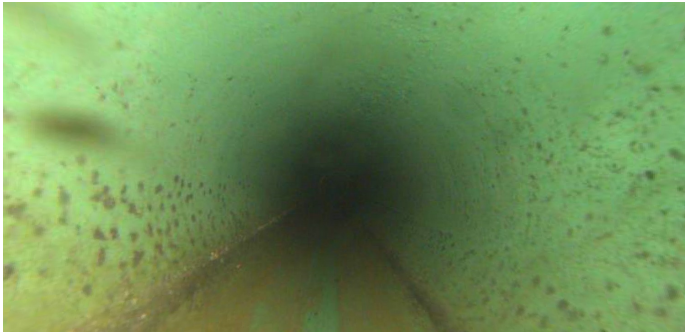
Code:	MWL
Description:	Water Level

Distance (ft):	.0
Structural Grade:	0
O&M Grade:	0
Clock Start/From:	
Clock To:	
1st Value:	
2nd Value:	
Value Percent:	5.000
Continuous Index:	
Within 8" of Joint:	NO
Remarks:

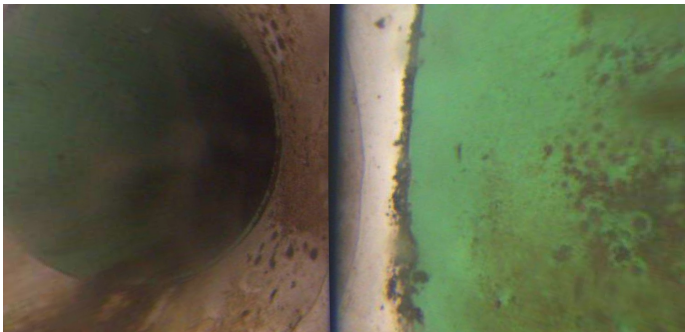
Code:	TF
Description:	Tap Factory

Distance (ft):	7.3
Structural Grade:	0
O&M Grade:	0
Clock Start/From:	9
Clock To:	
1st Value:	4.000
2nd Value:	
Value Percent:	
Continuous Index:	
Within 8" of Joint:	
Remarks:

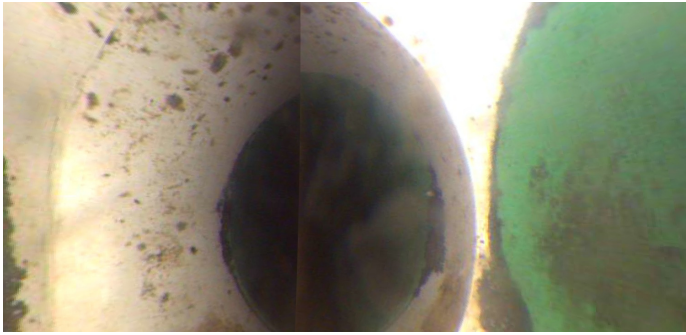
Code: **TF**
Description: **Tap Factory**

Distance (ft): **8.9**
Structural Grade: **0**
O&M Grade: **0**
Clock Start/From: **3**
Clock To:
1st Value: **4.000**
2nd Value:
Value Percent:
Continuous Index:
Within 8" of Joint:
Remarks:

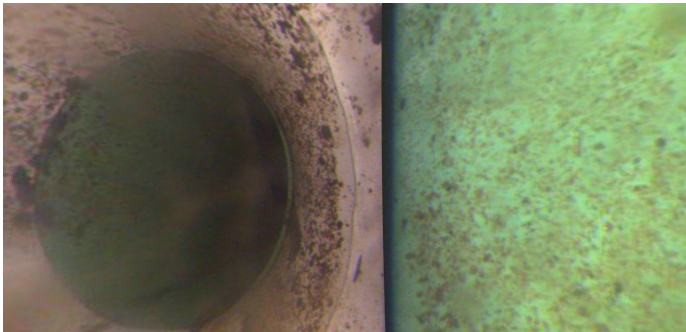
Code: **TF**
Description: **Tap Factory**

Distance (ft): **65.6**
Structural Grade: **0**
O&M Grade: **0**
Clock Start/From: **9**
Clock To:
1st Value: **4.000**
2nd Value:
Value Percent:
Continuous Index:
Within 8" of Joint:
Remarks:

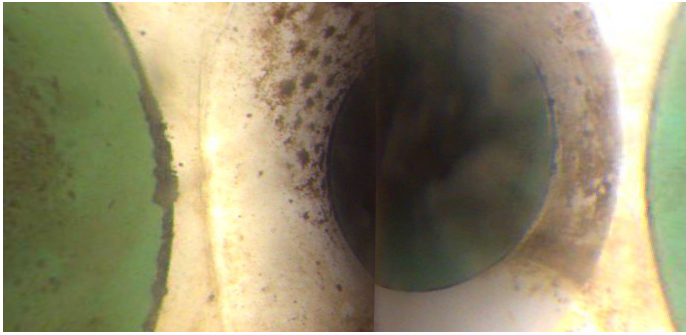
Code: **TF**
Description: **Tap Factory**

Distance (ft): **67.1**
Structural Grade: **0**
O&M Grade: **0**
Clock Start/From: **3**
Clock To:
1st Value: **4.000**
2nd Value:
Value Percent:
Continuous Index:
Within 8" of Joint:
Remarks:

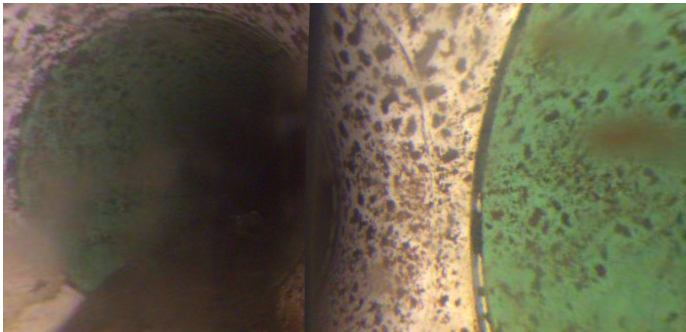
Code: **TFA**
Description: **Tap Factory Active**

Distance (ft): **130.0**
Structural Grade: **0**
O&M Grade: **0**
Clock Start/From: **9**
Clock To:
1st Value: **4.000**
2nd Value:
Value Percent:
Continuous Index:
Within 8" of Joint:
Remarks:

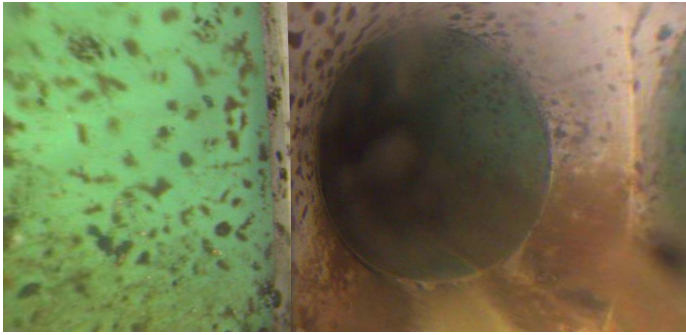
Code: **TFA**
Description: **Tap Factory Active**

Distance (ft): **132.1**
Structural Grade: **0**
O&M Grade: **0**
Clock Start/From: **3**
Clock To:
1st Value: **4.000**
2nd Value:
Value Percent:
Continuous Index:
Within 8" of Joint:
Remarks:

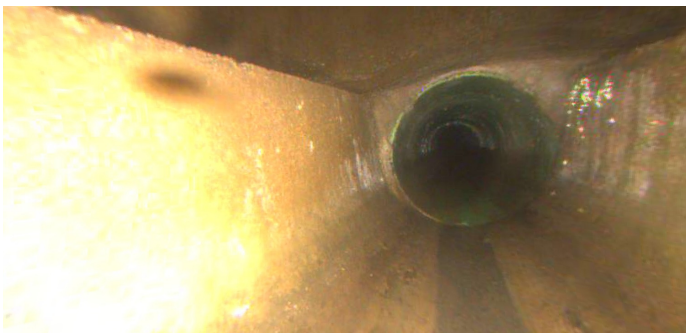
Code: **AMH**
Description: **Manhole**

Distance (ft): **161.2**
Structural Grade: **0**
O&M Grade: **0**
Clock Start/From:
Clock To:
1st Value:
2nd Value:
Value Percent:
Continuous Index:
Within 8" of Joint: **NO**
Remarks: **M-708-128**
