Profile/Photo Observation Report

Date:	04/02/2018	Weather:		Coding:	PACP 6.0
Pipe Length (ft):	152.2	Owner:	NA	Pre Clean:	Not Known
P.O.#:		Surveyor:	Jen Costello	PSR:	P-708-129-128
Customer:		Clean Date:	01/01/1900	Shape:	C

Street:	Magnolia	Flow Control:	Not Controlled
City:	Hobart, IN	Year Renewed:	
Location:	Sidewalk	Tape/Media #:	
Purpose:	Maintenance Related	Dia/Height:	8"
Use:	Sanitary	Material:	PVC
Drain Area:	NA	Lining:	Cured in Place
Category:	NA		
Comment:	Flow direction wrong.

Location Details:		Direction of Survey:	Upstream
US MH:	M-708-128	DS MH:	M-708-129
		Total Length Surveyed (ft):	161.2

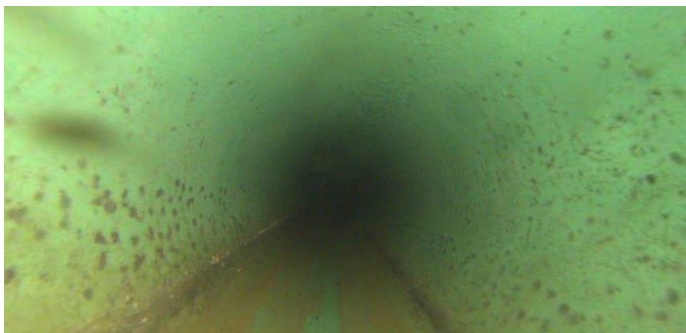
Code: **AMH**
Description: **Manhole**

Distance (ft): **.0**
Structural Grade: **0**
O&M Grade: **0**
Clock Start/From:
Clock To:
1st Value:
2nd Value:
Value Percent:
Continuous Index:
Within 8" of Joint: **NO**
Remarks: **M-708-129**

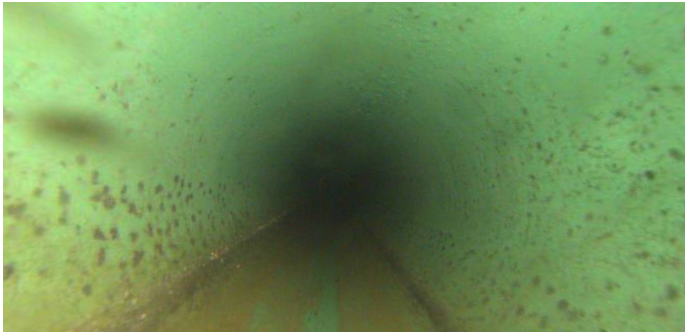
Code:	MWL
Description:	Water Level

Distance (ft):	.0
Structural Grade:	0
O&M Grade:	0
Clock Start/From:	
Clock To:	
1st Value:	
2nd Value:	
Value Percent:	5.000
Continuous Index:	
Within 8" of Joint:	NO
Remarks:

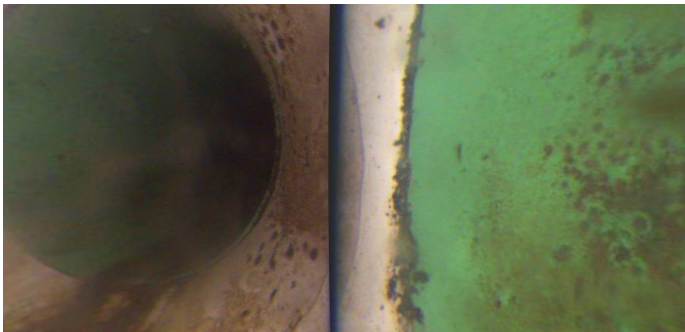
Code:	TF
Description:	Tap Factory

Distance (ft):	7.3
Structural Grade:	0
O&M Grade:	0
Clock Start/From:	9
Clock To:	
1st Value:	4.000
2nd Value:	
Value Percent:	
Continuous Index:	
Within 8" of Joint:	
Remarks:

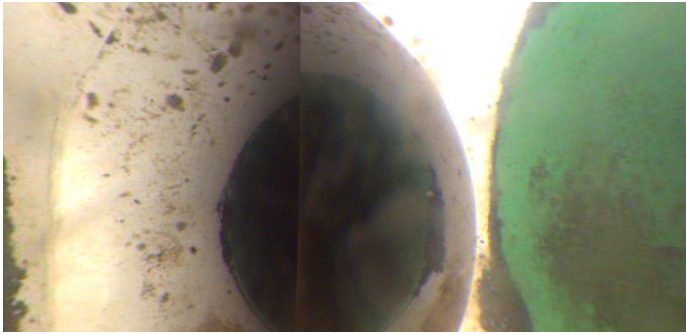
Code: **TF**
Description: **Tap Factory**

Distance (ft): **8.9**
Structural Grade: **0**
O&M Grade: **0**
Clock Start/From: **3**
Clock To:
1st Value: **4.000**
2nd Value:
Value Percent:
Continuous Index:
Within 8" of Joint:
Remarks:

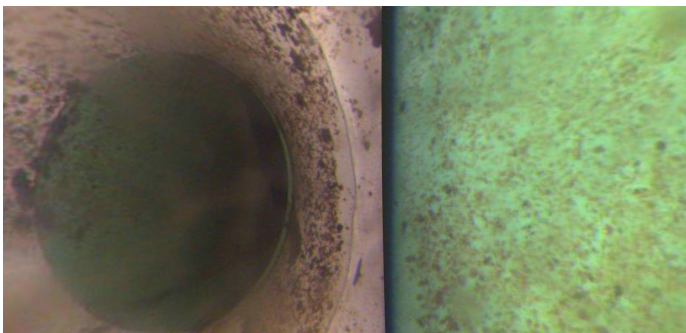
Code: **TF**
Description: **Tap Factory**

Distance (ft): **65.6**
Structural Grade: **0**
O&M Grade: **0**
Clock Start/From: **9**
Clock To:
1st Value: **4.000**
2nd Value:
Value Percent:
Continuous Index:
Within 8" of Joint:
Remarks:

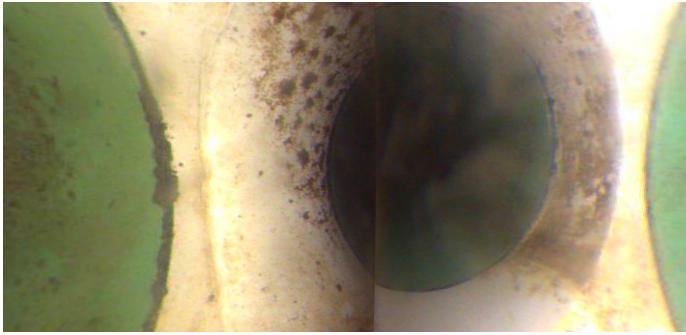
Code: **TF**
Description: **Tap Factory**

Distance (ft): **67.1**
Structural Grade: **0**
O&M Grade: **0**
Clock Start/From: **3**
Clock To:
1st Value: **4.000**
2nd Value:
Value Percent:
Continuous Index:
Within 8" of Joint:
Remarks:

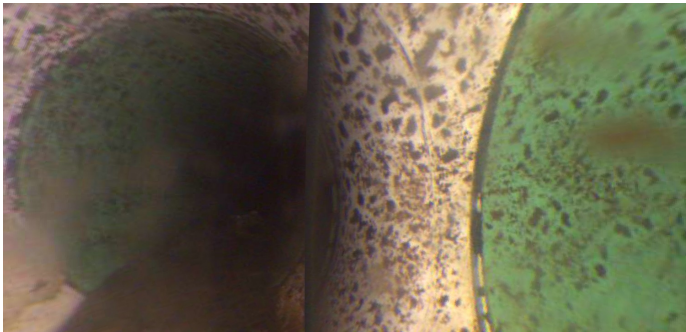
Code: **TFA**
Description: **Tap Factory Active**

Distance (ft): **130.0**
Structural Grade: **0**
O&M Grade: **0**
Clock Start/From: **9**
Clock To:
1st Value: **4.000**
2nd Value:
Value Percent:
Continuous Index:
Within 8" of Joint:
Remarks:

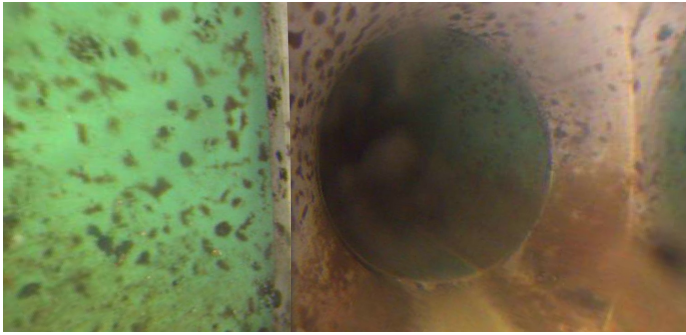
Code: **TFA**
Description: **Tap Factory Active**

Distance (ft): **132.1**
Structural Grade: **0**
O&M Grade: **0**
Clock Start/From: **3**
Clock To:
1st Value: **4.000**
2nd Value:
Value Percent:
Continuous Index:
Within 8" of Joint:
Remarks:

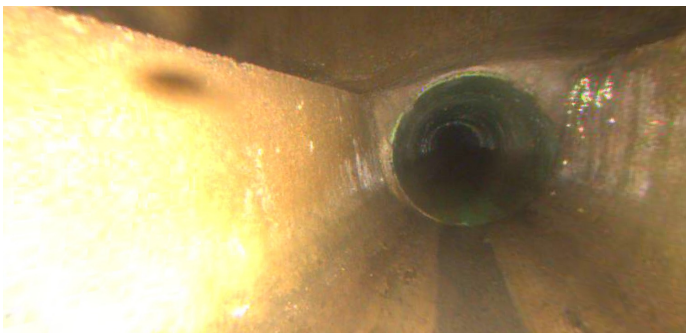
Code: **AMH**
Description: **Manhole**

Distance (ft): **161.2**
Structural Grade: **0**
O&M Grade: **0**
Clock Start/From:
Clock To:
1st Value:
2nd Value:
Value Percent:
Continuous Index:
Within 8" of Joint: **NO**
Remarks: **M-708-128**
