Profile/Photo Observation Report

Street:	AZALEA DR	Flow Control:	Not Controlled
City:	Hobart, IN	Year Renewed:	
Location:	Sidewalk	Tape/Media #:	
Purpose:	Maintenance Related	Dia/Height:	8"
Use:	Sanitary	Material:	PVC
Drain Area:	NA	Lining:	Cured in Place
Category:	NA		
Comment:	Flow direction wrong.

Location Details:		Direction of Survey:	Downstream
US MH:	M-708-129	DS MH:	M-708-130
		Total Length Surveyed (ft):	149.0

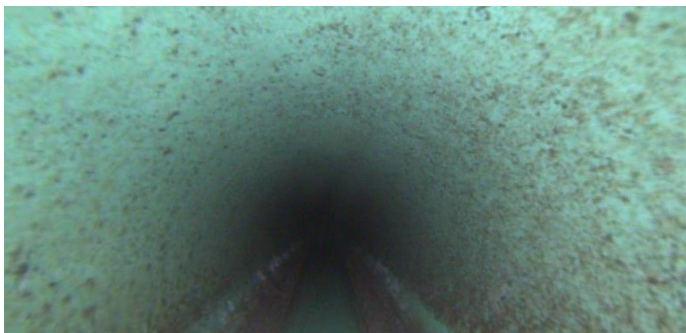
Code: **AMH**
Description: **Manhole**

Distance (ft): **.0**
Structural Grade: **0**
O&M Grade: **0**
Clock Start/From:
Clock To:
1st Value:
2nd Value:
Value Percent:
Continuous Index:
Within 8" of Joint: **NO**
Remarks: **M-708-129**

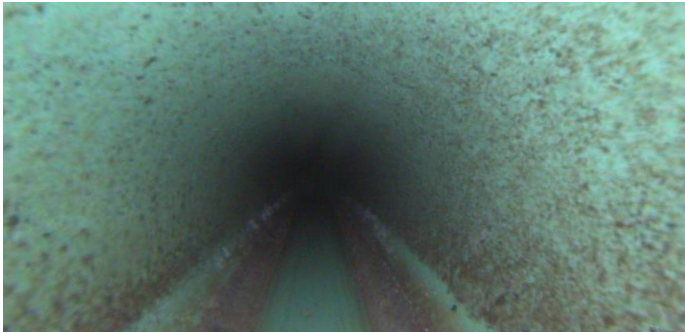
Code:	MWL
Description:	Water Level

Distance (ft):	.0
Structural Grade:	0
O&M Grade:	0
Clock Start/From:	
Clock To:	
1st Value:	
2nd Value:	
Value Percent:	5.000
Continuous Index:	
Within 8" of Joint:	NO
Remarks:

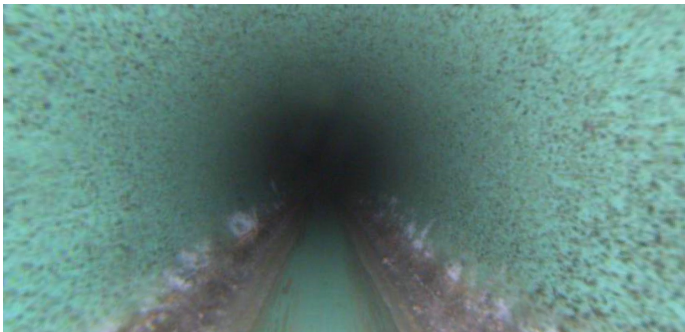
Code:	DAGS
Description:	Deposits Attached Grease

Distance (ft):	7.3
Structural Grade:	0
O&M Grade:	2
Clock Start/From:	5
Clock To:	7
1st Value:	
2nd Value:	
Value Percent:	5.000
Continuous Index:	S01
Within 8" of Joint:	NO
Remarks:

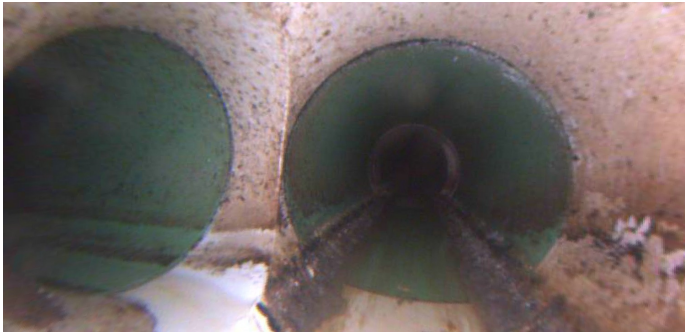
Code: **TF**
Description: **Tap Factory**

Distance (ft): **46.1**
Structural Grade: **0**
O&M Grade: **0**
Clock Start/From: **9**
Clock To:
1st Value: **4.000**
2nd Value:
Value Percent:
Continuous Index:
Within 8" of Joint:
Remarks:

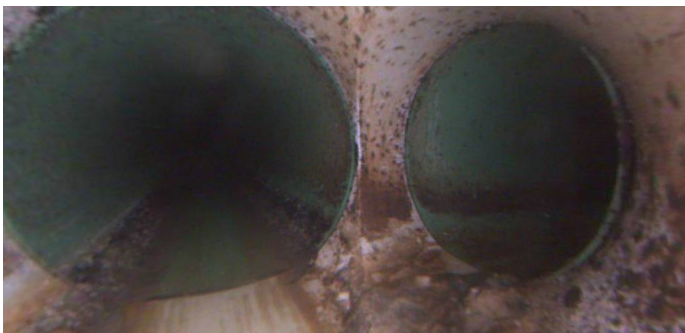
Code: **TF**
Description: **Tap Factory**

Distance (ft): **48.1**
Structural Grade: **0**
O&M Grade: **0**
Clock Start/From: **3**
Clock To:
1st Value: **4.000**
2nd Value:
Value Percent:
Continuous Index:
Within 8" of Joint:
Remarks:

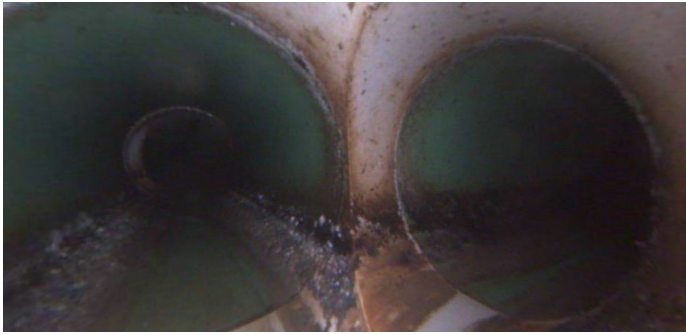
Code: **TF**
Description: **Tap Factory**

Distance (ft): **93.4**
Structural Grade: **0**
O&M Grade: **0**
Clock Start/From: **3**
Clock To:
1st Value: **4.000**
2nd Value:
Value Percent:
Continuous Index:
Within 8" of Joint:
Remarks:

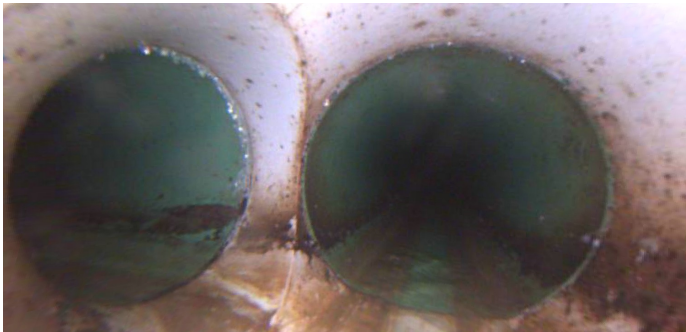
Code: **TFA**
Description: **Tap Factory Active**

Distance (ft): **95.5**
Structural Grade: **0**
O&M Grade: **0**
Clock Start/From: **9**
Clock To:
1st Value: **4.000**
2nd Value:
Value Percent:
Continuous Index:
Within 8" of Joint:
Remarks:

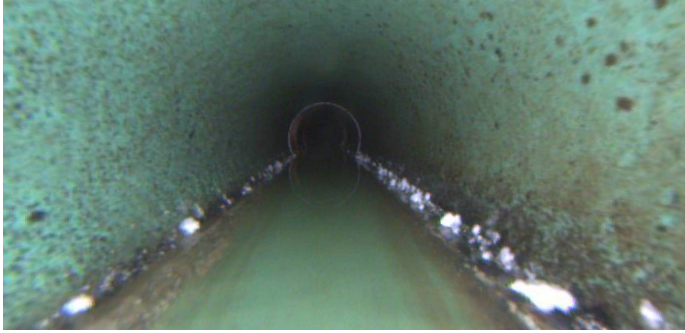
Code: **DAGS**
Description: **Deposits Attached Grease**

Distance (ft): **139.5**
Structural Grade: **0**
O&M Grade: **2**
Clock Start/From: **5**
Clock To: **7**
1st Value:
2nd Value:
Value Percent: **5.000**
Continuous Index: **F01**
Within 8" of Joint: **NO**
Remarks:

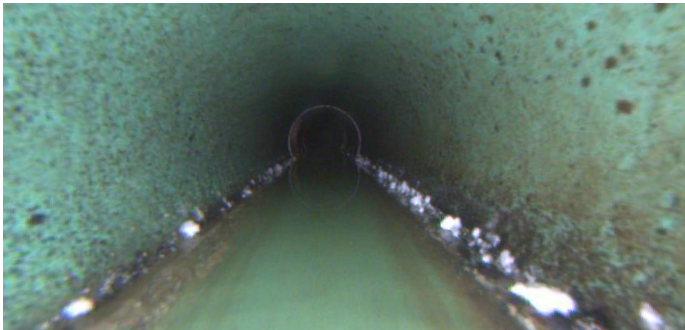
Code: **MWL**
Description: **Water Level**

Distance (ft): **139.5**
Structural Grade: **0**
O&M Grade: **0**
Clock Start/From:
Clock To:
1st Value:
2nd Value:
Value Percent: **15.000**
Continuous Index:
Within 8" of Joint: **NO**
Remarks:

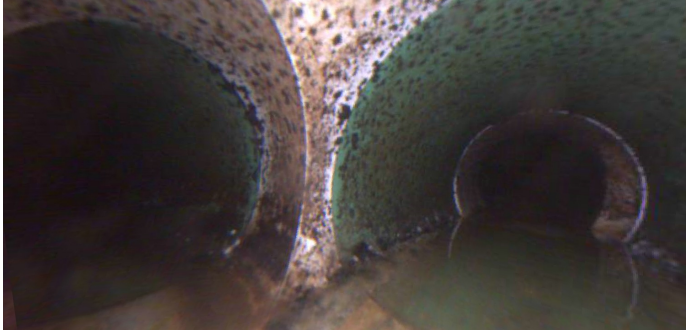
Code: **TFA**
Description: **Tap Factory Active**

Distance (ft): **142.3**
Structural Grade: **0**
O&M Grade: **0**
Clock Start/From: **9**
Clock To:
1st Value: **4.000**
2nd Value:
Value Percent:
Continuous Index:
Within 8" of Joint:
Remarks:

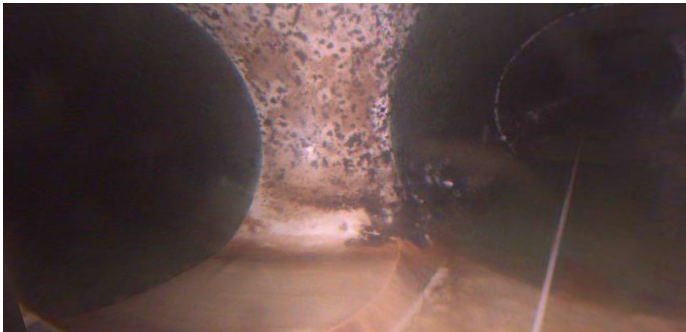
Code: **TFA**
Description: **Tap Factory Active**

Distance (ft): **144.2**
Structural Grade: **0**
O&M Grade: **0**
Clock Start/From: **3**
Clock To:
1st Value: **4.000**
2nd Value:
Value Percent:
Continuous Index:
Within 8" of Joint:
Remarks:

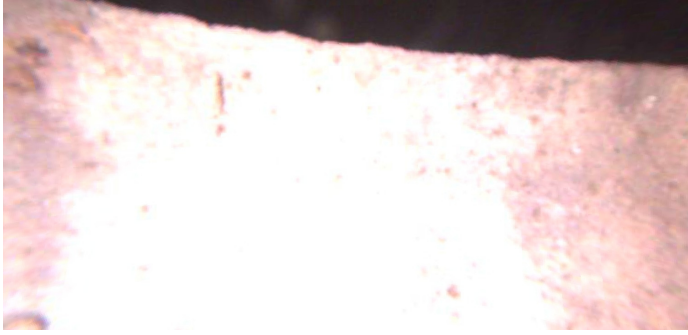
Code:	AMH
Description:	Manhole
Distance (ft):	149.0
Structural Grade:	0
O&M Grade:	0
Clock Start/From:	
Clock To:	
1st Value:	
2nd Value:	
Value Percent:	
Continuous Index:	
Within 8" of Joint:	NO
Remarks:	M-708-130
