Profile/Photo Observation Report

Street:	Magnolia	Flow Control:	Not Controlled
City:	Hobart, IN	Year Renewed:	
Location:	Sidewalk	Tape/Media #:	
Purpose:	Maintenance Related	Dia/Height:	8"
Use:	Sanitary	Material:	PVC
Drain Area:	NA	Lining:	Cured in Place
Category:	NA		
Comment:	Flow direction wrong.

Location Details:		Direction of Survey:	Downstream
US MH:	M-708-129	DS MH:	M-708-130
		Total Length Surveyed (ft):	149.0

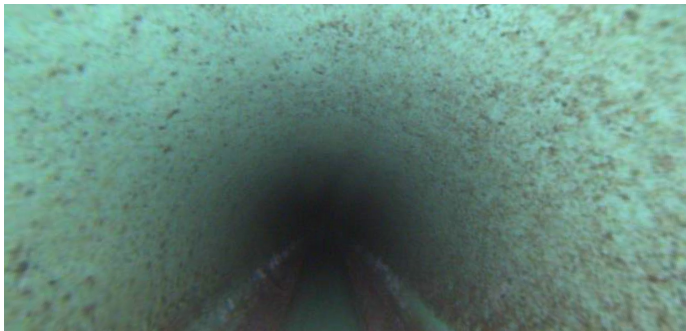
Code: **AMH**
Description: **Manhole**

Distance (ft): **.0**
Structural Grade: **0**
O&M Grade: **0**
Clock Start/From:
Clock To:
1st Value:
2nd Value:
Value Percent:
Continuous Index:
Within 8" of Joint: **NO**
Remarks: **M-708-129**

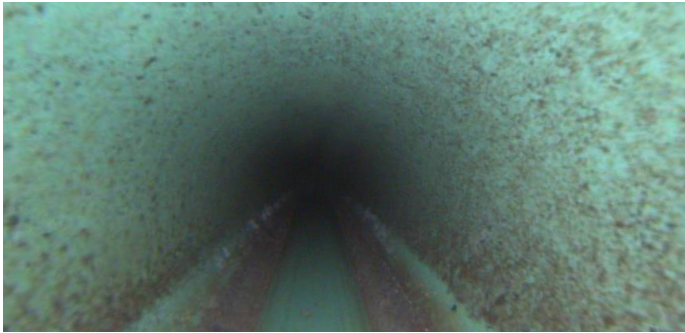
Code:	MWL
Description:	Water Level

Distance (ft):	.0
Structural Grade:	0
O&M Grade:	0
Clock Start/From:	
Clock To:	
1st Value:	
2nd Value:	
Value Percent:	5.000
Continuous Index:	
Within 8" of Joint:	NO
Remarks:

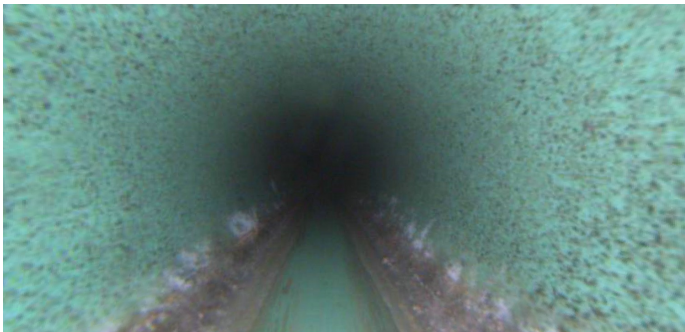
Code:	DAGS
Description:	Deposits Attached Grease

Distance (ft):	7.3
Structural Grade:	0
O&M Grade:	2
Clock Start/From:	5
Clock To:	7
1st Value:	
2nd Value:	
Value Percent:	5.000
Continuous Index:	S01
Within 8" of Joint:	NO
Remarks:

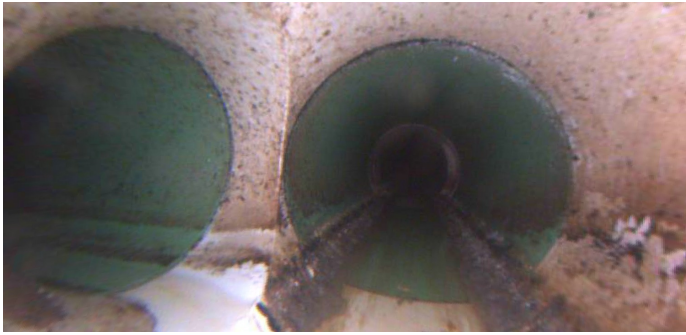
Code: **TF**
Description: **Tap Factory**

Distance (ft): **46.1**
Structural Grade: **0**
O&M Grade: **0**
Clock Start/From: **9**
Clock To:
1st Value: **4.000**
2nd Value:
Value Percent:
Continuous Index:
Within 8" of Joint:
Remarks:

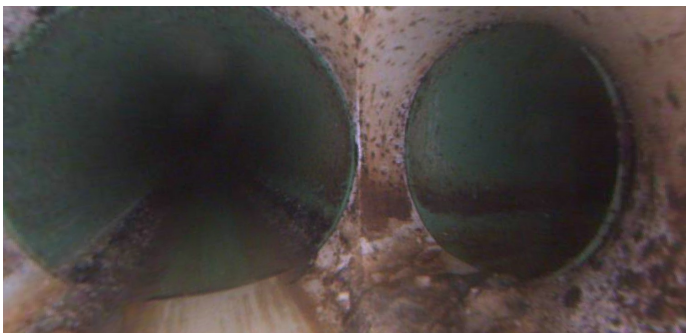
Code: **TF**
Description: **Tap Factory**

Distance (ft): **48.1**
Structural Grade: **0**
O&M Grade: **0**
Clock Start/From: **3**
Clock To:
1st Value: **4.000**
2nd Value:
Value Percent:
Continuous Index:
Within 8" of Joint:
Remarks:

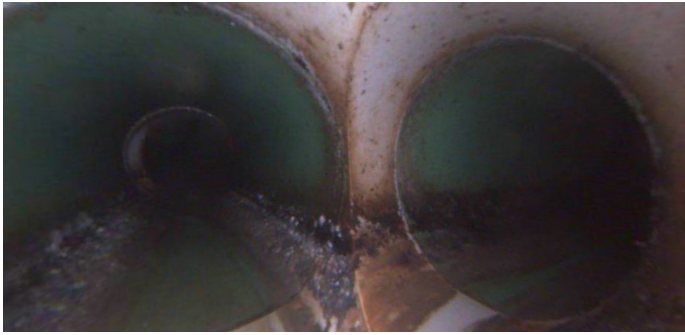
Code: **TF**
Description: **Tap Factory**

Distance (ft): **93.4**
Structural Grade: **0**
O&M Grade: **0**
Clock Start/From: **3**
Clock To:
1st Value: **4.000**
2nd Value:
Value Percent:
Continuous Index:
Within 8" of Joint:
Remarks:

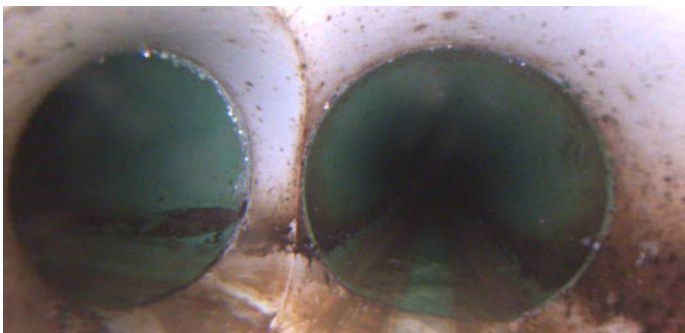
Code: **TFA**
Description: **Tap Factory Active**

Distance (ft): **95.5**
Structural Grade: **0**
O&M Grade: **0**
Clock Start/From: **9**
Clock To:
1st Value: **4.000**
2nd Value:
Value Percent:
Continuous Index:
Within 8" of Joint:
Remarks:

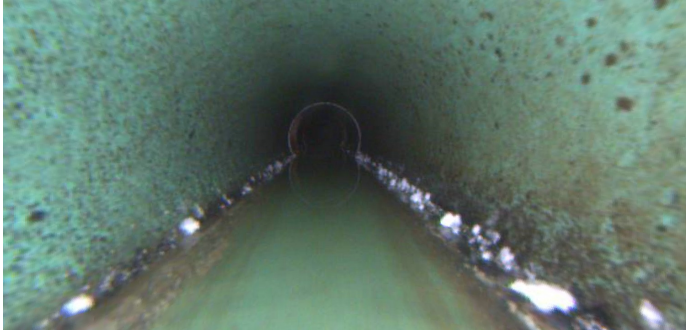
Code: **DAGS**
Description: **Deposits Attached Grease**

Distance (ft): **139.5**
Structural Grade: **0**
O&M Grade: **2**
Clock Start/From: **5**
Clock To: **7**
1st Value:
2nd Value:
Value Percent: **5.000**
Continuous Index: **F01**
Within 8" of Joint: **NO**
Remarks:

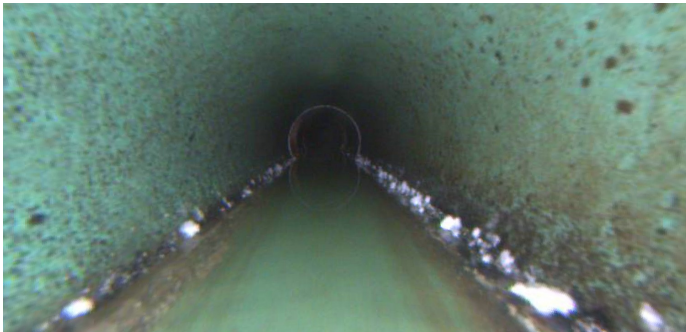
Code: **MWL**
Description: **Water Level**

Distance (ft): **139.5**
Structural Grade: **0**
O&M Grade: **0**
Clock Start/From:
Clock To:
1st Value:
2nd Value:
Value Percent: **15.000**
Continuous Index:
Within 8" of Joint: **NO**
Remarks:

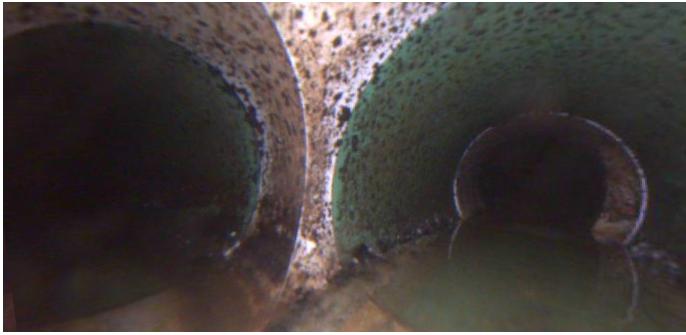
Code: **TFA**
Description: **Tap Factory Active**

Distance (ft): **142.3**
Structural Grade: **0**
O&M Grade: **0**
Clock Start/From: **9**
Clock To:
1st Value: **4.000**
2nd Value:
Value Percent:
Continuous Index:
Within 8" of Joint:
Remarks:

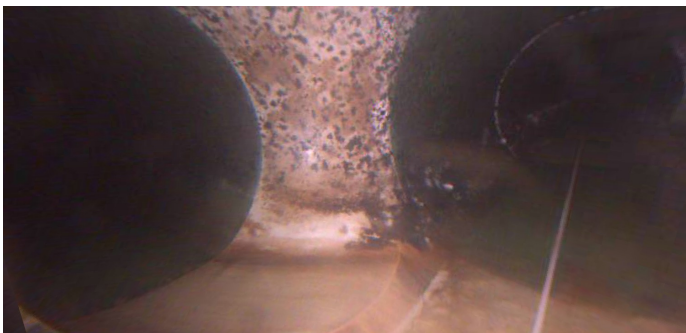
Code: **TFA**
Description: **Tap Factory Active**

Distance (ft): **144.2**
Structural Grade: **0**
O&M Grade: **0**
Clock Start/From: **3**
Clock To:
1st Value: **4.000**
2nd Value:
Value Percent:
Continuous Index:
Within 8" of Joint:
Remarks:

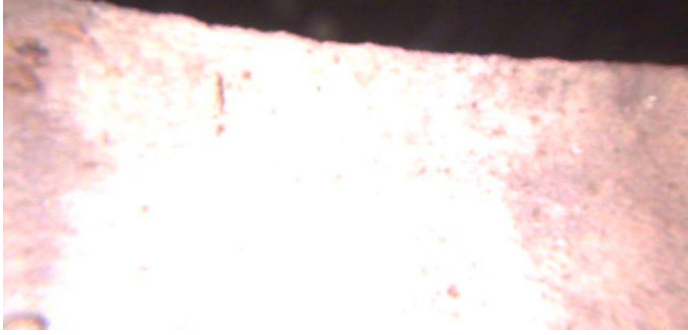
Code:	AMH
Description:	Manhole
Distance (ft):	149.0
Structural Grade:	0
O&M Grade:	0
Clock Start/From:	
Clock To:	
1st Value:	
2nd Value:	
Value Percent:	
Continuous Index:	
Within 8" of Joint:	NO
Remarks:	M-708-130
