Profile/Photo Observation Report

Street:	Magnolia Dr.	Flow Control:	Not Controlled
City:	Hobart, IN	Year Renewed:	
Location:	Light Highway	Tape/Media #:	
Purpose:	Routine Assessment	Dia/Height:	8"
Use:	Sanitary	Material:	PVC
Drain Area:	NA	Lining:	
Category:	NA		
Comment:

Location Details:		Direction of Survey:	Downstream
US MH:	M-708-131	DS MH:	M-708-132
		Total Length Surveyed (ft):	133.5

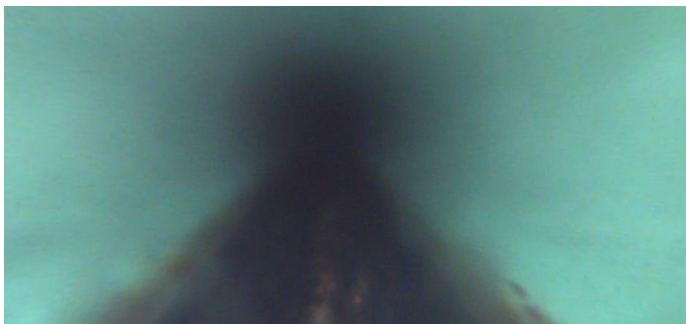
Code: **AMH**
Description: **Manhole**

Distance (ft): **.0**
Structural Grade: **0**
O&M Grade: **0**
Clock Start/From:
Clock To:
1st Value:
2nd Value:
Value Percent:
Continuous Index:
Within 8" of Joint: **NO**
Remarks: **M-708-131**

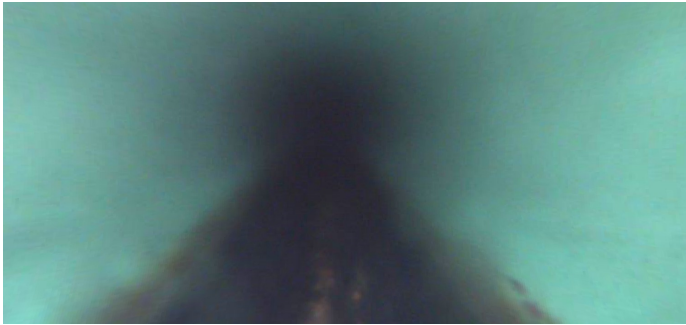
Code:	MWL
Description:	Water Level

Distance (ft):	.0
Structural Grade:	0
O&M Grade:	0
Clock Start/From:	
Clock To:	
1st Value:	
2nd Value:	
Value Percent:	5.000
Continuous Index:	
Within 8" of Joint:	NO
Remarks:

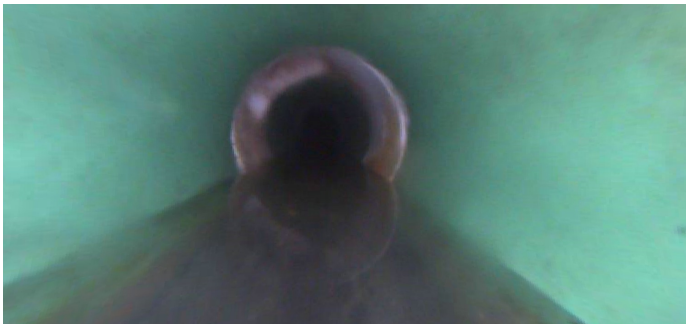
Code:	TF
Description:	Tap Factory

Distance (ft):	62.1
Structural Grade:	0
O&M Grade:	0
Clock Start/From:	10
Clock To:	
1st Value:	4.000
2nd Value:	
Value Percent:	
Continuous Index:	
Within 8" of Joint:	
Remarks:

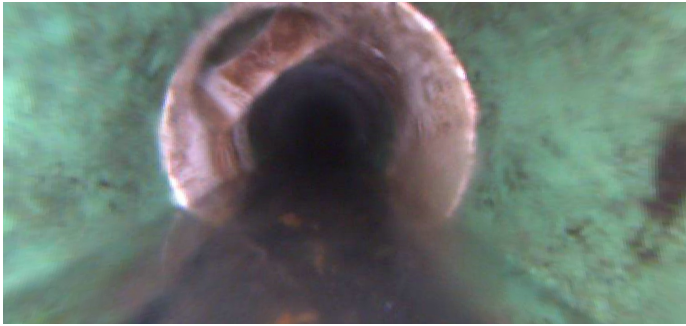
Code: **TF**
Description: **Tap Factory**

Distance (ft): **121.1**
Structural Grade: **0**
O&M Grade: **0**
Clock Start/From: **10**
Clock To:
1st Value: **4.000**
2nd Value:
Value Percent:
Continuous Index:
Within 8" of Joint:
Remarks:

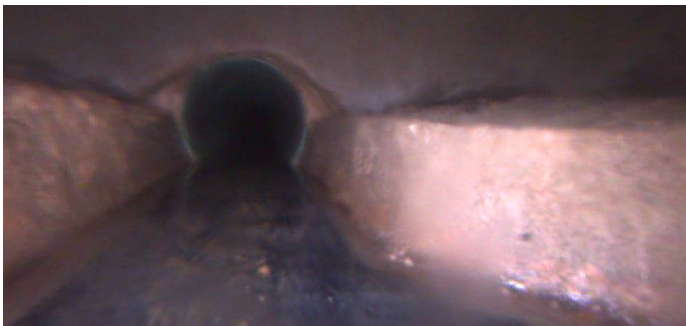
Code: **AMH**
Description: **Manhole**

Distance (ft): **133.5**
Structural Grade: **0**
O&M Grade: **0**
Clock Start/From:
Clock To:
1st Value:
2nd Value:
Value Percent:
Continuous Index:
Within 8" of Joint: **NO**
Remarks: **M-708-132**
