Profile/Photo Observation Report

Street:	Magnolia	Flow Control:	Not Controlled
City:	Hobart, IN	Year Renewed:	
Location:	Sidewalk	Tape/Media #:	
Purpose:	Maintenance Related	Dia/Height:	8"
Use:	Sanitary	Material:	PVC
Drain Area:	NA	Lining:	Cured in Place
Category:	NA		
Comment:	Flow direction wrong.

Location Details:		Direction of Survey:	Upstream
US MH:	M-708-132	DS MH:	M-708-133
		Total Length Surveyed (ft):	129.5

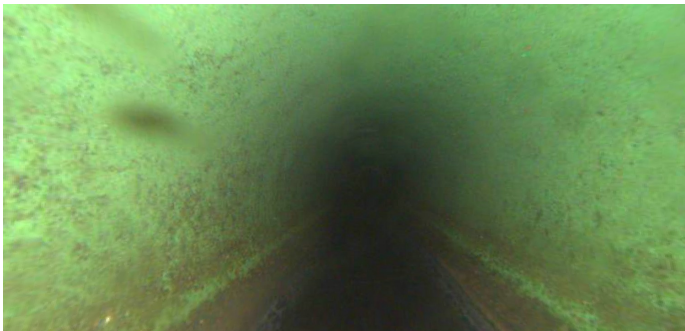
Code: **AMH**
Description: **Manhole**

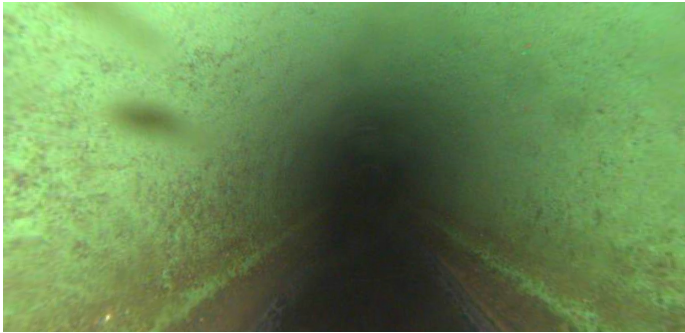
Code:	MWL
Description:	Water Level

Distance (ft):	.0
Structural Grade:	0
O&M Grade:	0
Clock Start/From:	
Clock To:	
1st Value:	
2nd Value:	
Value Percent:	5.000
Continuous Index:	
Within 8" of Joint:	NO
Remarks:

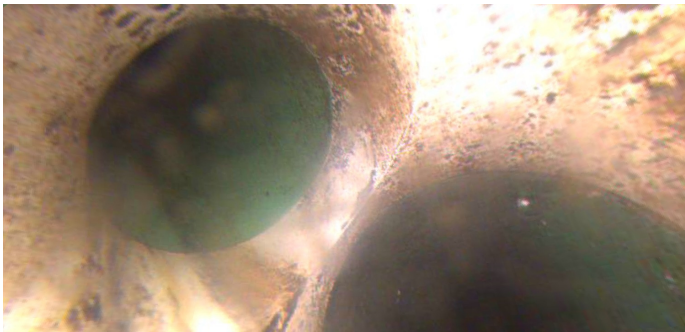
Code:	TF
Description:	Tap Factory

Distance (ft):	9.4
Structural Grade:	0
O&M Grade:	0
Clock Start/From:	2
Clock To:	
1st Value:	4.000
2nd Value:	
Value Percent:	
Continuous Index:	
Within 8" of Joint:	
Remarks:

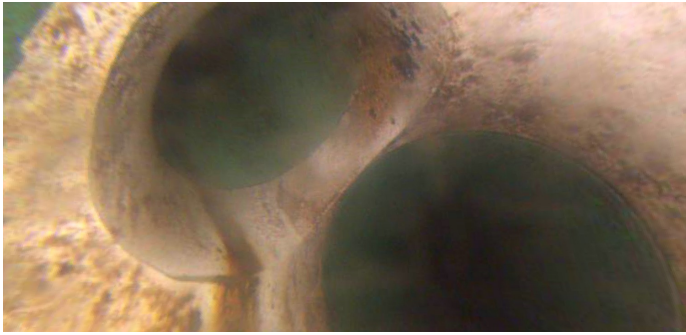
Code: **TF**
Description: **Tap Factory**

Distance (ft): **64.5**
Structural Grade: **0**
O&M Grade: **0**
Clock Start/From: **2**
Clock To:
1st Value: **4.000**
2nd Value:
Value Percent:
Continuous Index:
Within 8" of Joint:
Remarks:

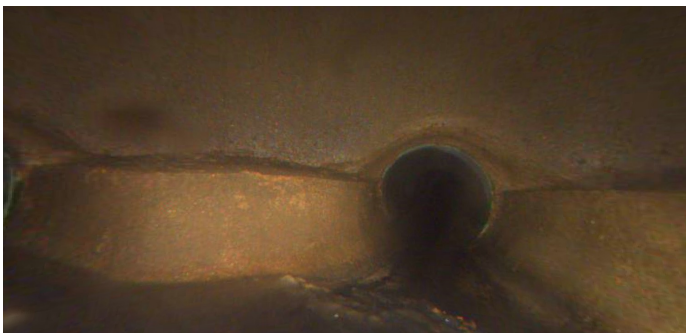
Code: **AMH**
Description: **Manhole**

Distance (ft): **129.5**
Structural Grade: **0**
O&M Grade: **0**
Clock Start/From:
Clock To:
1st Value:
2nd Value:
Value Percent:
Continuous Index:
Within 8" of Joint: **NO**
Remarks: **M-708-132**
