## Profile/Photo Observation Report

Street:	<b>MAGNOLIA DR</b>	Flow Control:	<b>Not Controlled</b>
City:	<b>Hobart, IN</b>	Year Renewed:	
Location:	<b>Sidewalk</b>	Tape/Media #:	
Purpose:	<b>Maintenance Related</b>	Dia/Height:	<b>8"</b>
Use:	<b>Sanitary</b>	Material:	<b>PVC</b>
Drain Area:	<b>NA</b>	Lining:	<b>Cured in Place</b>
Category:	<b>NA</b>		
Comment:	<b>Flow direction wrong.</b>

Location Details:		Direction of Survey:	<b>Downstream</b>
US MH:	<b>M-708-133</b>	DS MH:	<b>M-708-134</b>
		Total Length Surveyed (ft):	<b>115.9</b>

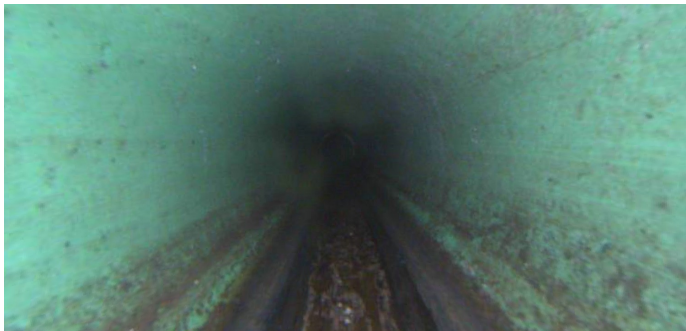
Code: **AMH**  
Description: **Manhole**

Distance (ft): **.0**  
Structural Grade: **0**  
O&M Grade: **0**  
Clock Start/From:  
Clock To:  
1st Value:  
2nd Value:  
Value Percent:  
Continuous Index:  
Within 8" of Joint: **NO**  
Remarks: **M-708-133**

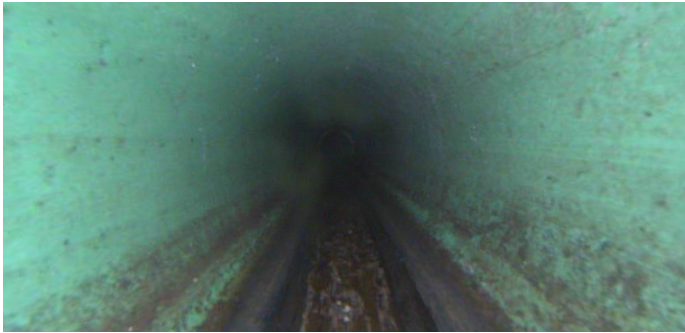
Code:	<b>MWL</b>
Description:	<b>Water Level</b>

Distance (ft):	<b>.0</b>
Structural Grade:	<b>0</b>
O&M Grade:	<b>0</b>
Clock Start/From:	
Clock To:	
1st Value:	
2nd Value:	
Value Percent:	<b>5.000</b>
Continuous Index:	
Within 8" of Joint:	<b>NO</b>
Remarks:

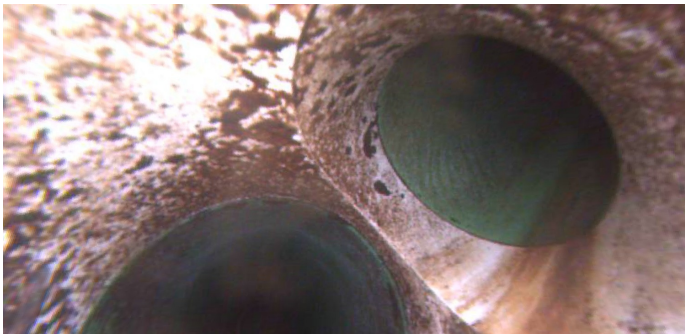
Code:	<b>TF</b>
Description:	<b>Tap Factory</b>

Distance (ft):	<b>6.0</b>
Structural Grade:	<b>0</b>
O&M Grade:	<b>0</b>
Clock Start/From:	<b>2</b>
Clock To:	
1st Value:	<b>4.000</b>
2nd Value:	
Value Percent:	
Continuous Index:	
Within 8" of Joint:	
Remarks:

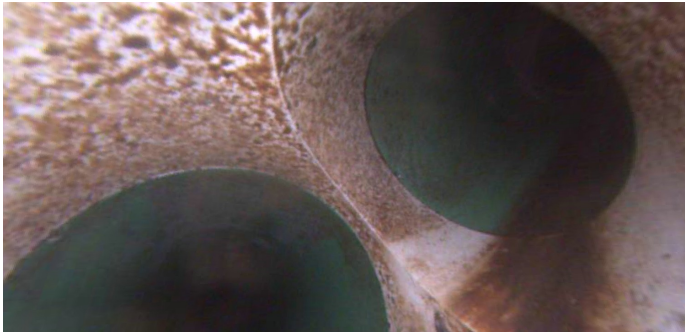
Code: **TF**  
Description: **Tap Factory**

Distance (ft): **42.0**  
Structural Grade: **0**  
O&M Grade: **0**  
Clock Start/From: **2**  
Clock To:  
1st Value: **4.000**  
2nd Value:  
Value Percent:  
Continuous Index:  
Within 8" of Joint:  
Remarks:

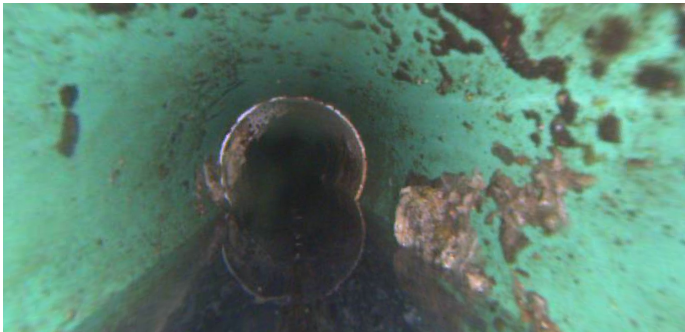
Code: **DAGS**  
Description: **Deposits Attached Grease**

Distance (ft): **54.3**  
Structural Grade: **0**  
O&M Grade: **2**  
Clock Start/From: **3**  
Clock To: **4**  
1st Value:  
2nd Value:  
Value Percent: **5.000**  
Continuous Index:  
Within 8" of Joint: **NO**  
Remarks:

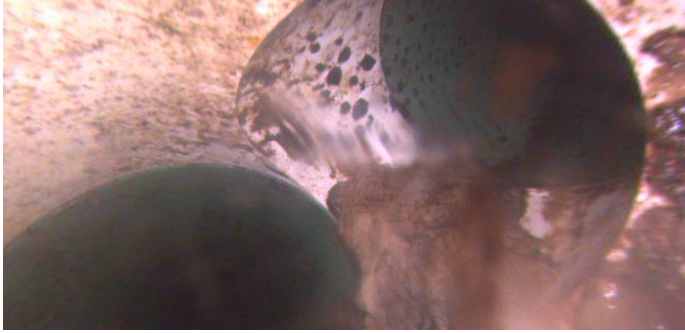
Code: **TF**  
Description: **Tap Factory**

Distance (ft): **56.2**  
Structural Grade: **0**  
O&M Grade: **0**  
Clock Start/From: **10**  
Clock To:  
1st Value: **4.000**  
2nd Value:  
Value Percent:  
Continuous Index:  
Within 8" of Joint:  
Remarks:

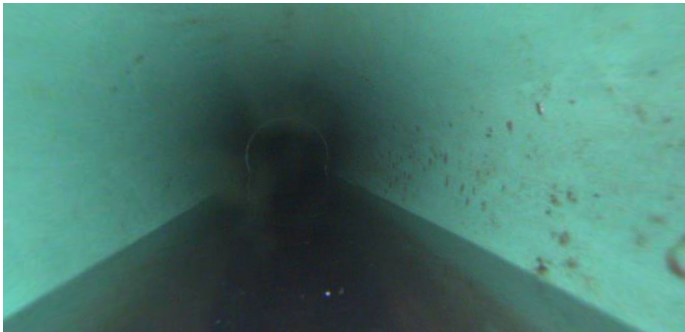
Code: **MWL**  
Description: **Water Level**

Distance (ft): **96.6**  
Structural Grade: **0**  
O&M Grade: **0**  
Clock Start/From:  
Clock To:  
1st Value:  
2nd Value:  
Value Percent: **30.000**  
Continuous Index:  
Within 8" of Joint: **NO**  
Remarks:

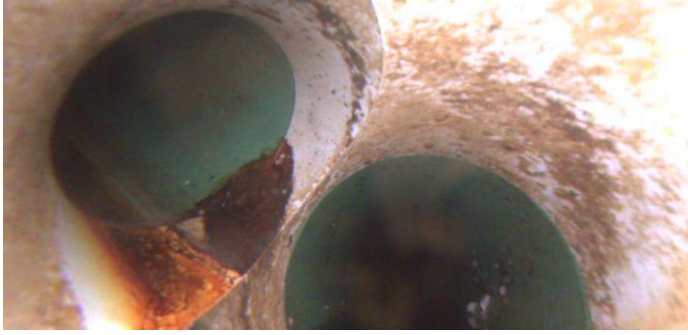
Code: **TF**  
Description: **Tap Factory**

Distance (ft): **104.8**  
Structural Grade: **0**  
O&M Grade: **0**  
Clock Start/From: **10**  
Clock To:  
1st Value: **4.000**  
2nd Value:  
Value Percent:  
Continuous Index:  
Within 8" of Joint:  
Remarks:

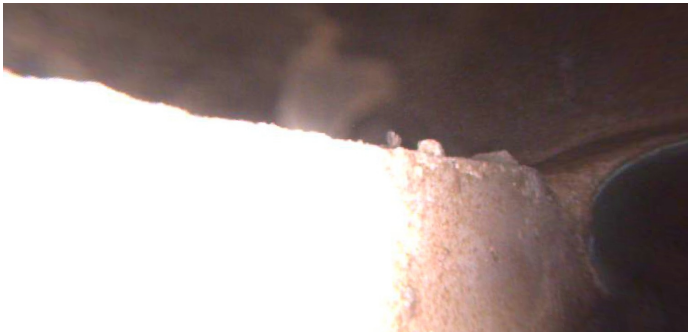
Code: **AMH**  
Description: **Manhole**

Distance (ft): **115.9**  
Structural Grade: **0**  
O&M Grade: **0**  
Clock Start/From:  
Clock To:  
1st Value:  
2nd Value:  
Value Percent:  
Continuous Index:  
Within 8" of Joint: **NO**  
Remarks: **M-708-134**
