Profile/Photo Observation Report

Street:	Magnolia	Flow Control:	Not Controlled
City:	Hobart, IN	Year Renewed:	
Location:	Sidewalk	Tape/Media #:	
Purpose:	Maintenance Related	Dia/Height:	8"
Use:	Sanitary	Material:	PVC
Drain Area:	NA	Lining:	Cured in Place
Category:	NA		
Comment:	Flow direction wrong.

Location Details:		Direction of Survey:	Downstream
US MH:	M-708-133	DS MH:	M-708-134
		Total Length Surveyed (ft):	115.9

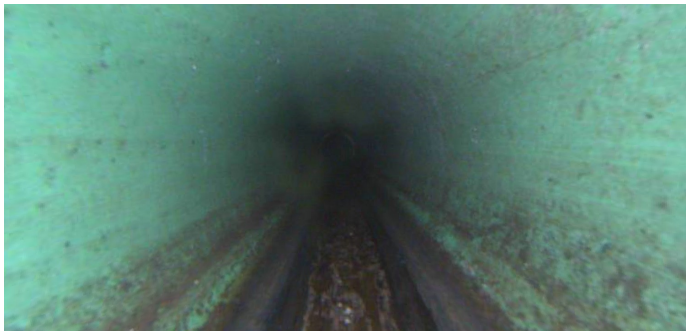
Code: **AMH**
Description: **Manhole**

Distance (ft): **.0**
Structural Grade: **0**
O&M Grade: **0**
Clock Start/From:
Clock To:
1st Value:
2nd Value:
Value Percent:
Continuous Index:
Within 8" of Joint: **NO**
Remarks: **M-708-133**

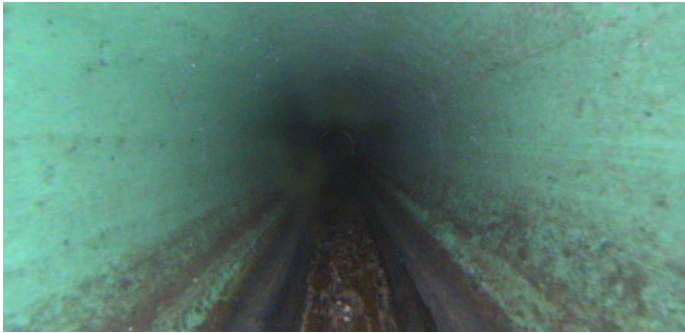
Code:	MWL
Description:	Water Level

Distance (ft):	.0
Structural Grade:	0
O&M Grade:	0
Clock Start/From:	
Clock To:	
1st Value:	
2nd Value:	
Value Percent:	5.000
Continuous Index:	
Within 8" of Joint:	NO
Remarks:

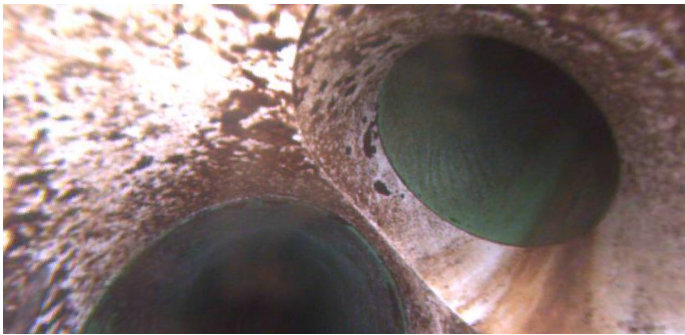
Code:	TF
Description:	Tap Factory

Distance (ft):	6.0
Structural Grade:	0
O&M Grade:	0
Clock Start/From:	2
Clock To:	
1st Value:	4.000
2nd Value:	
Value Percent:	
Continuous Index:	
Within 8" of Joint:	
Remarks:

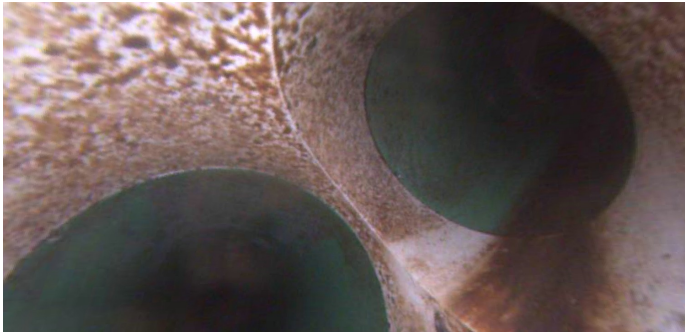
Code: **TF**
Description: **Tap Factory**

Distance (ft): **42.0**
Structural Grade: **0**
O&M Grade: **0**
Clock Start/From: **2**
Clock To:
1st Value: **4.000**
2nd Value:
Value Percent:
Continuous Index:
Within 8" of Joint:
Remarks:

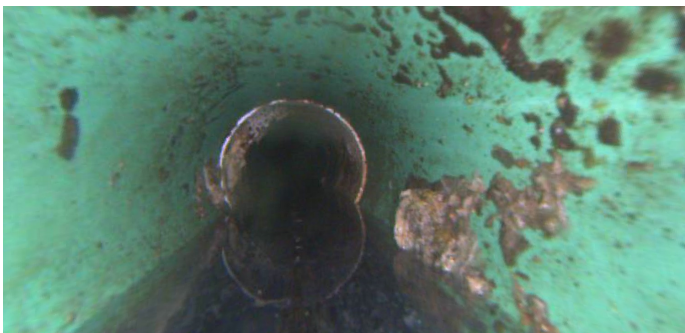
Code: **DAGS**
Description: **Deposits Attached Grease**

Distance (ft): **54.3**
Structural Grade: **0**
O&M Grade: **2**
Clock Start/From: **3**
Clock To: **4**
1st Value:
2nd Value:
Value Percent: **5.000**
Continuous Index:
Within 8" of Joint: **NO**
Remarks:

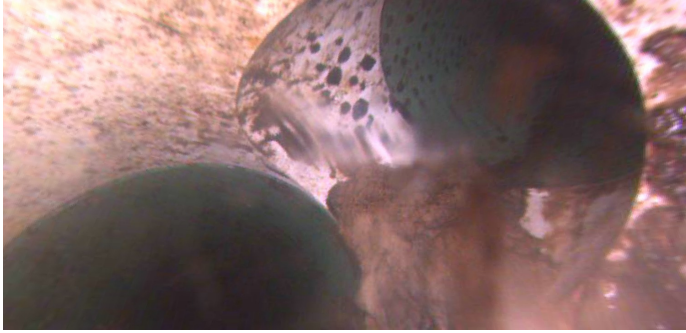
Code: **TF**
Description: **Tap Factory**

Distance (ft): **56.2**
Structural Grade: **0**
O&M Grade: **0**
Clock Start/From: **10**
Clock To:
1st Value: **4.000**
2nd Value:
Value Percent:
Continuous Index:
Within 8" of Joint:
Remarks:

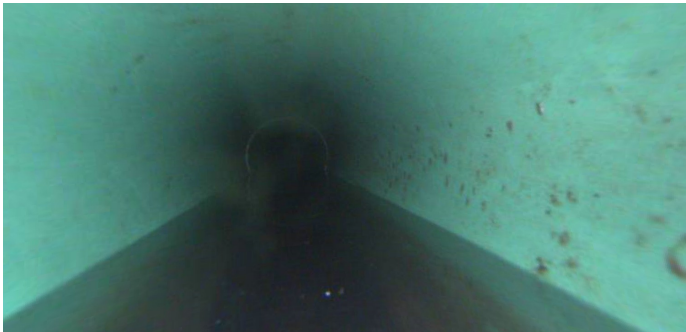
Code: **MWL**
Description: **Water Level**

Distance (ft): **96.6**
Structural Grade: **0**
O&M Grade: **0**
Clock Start/From:
Clock To:
1st Value:
2nd Value:
Value Percent: **30.000**
Continuous Index:
Within 8" of Joint: **NO**
Remarks:

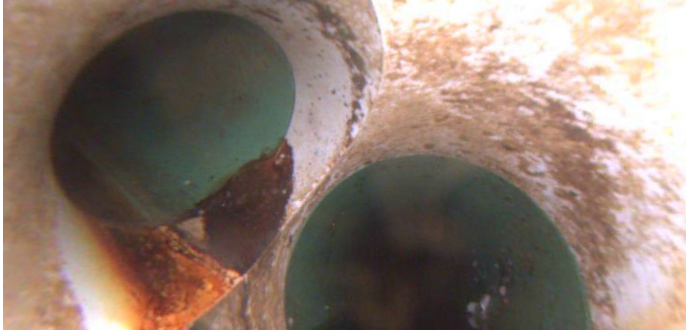
Code: **TF**
Description: **Tap Factory**

Distance (ft): **104.8**
Structural Grade: **0**
O&M Grade: **0**
Clock Start/From: **10**
Clock To:
1st Value: **4.000**
2nd Value:
Value Percent:
Continuous Index:
Within 8" of Joint:
Remarks:

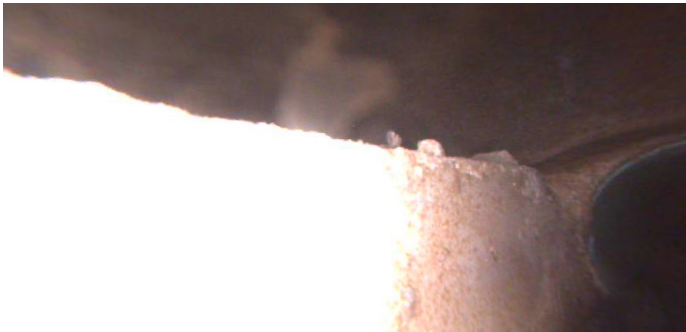
Code: **AMH**
Description: **Manhole**

Distance (ft): **115.9**
Structural Grade: **0**
O&M Grade: **0**
Clock Start/From:
Clock To:
1st Value:
2nd Value:
Value Percent:
Continuous Index:
Within 8" of Joint: **NO**
Remarks: **M-708-134**
